## AVIATION INVESTIGATION REPORT

A07W0099

**LOAD SHIFT/LOSS OF CONTROL ON TAKE-OFF**

**de HAVILLAND DHC-3T C-GZCW**

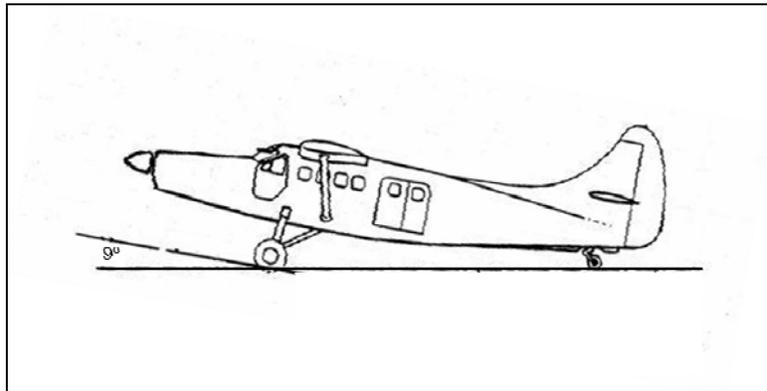
**Figure 1.** de Havilland DHC-3T Turbo Otter

The occurrence aircraft was a de Havilland DHC-3T Turbo Otter manufactured in 1965 (see Figure 1). The aircraft had undergone a Texas Turbine conversion in March 2007 and was equipped with a Garrett TPE 331-10R-511L engine and a Hartzell HC-B4TN-5NL propeller. The aircraft was certified to a maximum take-off weight of 8000 pounds under Supplemental Type Certificate

C-GZCW was loaded with a mixture of rough and finished lumber weighing approximately 2213 pounds. The cargo was composed of six 16-foot rough beams measuring 7 ½ inches by 7 ½ inches, a selection of 16-foot rough lumber, and a selection of 10-, 12- and 14-foot finished boards. The lumber was loaded so that all the boards were flush with the front of the cabin. At rest, the aircraft described a 9° nose-up attitude, resulting in the cargo being loaded in an “uphill” manner while the aircraft was on the ground (see Figure 1). Before the occurrence flight, several loads of lumber had been hauled to the same destination.
