**AVIATION INVESTIGATION REPORT  
A07C0114**

**POWER LOSS - COLLISION WITH WATER**

**EXPEDITION HELICOPTERS INC.  
EUROCOPTER AS 350 B-2 C-FLUK  
BERNICK LAKE, SASKATCHEWAN  
01 JULY 2007**

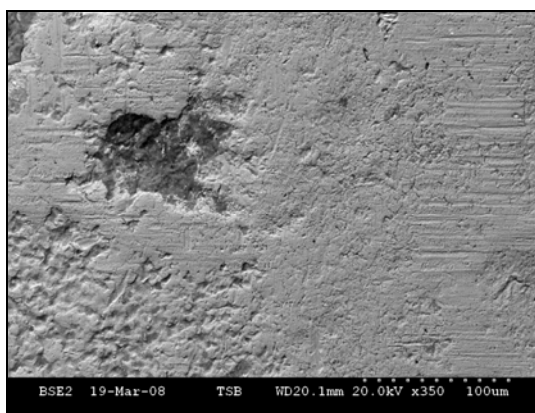
The number two bearing was examined visually and localized areas of corrosion were noted. Rub marks were found in the corrosion and the pit edges on the rollers and inner ring were burnished and plastically deformed, indicating that the number two bearing was operated for some time subsequent to the formation of the corrosion pits (see Photo 1). The number three bearing was destroyed (see Photo 2 and Photo 3); however, examination of the less damaged portions of the number three bearing's outer ring revealed corrosion pits and spalls similar to those observed on the number two bearing.

**Photo 1.** Scanning electron micrograph of a representative roller of the No. 2 bearing

The burnishing and plastic deformation of the corrosion pit edges on the number two bearing indicate that the number two bearing was operated subsequent to the formation of the corrosion pits. Consequently, the corrosion pitting of the number two bearing occurred prior to the engine being submerged in the lake. Since the number two and number three bearings are located close to each other and share the same lubrication system, the number two and number three bearings would have been exposed to the same environmental conditions. Consequently, since the corrosion pitting of the number three bearing is similar, the corrosion pitting of the number three bearing also occurred prior to the engine being submerged in the lake. Therefore, it is likely that corrosion pitting caused the failure of the number three bearing.

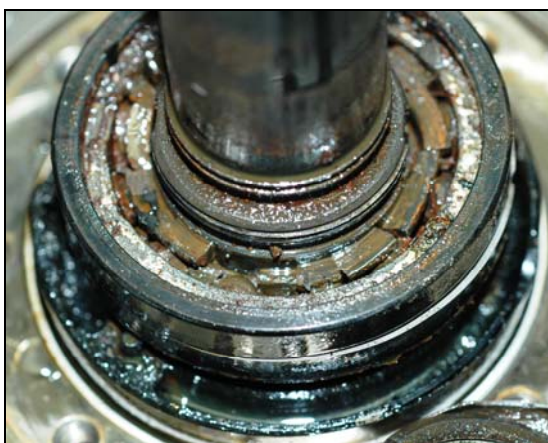
**Photo 2.** No. 3 bearing as-received condition

The engine's number three bearing failed, resulting in a rearward movement of the power turbine shaft which cut the engine's Py line. As a result, the engine's rotational speed decreased to about ground idle speed, which is insufficient to sustain flight. Since there was no message from the helicopter by the survey technician indicating any emergency condition, it is likely that the power loss occurred quickly and that there was little advance warning of the impending bearing failure.

1. The number three bearing of the engine's power turbine failed and engine power was automatically reduced to about ground idle, requiring the pilot to conduct an autorotation. The bearing likely failed when corrosion pitting occurred during a period where the required storage procedures were not followed.
