AVIATION INVESTIGATION REPORT
A07Q0014

FUEL STARVATION

PROPAIR INC.
DHC-2 BEAVER C-GUGQ
LA GRANDE-4, QUEBEC, 25 nm N
21 JANUARY 2007

Report Number A07Q0014

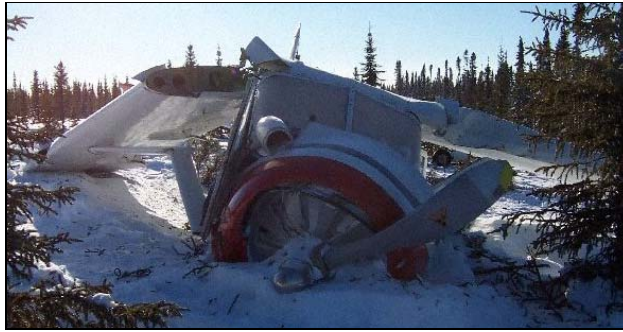
Photo 1. View of the position of the wings

After the accident, the wing tips were touching the ground; as a result, the remaining fuel ran to the outboard part ⁴ of the tanks. These fuel tanks contained less fuel than the unusable fuel quantity. Because the fuel filter broke in the accident, the contents of the belly fuel tank (auxiliary tank) drained out onto the ground.

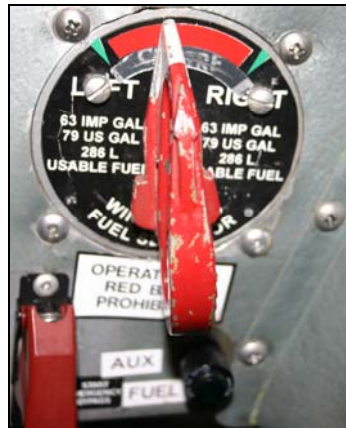
Photo 2. Wing tank selector

During winter operation, being able to select one wing tank or the other was not assured because the secondary cable would freeze. Because of this problem, the company pilots had adopted the practice of placing the wing tank selector in the middle position, as was the case during the occurrence flight. This position partially opened both valves and had shown over the course of several hundred hours of operation that it could provide an adequate flow of fuel to the engine. As this procedure did not conform to the flight manual supplement, the operator should have objected and ensured that the pilots operated the aircraft in accordance with the amended flight manual.

Pilots reported that, because of the longer wings on the aircraft, it was more demanding to maintain coordinated flight than a standard DHC-2. In this case, the partial opening of both valves allowed the fuel to flow toward the low wing. Because of the length of the tanks, the fuel could run to the outboard of one of the tanks, leaving the fuel supply outlet uncovered, especially when the fuel level was low.

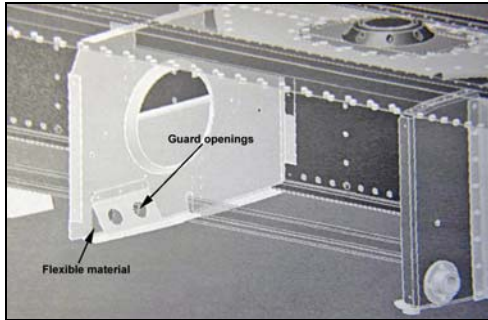
Figure 1. View of the drawing⁷

The flow of fuel between the wings should have stopped in the first compartment of each tank where the fuel supply outlet was located (see Appendix A). These compartments are equipped with a flapper valve to stop the fuel from returning to the outboard compartments. The flapper was made of a flexible material similar to neoprene. It was riveted to the outboard bulkhead, behind a guard (part number MW14-99) that restricted its movement and kept it in proper position. The investigation revealed that the guards were not fabricated in accordance with the drawings (see Figure 1); two round openings about one inch in diameter were not drilled (see

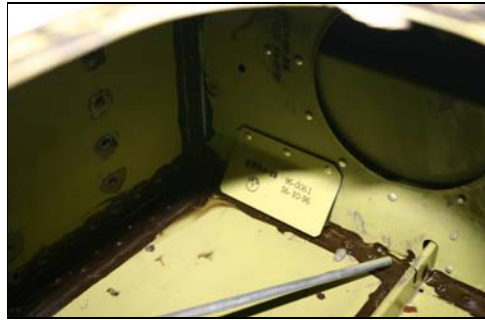
Photo 3. Guard for the flapper valve as installed

Photo 3). Normally, the openings allowed the fuel to put pressure on the flapper and help keep it closed. Without the openings, the fuel could flow around the guard and lift the side of the flapper. Also, the bulkhead is installed at a right angle to the wing. Considering the 2° dihedral angle and that the flapper is only maintained against the bulkhead by gravity, proper sealing was not assured. As a result, fuel could return toward the outboard compartments.

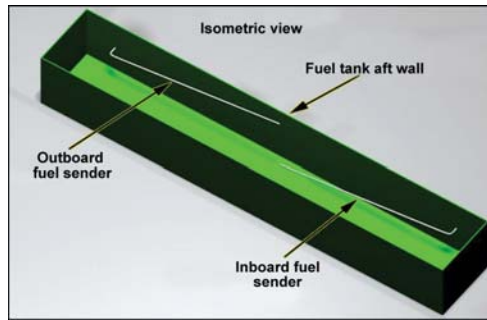
Figure 2. Orientation of the fuel senders in the wing tanks

AWT drawing MF001-005 rev IR specified that the fuel senders had to be bent into an inverted U-shape. However, as per Westach, the model number specified at the AWT drawing cannot be bent into an inverted U-shape. It can only be bent near its anchorage at an angle up to 90°. Consequently, the shape of the fuel senders was in accordance with Westach instructions but the AWT drawing was not. The drawing also wrongly quoted part number WS34T13 for the triple fuel indicator. That part number is not known to Westach. The only indicator recommended for use with their fuel sender is indicator part number A3T13-IV, which was found installed in the aircraft.

The probe of the outboard fuel sender in the left tank had rotated in its base to an almost horizontal position until its tip contacted a bulkhead. Several friction marks on the bulkhead indicated that the probe had moved before the accident. Since the fuel sender was immersed until the tank level reached about half, the signal transmitted to the fuel level gauge was for a full tank.

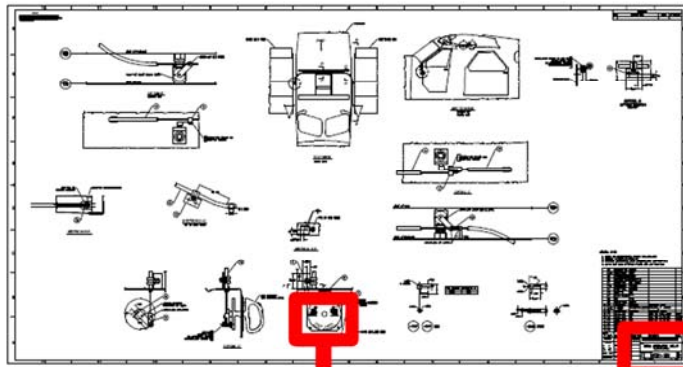
Appendix B – Drawing MF001-003

- the bending of the fuel senders;
- the absence of perforations in the flapper valve guards;
- the wing fuel selector placard did not conform to drawing MF001-003 (Rev IR);
- the error in the flight manual supplement about the cruise flaps position; and
- the description of the fuel system.
