**AVIATION INVESTIGATION REPORT  
A07A0029**

**RUNWAY EXCURSION**

**VOLGA-DNEPR AIRLINES  
ANTONOV AN 124-100 RA-82078  
GANDER, NEWFOUNDLAND AND LABRADOR  
31 MARCH 2007**

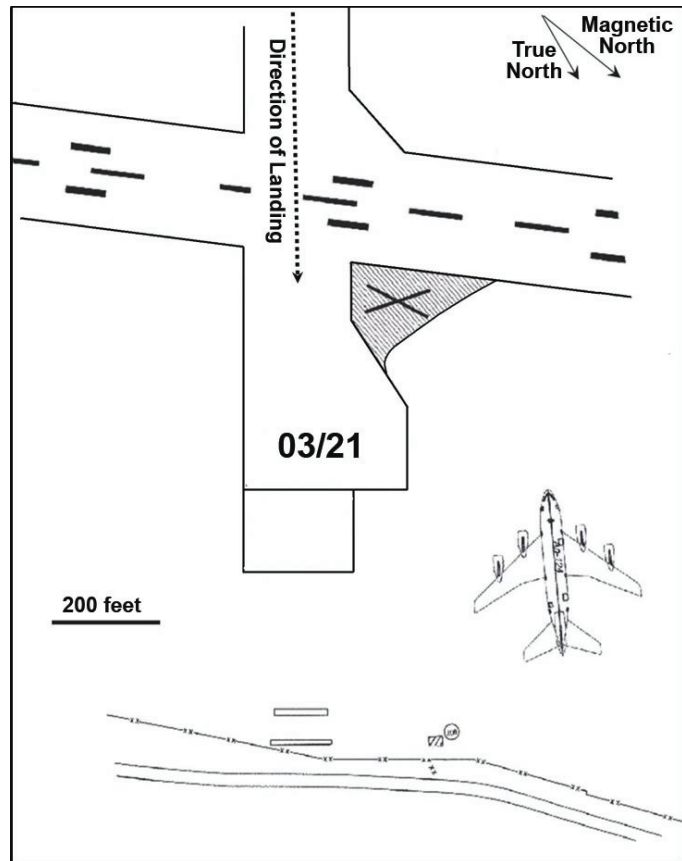
Figure 1. Final position of aircraft

During the latter part of the landing rollout, it became apparent that the aircraft would not stop on the runway. The aircraft was intentionally steered toward the left side of the runway to avoid colliding with ILS equipment located off the departure end of the runway. The aircraft departed the left edge of Runway 03/21, near the runway end at about 35 knots. The aircraft rotated to the left and came to rest approximately 480 feet from the runway end with the aircraft oriented nearly opposite to the direction of landing. The crew conducted an emergency shutdown during which they assessed that an immediate evacuation was not necessary.
