AVIATION INVESTIGATION REPORT

A08Q0055

LANDING WITH NOSE WHEEL RETRACTED

SERVICE AÉRIEN GOUVERNEMENTAL DU QUÉBEC
CHALLENGER CL-600-2A12 C-FURG
QUÉBEC/JEAN LESAGE INTERNATIONAL AIRPORT, QUEBEC
20 MARCH 2008

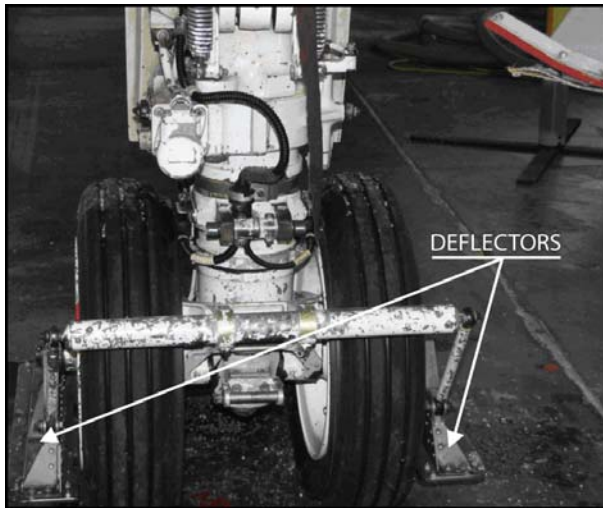
The nose gear consists of a set of dual wheels and two gravel deflectors installed on each side of the tires (see Photo 1). The total width of the landing gear set equipped with the two gravel deflectors is 23.125 inches. The opening of the nose landing gear well structure is 23.625 inches wide. To allow the gravel deflectors to move freely, a modification to the width of the well was done. A notch was made in each side of the well, making the total width 24.250 inches (see Photo 2).

Photo 1. Nose gear defectors

The compression of the oleo strut allowed the landing gear to migrate out of the uplock latch and fall on to the nose landing gear doors. Some nose wheel rotation was also permitted in this unsecured position because the centring cam was no longer engaged in the compressed oleo strut, thereby resulting in the wheel/ deflector assembly not having sufficient clearance for the landing gear to extend normally. The rotation of the nose gear in the well resulted in the right-side gravel deflector becoming stuck, preventing extension of the nose landing gear.

1. The oleo pneumatic shock absorber (oleo strut) was found to be compressed due to a loss of nitrogen. As a result, the nose landing gear was released from the landing gear uplock latch, which allowed the wheel assembly to pivot and become jammed in the well.
2. The right deflector remained jammed in the nose landing gear well, preventing extension of the landing gear.

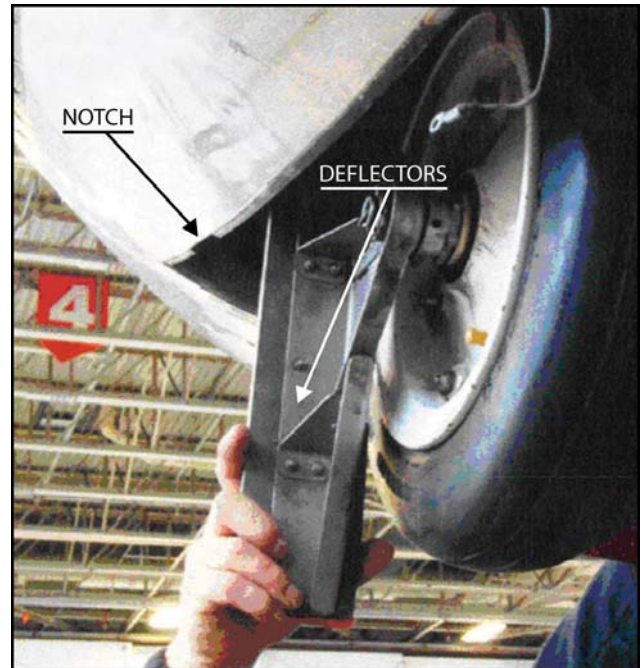
Photo 2. Notch for deflector

When retracting the landing gear, the fully extended oleo strut goes through the notches and the clearance between the defectors and the nose landing gear well structure is 0.562 inches on each side. When the oleo strut does not extend and thus does not pass through the notches, the clearance is reduced by 0.250 inches on each side. For comparison purposes, the clearance between the tires and the structure is 3.562 inches on each side for aircraft not equipped with gravel defectors. Service history on Challenger 601 aircraft indicates no record of oleo nitrogen depletion leading to the inability to extend nose landing gear for aircraft not equipped with a gravel runway kit.

C-FURG is equipped with a kit enabling it to operate on unpaved/ gravel runways. When the oleo strut does not extend, the clearance between the gravel deflectors and the nose landing gear well is reduced to 0.250 inches on each side. Tests with the oleo strut compressed revealed that the gravel deflectors need only pivot a few inches to become jammed in the well. Nevertheless, when the oleo strut operates correctly, the clearance available is sufficient for the landing gear to deploy as designed.

1. The design of the landing gear latch and pin allows the landing gear to be released from the landing gear uplock latch and to drop into the well during flight, causing the right gravel deflectors to jam, preventing extension of the nose landing gear.
2. The clearance between the gravel deflectors and the nose landing gear well structure is very narrow when compared to similar aircraft that are not equipped with gravel deflectors. Another oleo pneumatic shock absorber (oleo strut) compression could result in the same situation occurring again.
