# **AVIATION INVESTIGATION REPORT**

## **A08Q0231**

### **CONTROLLED FLIGHT INTO WATER**

**ROBINSON R44 RAVEN I (HELICOPTER) C-GSVX**  
**LAC SIMON, QUEBEC**  
**03 DECEMBER 2008**

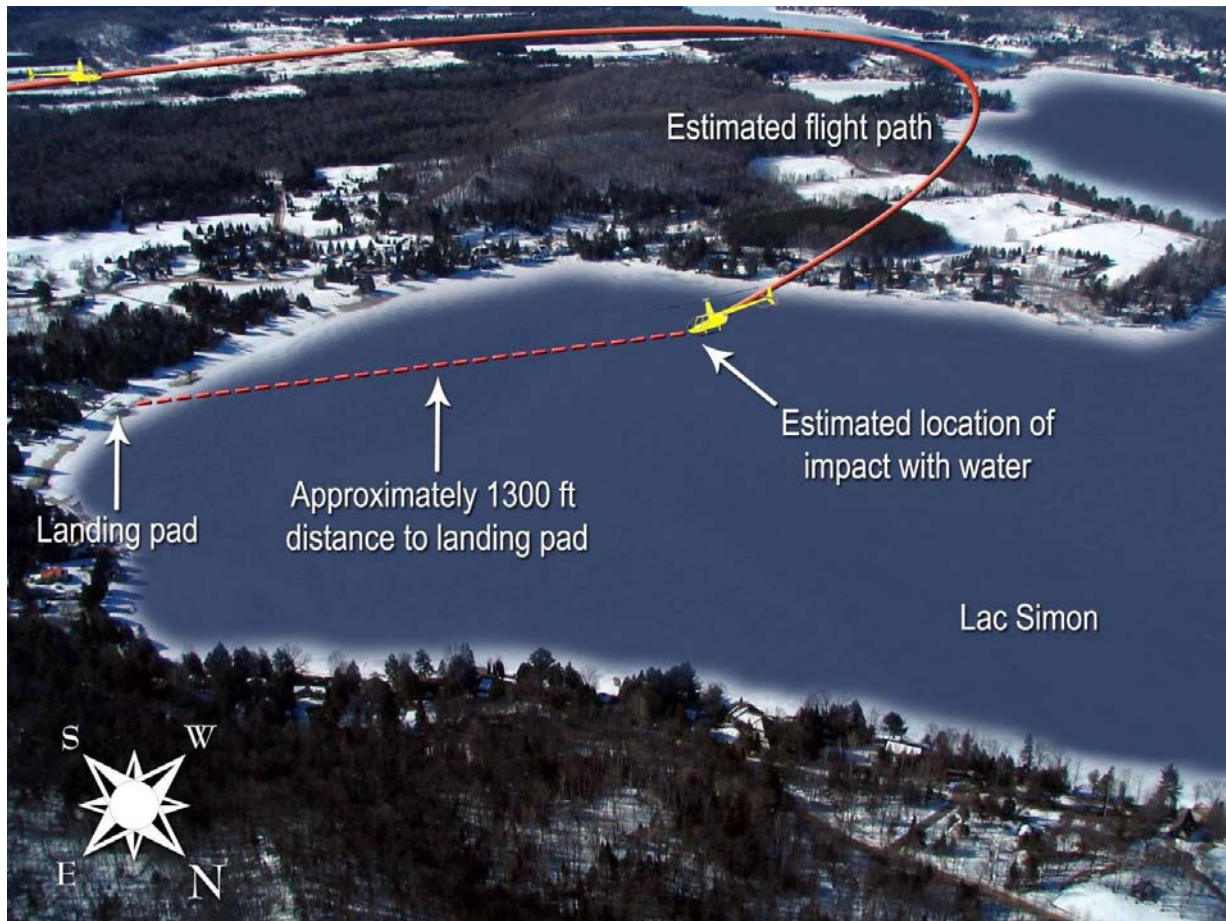
*Appendix A - Estimated Robinson R44 Flight Path before Impact with Water*

Upon arriving at Lac Simon at approximately 1800,<sup>1</sup> the pilot circled the cottage once, then flew by from the southwest side of the bay at approximately 150 feet above ground level (agl) and turned right over the open water for the final approach to the lit landing pad (see Appendix A – Estimated Robinson R44 Flight Path before Impact with Water). The landing pad was equipped with four low-intensity, solar-powered, light-emitting diode (LED) lights; three of the four lights were functional. A small bonfire was visible between the cottage and the landing pad. The helicopter's landing lights were on. Because it was off-season for cottagers, few lights from surrounding dwellings were lit. Only a few street lights were illuminated on the street that contours the bay. After executing a right-hand turn onto final approach, the helicopter descended below the normal final approach glide path to the landing pad and collided with the surface of the water. The helicopter was at an estimated speed of less than 20 knots at the time of impact and flipped on its left side.

The pilot’s cottage is situated in a large bay on Lac Simon (see Appendix A – Estimated Robinson R44 Flight Path before Impact with Water). Although there are cottages situated on the shore all around the bay, few were occupied at the time because it was the winter season. Therefore, very few surrounding dwellings were lit. The environment in which the pilot executed the final approach was dark with very few visual cues to help the pilot identify surrounding objects, textures, and features. These visual cues are necessary for a pilot to properly assess an aircraft’s speed, altitude, rate of closure, and rate of descent while on a descent to land. It is also necessary for a pilot to scan the flight instruments and correlate that information with any perceived outside visual information.
