AVIATION INVESTIGATION REPORT A08W0001

RUNWAY OVERRUN

**NORTHWESTERN AIR LEASE LIMITED
BRITISH AEROSPACE JETSTREAM 3212 C-FNAE
FORT SMITH, NORTHWEST TERRITORIES
04 JANUARY 2008**

Report Number A08W0001

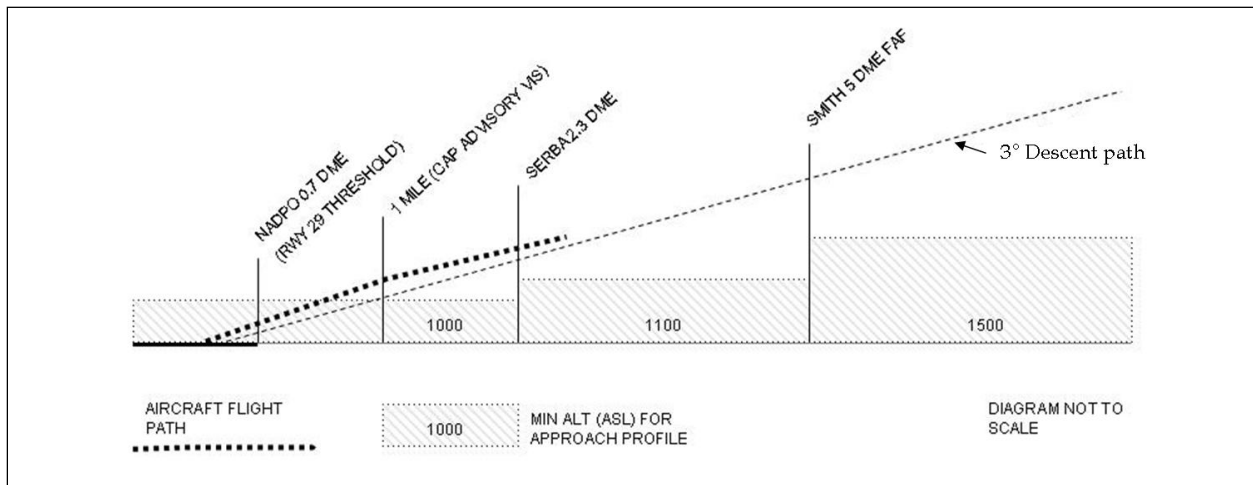
Figure 1. Approach profile

At the 2.3 DME SERBA fix, the aircraft was 200 to 300 feet above the minimum crossing altitude of 1100 feet asl. In accordance with standard operating procedures (SOPs), the crew had added approximately 10 knots to the V_{ref} of 112 knots⁵ due to the existence of light ice observed on the engine inlets during the descent.

The reported ground visibility was below the CAP⁶ advisory visibility. However, the runway clearway and runway identification strobe lights became visible between 1 and 1.5 DME, and the captain transitioned to visual manoeuvring and called for flaps to be increased from 20 degrees to 35 degrees. At that time, the aircraft was between 1200 and 1300 feet asl, which was 200 to 300 feet above the minimum descent altitude for the approach, and between 0.3 and 0.8 nautical miles from the missed approach point. When the VASIS became visible at approximately 1000 feet from the threshold, it displayed 4 white lights, indicating that the aircraft was above the optimum glide path for a normal touchdown. At that point the aircraft was at 500 feet agl. Engine power was reduced, and the descent steepened in an attempt to regain the optimum glide path on the VASIS. The airspeed increased to between 132 and 137 knots.

When the VASIS became visible, the first officer informed the captain that the aircraft was high on the approach. The approach was continued to the landing and a go-around was not proposed by either pilot.

When the VASIS became visible, the aircraft was above the optimum glide path for a touchdown in the first 1000 feet of the runway. In the attempt to regain the glide path, the pilot allowed the airspeed to increase to at least 20 knots above V_{ref} . By the time the aircraft decelerated to a speed allowing a firm touch-down, a considerable portion of the runway was over-flown. The remaining 3400 feet would have been sufficient for the aircraft to stop on a bare, dry runway after a touchdown at, or near, V_{ref} ; however, at a higher touchdown speed on a runway with a CRFI of 0.18 or 0.34, stopping in this distance could not be assured. Conservative CRFI charted landing distances are designed to cue flight crews to consider aircraft performance options for landing. Reference to CRFI charts prior to the approach would likely have prompted the crew of PLR 599 to consider rejecting the landing when the airspeed and height profile exceeded normal parameters.

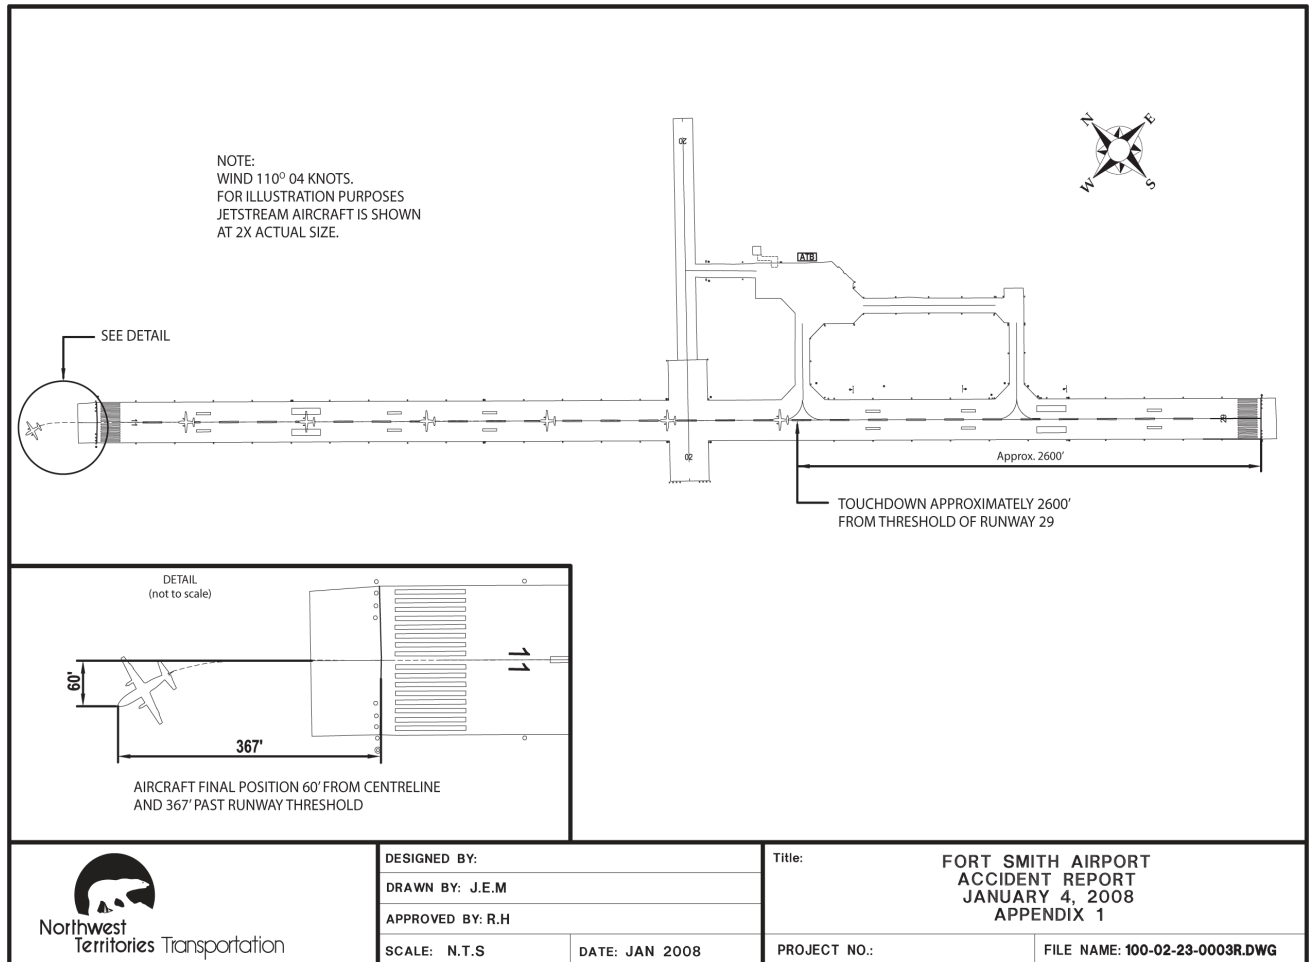
Appendix A - Site Diagram

The aircraft touched down on the centreline of the runway at about 2600 feet from the threshold (see Appendix A - Site Diagram). About 3400 feet of runway remained in which to stop. The touchdown airspeed was at about 120 knots, or 8 knots above the airspeed recommended in the aircraft flight manual (AFM). The power levers were brought to flight idle and after the aircraft slowed to 90 knots, reverse thrust was selected in accordance with flight manual procedures.

Maximum braking with anti-skid was then applied. Braking action was reported to be poor during the landing roll. As the aircraft overran the paved surface, the PF steered the aircraft to the left to avoid the approach lights for Runway 11. During this turn, the right propeller contacted the snow, curling the tips of all four blades. There was no other damage to the aircraft. Steam emanating from the right engine due to snow ingestion was cleared by conducting a venting run on the engine. The passengers were briefed on the situation by the captain and were evacuated by vehicles within 15 minutes.
