## AVIATION INVESTIGATION REPORT A10Q0019

### CABIN FIRE

**SKYJET M.G. INC.  
BEECH 200 C-FSKQ  
SEPT-ÎLES AIRPORT, QUEBEC  
02 JANUARY 2010**

Report Number A10Q0019

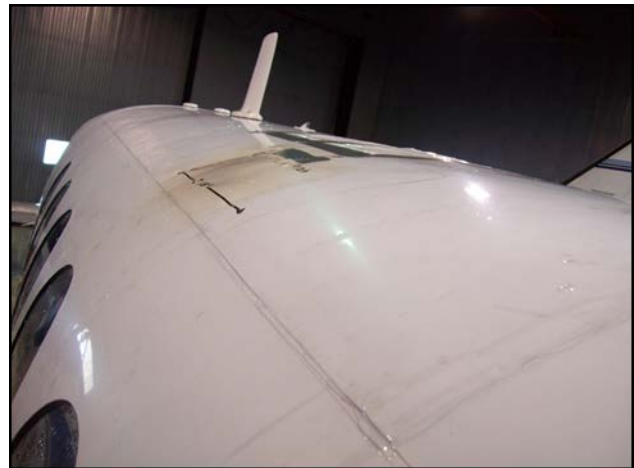
The fire broke out at station 236,<sup>3</sup> on the top left side of the cabin. The skin of the aircraft was significantly damaged between stations 236.25 and 246.75 on the top left side of the cabin. (See photo 1). Following the incident, part of the exterior skin had to be replaced and all the insulation material and fluorescent lighting power supplies were replaced by newer models.

**Photo 1.** Damage as seen from outside aircraft

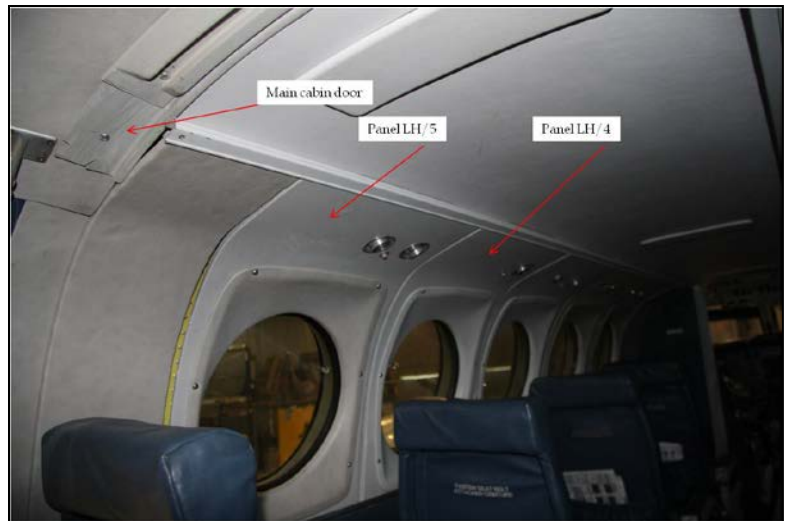
Two interior cabin panels were damaged by fire. The panel identified as LH/5 is located just before the main door on the left side, while panel LH/4 is adjacent to the first, towards the front of the aircraft (see photo 2). The 2 panels were sent to the TSB Laboratory in Ottawa to determine the origin of the fire.

**Photo 2.** Location of undamaged interior cabin panels

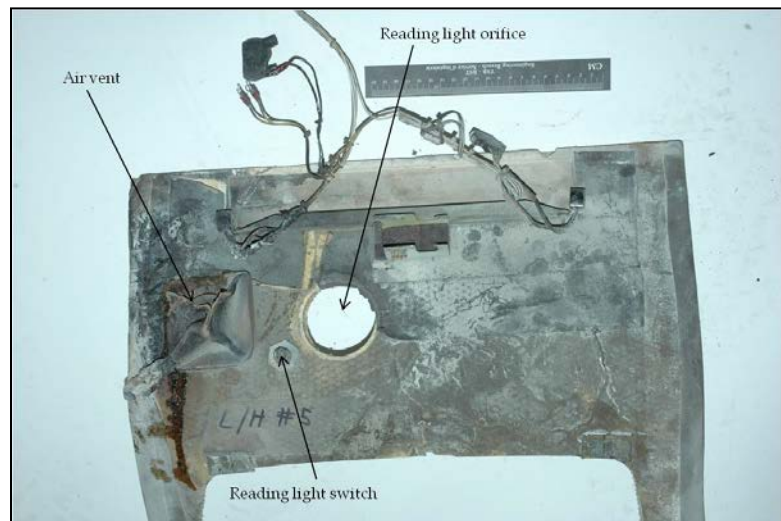
The upper left corner of panel LH/5 was slightly burned. The plastic air outlet housing was completely melted, as was the wire insulating material. There was a deposit of soot over much of the upper section of the panel (see photo 3). A strip of cloth on the top left side was partially burned, and much of the strip at the top of the panel was covered with soot. The front of the panel had no trace of burning. The wiring damaged by the fire showed no evidence of burns caused by electrical arcing.

part number PW-FLC-28. It was received separately from the panel assembly. A lower section of the power supply was damaged, and there were cracks in the housing opposite the connector. There was no sign of burning or overheating of the power supply or its electrical circuit. The power supply was covered with an evenly distributed grey layer of dirt. Some corrosion was observed between connecting pins 1 and 2 that resulted in wear on some of the contact pads.

**Photo 3.** Interior of panel LH/5

The damage to the electrical power supply of panel LH/5 appears to be physical damage, not electrical damage as no evidence of electrical arcing or overheating were found. Since there was no arcing on the wire supplying the power supply, and only dirt on the side near panel LH/4, it is unlikely that the fire originated in panel LH/5.

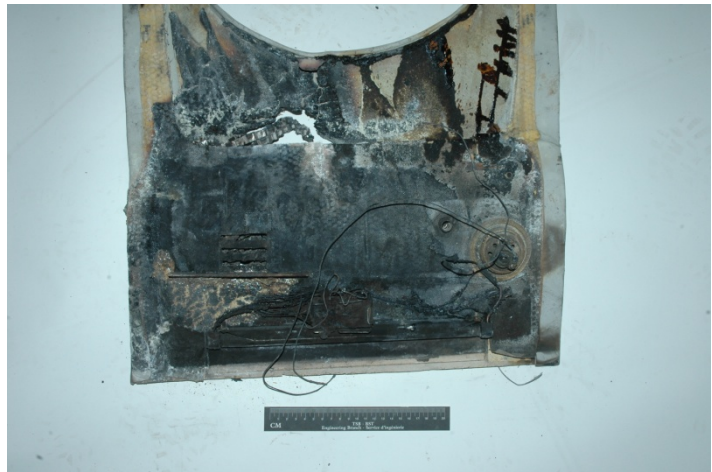
Most of the upper section on the front and back of panel LH/4 was damaged by fire. Some parts were melted to such a degree that perforations were visible in the panel (see photo 4).

An analysis using Fourier Transform Infrared Spectroscopy (FTIR) revealed that the melted plastic found on the panel was composed of a polystyrene-based material. The melted material was from the chime<sup>4</sup> of the FASTEN SEATBELT ordinance light attached to the fuselage just above the mount for panel LH/4. The fluorescent light assembly and the area of the panel located above it contained traces of soot, but did not burn. The fluorescent light electrical wiring showed no evidence of burning as a result of electrical arcing.

The fluorescent light power supply in panel LH/4 was mostly burned and melted. Because of its shape, size and its type of connection, the power supply was found to be similar to the one in LH/5. However, no labelling that could formally identify it was found. The plastic wire connector was melted, but it was still attached to the connector of the fluorescent light power supply. The electrical power supply was removed from its support and the wires were cut in order to be examined. Contacts 1 and 2 were missing, only the fibreglass printed circuit board remained relatively intact while the rest had burned. The metal of contact 1 on the connector had melted into a ball, which is consistent with damage resulting from electrical arcing.

**Photo 4.** Interior of panel LH/4 indicating where the power supply melted and burned

However, arcing between the contacts of the power supply of panel LH/4 and the connector was discovered. It is likely that the fire originated on the connector. There would have been sufficient heat to ignite the strip of fabric located near the power supply. When the strip of fabric ignited, the flames spread to then reach the air outlet, to melt it and to burn it completely.

1. Arcing between the connector and electrical power supply of panel LH/4 produced overheating to the point of igniting the fire.
2. The strip of fabric ignited and spread the fire to the air outlet melted it and burned it completely.
