**AVIATION INVESTIGATION REPORT
A10Q0087**

**COLLISION WITH WATER
LAKE BUCCANEER LA-4-200 (PRIVATE), C-GGFK
LAC BERTÉ, QUEBEC
03 JUNE 2010**

Report Number A10Q0087

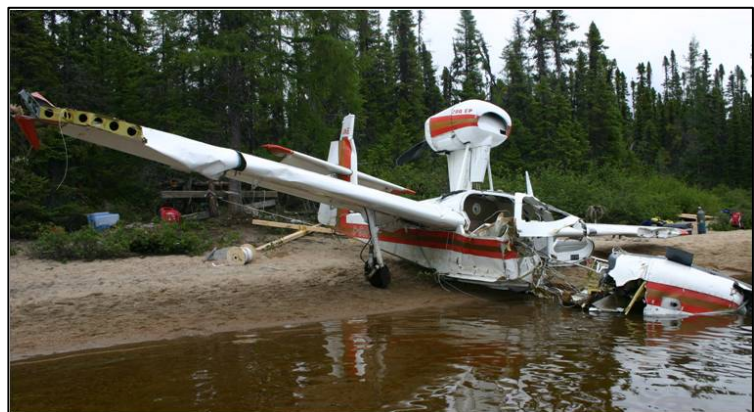
Photo 1. Lake Buccaneer C-GGFK

The aircraft collided with the water at an approximate 20° nose-down attitude, right lateral movement and right wing low attitude. The right wing tip collided with the water first, tearing away the right wing sponson and the outboard portion of the right wing leading edge and wing tip cover (Photo 1). The nose section, from the instrument panel to the nose cone of the aircraft, was torn open from right to left. It remained attached to the rest of the fuselage by the front left side skin, electrical wires and hydraulic lines. The cabin floor was torn apart as the nose section separated from the rest of the aircraft. The seat rails failed in overload as the floor was torn open allowing the seats to come free of the aircraft. The left wing outboard leading edge was flattened as it whipped around to

hit the surface of the water after the right wing and nose struck the water. The tail section and top vertical fin of the aircraft also showed kinks in the aircraft skin indicating the aircraft struck the water while rotating around the right wing. The aircraft was found upside down, resting on the top of the engine, at the bottom of the lake. There were no signs of pre-impact fire or bird strike.

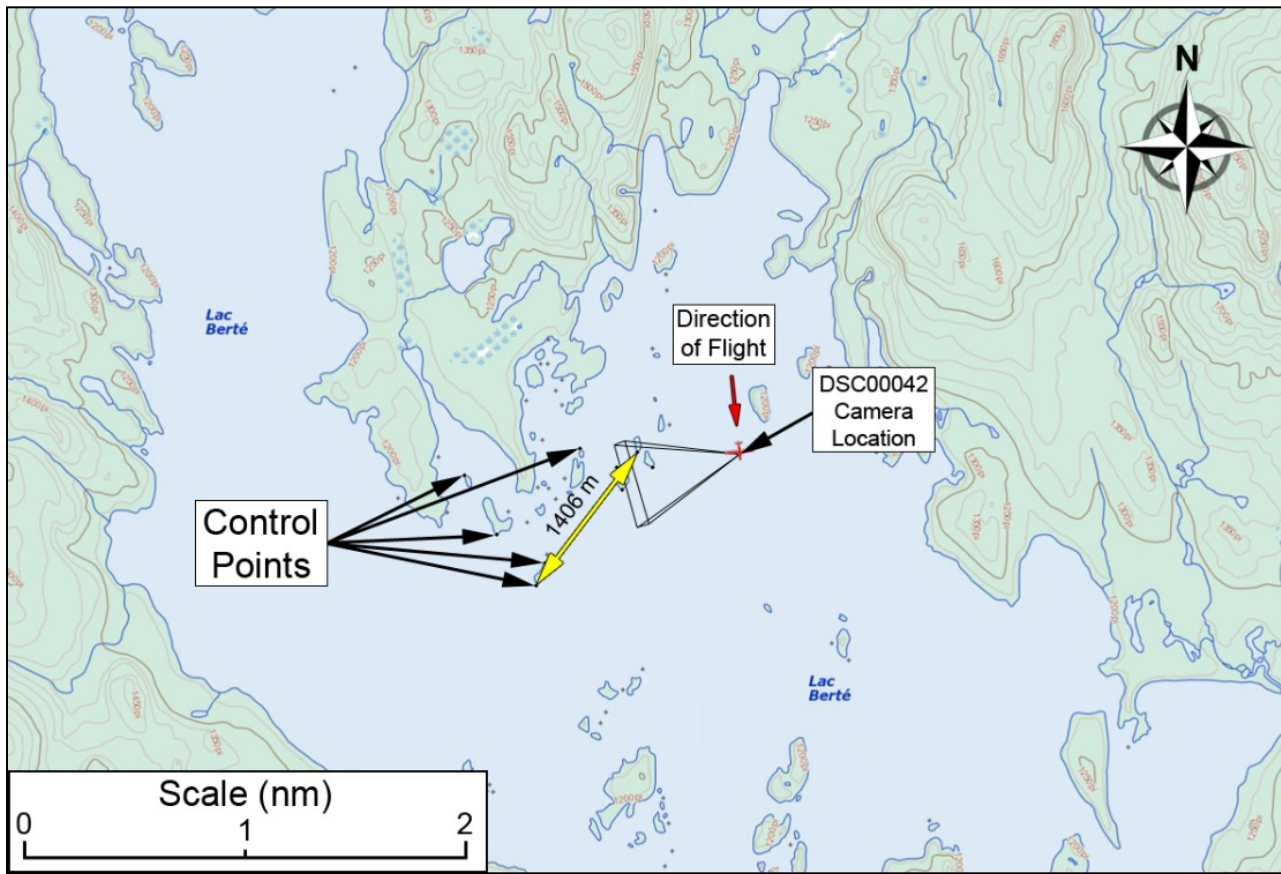
Figure 1. Camera location

Appendix B – Last photo taken with passenger’s camera and its location relative to direction of flight

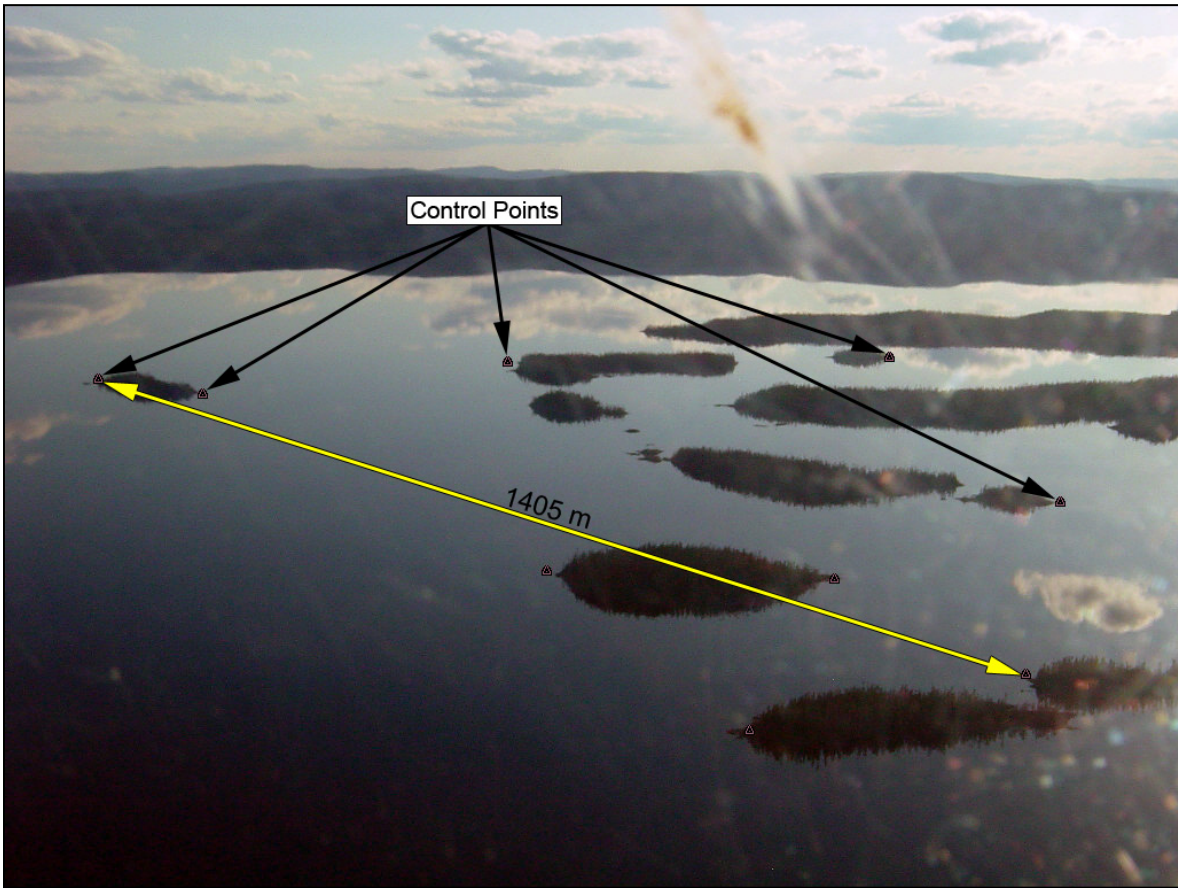
Photo 2. Last photo taken with passenger's camera

The passenger's camera was found in the wreckage. Photos extracted from the camera were taken over a 3-day period coinciding with the 3 days the pilot and passenger spent at the pilot's cottage. The last group of photos shows the aircraft on take-off, heading south from Lac de la Marmotte II towards Lac Berté, and in cruise flight over the tip of the northeast bay of Lac Berté heading south. It was determined that the pictures were taken in the evening because photos show the sun setting to the right, while the aircraft is flying in a southerly direction. This information helped confirm that the occurrence flight took place on the evening of 03 June 2010. The aircraft's altitude as shown on the last photo (Appendix B) was estimated to be approximately 876 feet above the surface of the lake (2073 feet above sea level). The exact time of the occurrence is unknown.

The retrieved photos also helped determine the weather conditions at the approximate time of the occurrence flight. The reflection of the sky and clouds on the surface of Lac Berté, revealed that weather was conducive to VFR flight; it was sunny with scattered clouds, winds were light to nil giving glassy water conditions for the lake surface; no thunderstorm activity or precipitation was visible in the area at the time the photos were taken.
