**AVIATION INVESTIGATION REPORT
A10Q0111**

CONTROLLED FLIGHT INTO TERRAIN AT CRUISING SPEED

**AIR SAGUENAY (1980) INC.
DE HAVILLAND DHC-2 C-GAXL
LAKE PÉRIBONKA, QUEBEC, 12 NM WSW
16 JULY 2010**

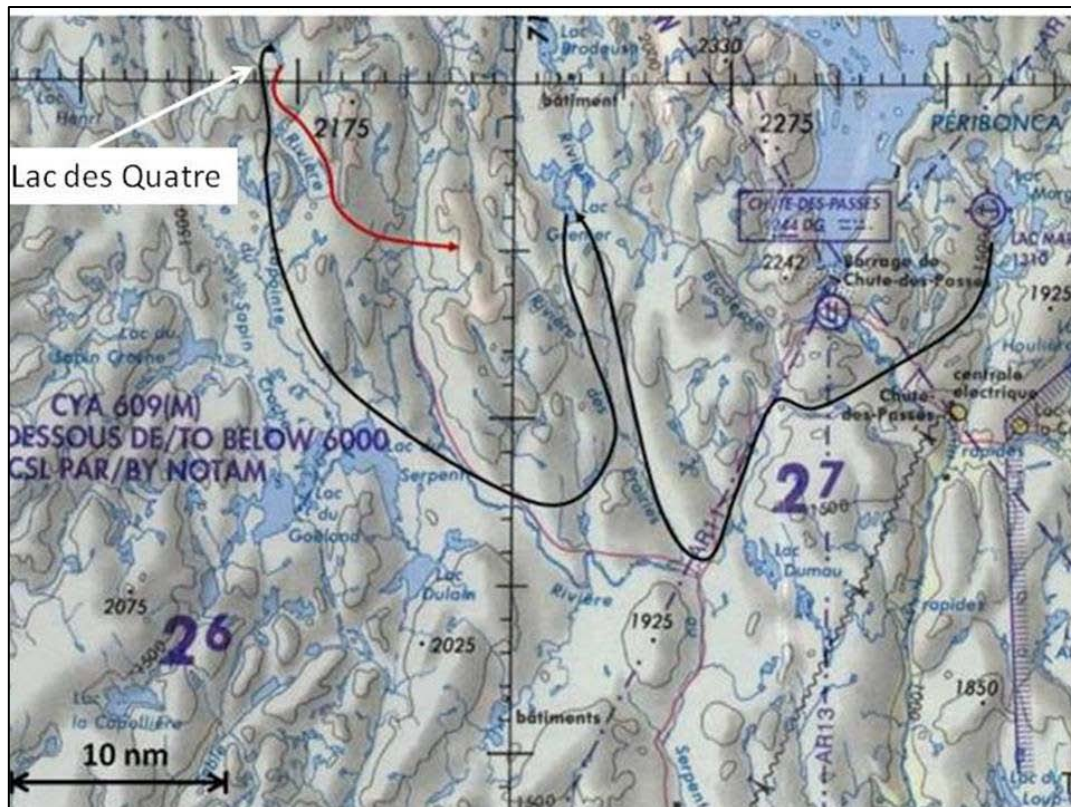
Figure 1. Estimated trajectory

the flight under VFR. This practice is common in the area, since weather observations are limited and conditions can vary considerably from one valley to another. Moreover, the existence of numerous lakes in the area makes this practice convenient (see Figure 1).

At 0813, the pilot landed at Lac Grenier due to adverse weather and notified the base at Lac Sébastien by radio. The linear distance between Lac Margane and Lac Grenier is 13 nautical miles (nm) and the flight time to travel this distance in a straight line is less than 10 minutes. However, due to the weather conditions, the flight in question took 33 minutes.

The prolonged flying times between Lac Margane and Lac Grenier, and between Lac Grenier and Lac des Quatre, indicate that considerable detours had to be made before the flight arrived at its destination. It is therefore likely that the adverse weather conditions forced the pilot to follow the valleys and possibly to divert a few times. Moreover, the scope of these extended flight times suggests that it is quite likely that the weather conditions were below the thresholds prescribed by the CARs.

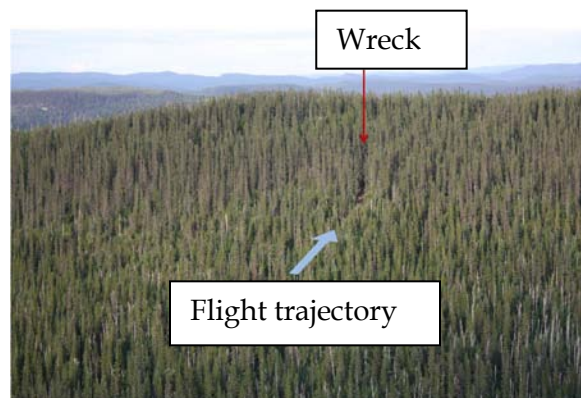
Photo 1. Flight trajectory and position of the wreck on the side of the mountain

The aircraft hit the side of the mountain while flying straight and level, on a 100° magnetic heading, at an altitude of 2100 feet above sea level (asl), approximately 100 feet below the mountain peak (see Photo 1). The slope of the mountainside is approximately 25°. The wings, empennage, floats and engine all became detached from the fuselage from the force of the impact with the trees and the ground. The gasoline tanks located in the lower part of the fuselage broke, and the fuel quickly caught fire.

accident. The aircraft hit the side of a mountain at approximately 100 feet from the peak during level flight, in adverse weather conditions. Consequently, this analysis will focus on the decision to carry out this VFR flight in bad weather, and on the survival of the occupants.

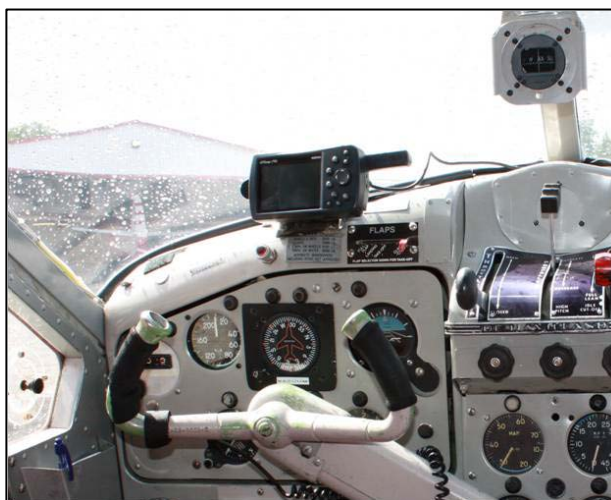
Photo 2. Similar installation of a GPS on the dashboard

The pilot used his own portable global positioning system (GPS) ⁶ attached to the dashboard (see Photo 2). The GPS enables the pilot to improve the accuracy of navigation or to carry out a diversion efficiently. The GPS complements the maps; it cannot replace up-to-date maps. It lets the pilot know his position at all times.

A few moments prior to the impact with the trees, an "X" on a red background was observed on the screen of the GPS attached to the dashboard.

During a flight in adverse weather conditions, the pilot focuses his attention on maintaining visual reference with the surface and sometimes through the side window, thereby reducing his attention to the GPS screen. There is reason to believe that the pilot did not see the "X" on the GPS screen, since the pilot did not perform any avoidance manoeuvre.

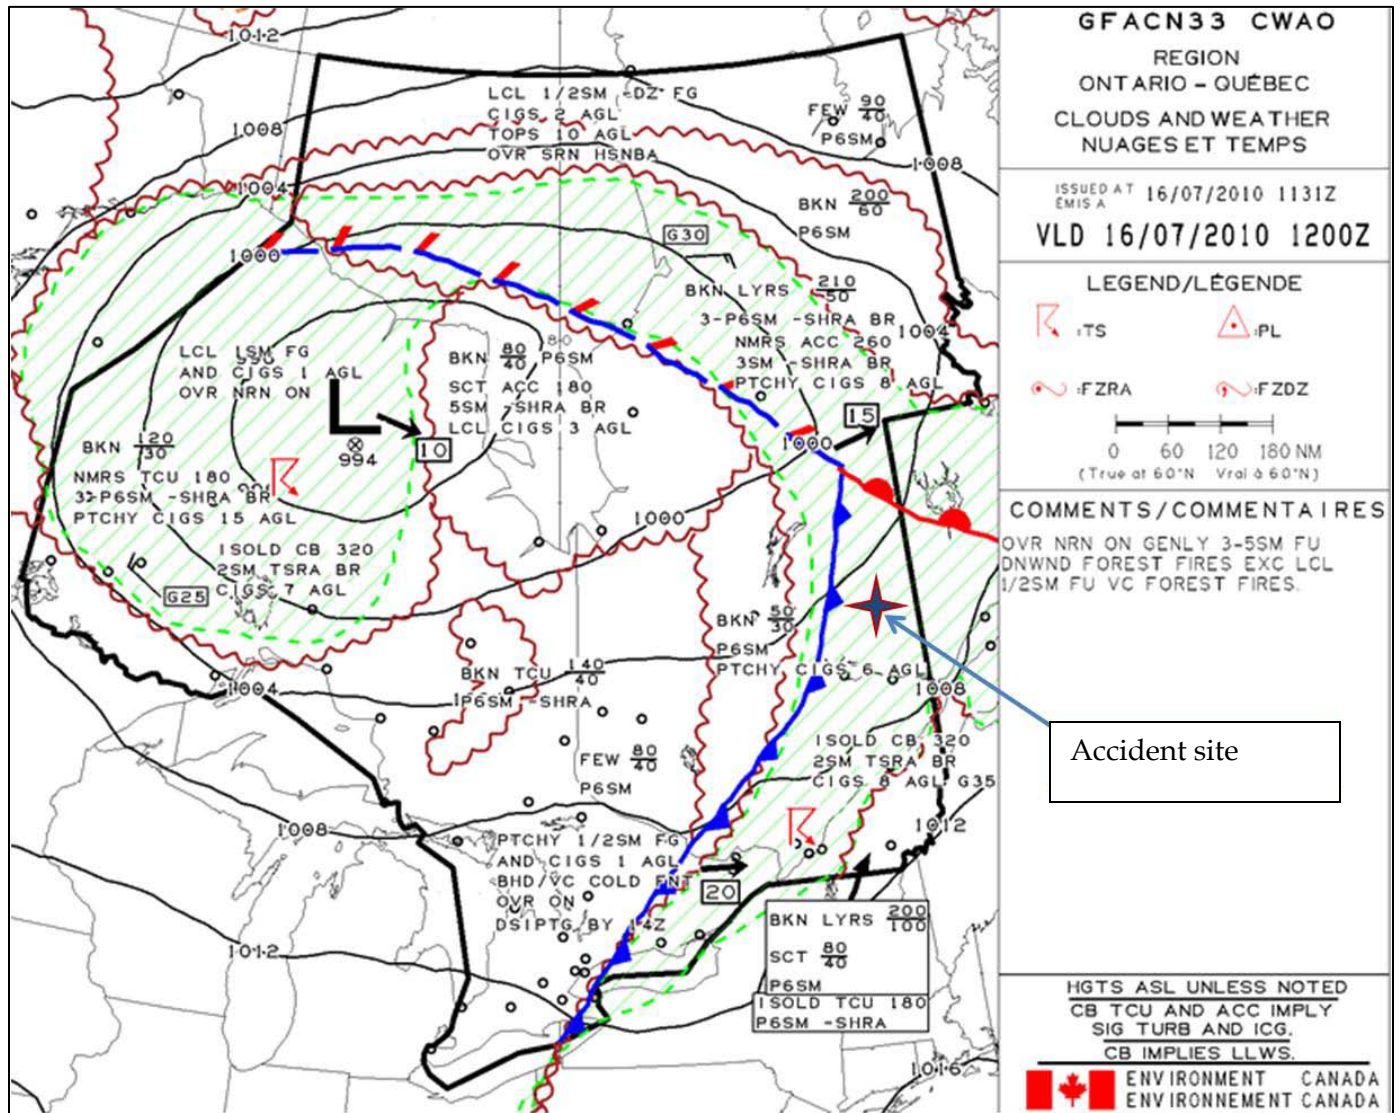
Appendix A – Graphical Area Forecast (GFA)

On the morning of the flight, the Lac Margane and Lac des Quatre area was affected by a nearby warm front and an approaching cold front moving eastwards at a speed of 20 knots. The graphical area forecast (GFA), valid at 0800, shows a cloudy area with ceilings at 800 feet above ground level (agl). Isolated cumulonimbus clouds with tops of up to 32 000 feet were forecast which could reduce the visibility to 2 statute miles in rainshower and thunderstorm conditions (see Appendix A). West of that area, scattered ceilings at 600 feet agl were also forecast. The base at Lac Margane is equipped with a computer and Internet access that can be used to obtain weather information. The investigation was unable to determine whether the pilot had checked the weather information before his departure.

Although the ceiling and the visibility forecasted in the GFA were, respectively, 800 feet agl and 2 miles, the ceiling was below 300 feet since the base of the clouds covered the peak of the mountains located on the shore of Lac des Quatre, whose elevation is approximately 250 feet above the surface of the lake. Consequently, the weather conditions at the time of the take-off from Lac des Quatre were below the minimum prescribed by the CARs for VFR flights.
