**AVIATION INVESTIGATION REPORT
A10A0122**

**CONTROLLED FLIGHT INTO TERRAIN
AERO PENINSULE LTEE (DBA AIR OPTIMA)
CESSNA 310R, C-GABL
POKEMOUCHE, NEW BRUNSWICK
14 DECEMBER 2010**

Report Number A10A0122

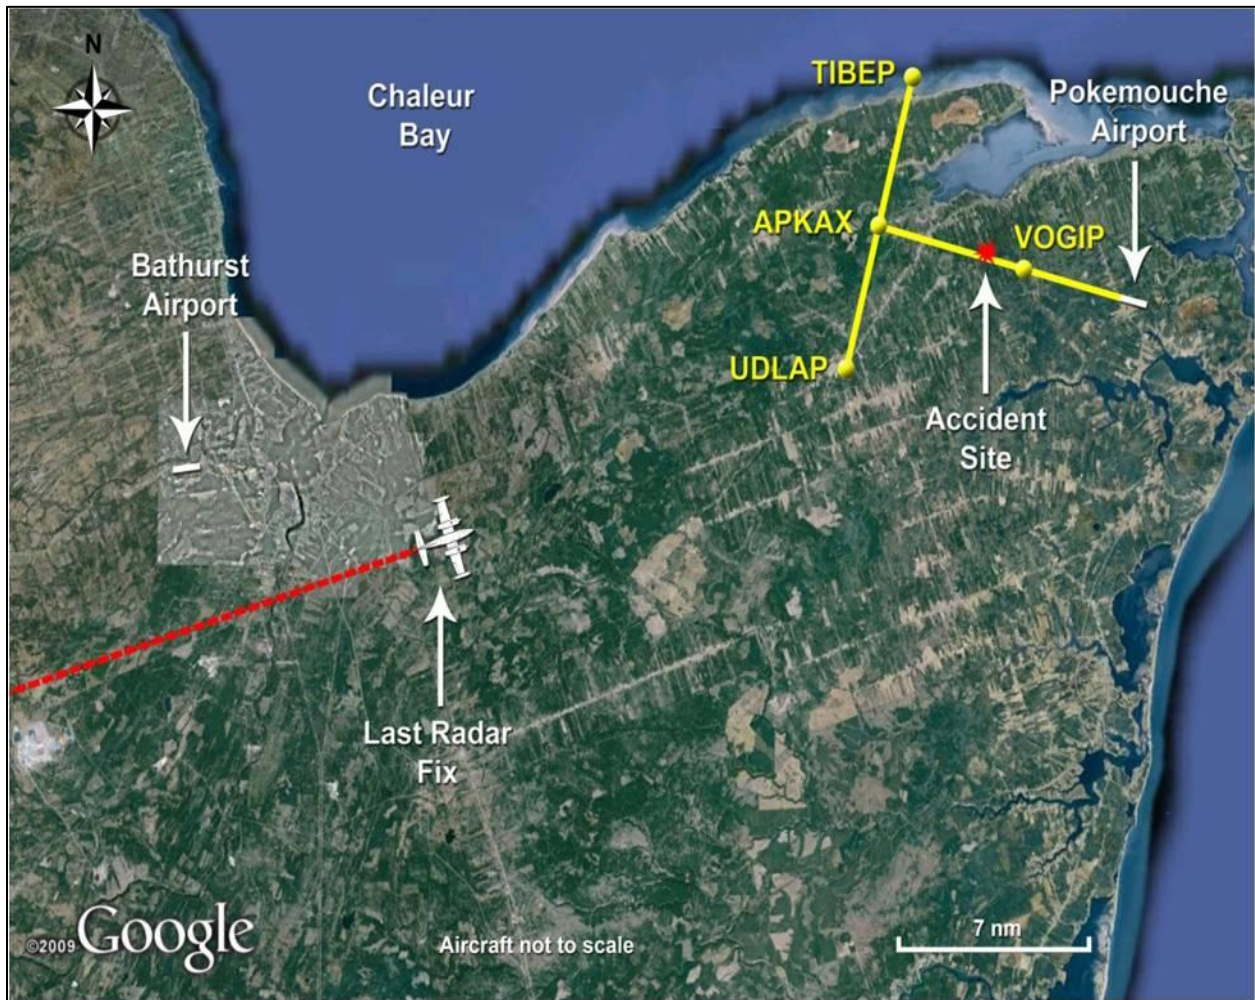
At 2139:09, the aircraft started a normal descent. At 2146:04, approximately 26 nautical miles (nm) from CDA4, the aircraft descended below radar coverage at an altitude of 4400 feet asl.

Figure 1. Aircraft flight path to Pokemouche Airport (CDA4)

The aircraft was located approximately 5.5 nm west-northwest of CDA4, aligned with the final approach segment of the RNAV instrument approach to Runway 13. The aircraft began striking the tops of the trees approximately 70 feet above ground. The tree strike damage and wreckage trail indicate that initial contact with the trees occurred with the wings level in a shallow descent. As the aircraft's forward speed decreased, impact strikes to the right wing caused the aircraft to roll to the right as it continued to descend. The right wing tip fuel tank was found lodged in a tree 235 feet from the main wreckage. The right engine cowl and right aileron were located 153 and 120 feet respectively from the main wreckage. The aircraft struck the ground inverted, approximately 589 feet from the point of initial impact with the trees, and was destroyed by the impact and an intense post-crash fire.

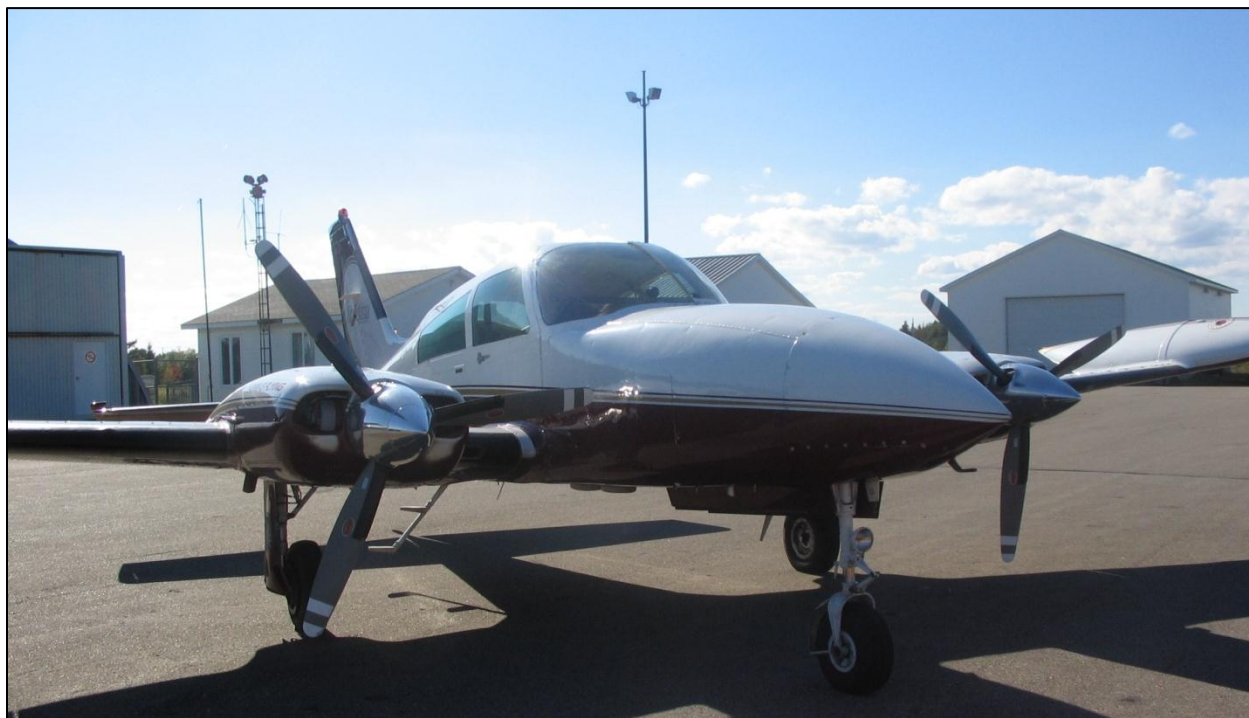
The aircraft was certified, equipped and maintained in accordance with existing regulations and approved procedures. The occurrence aircraft had a 100-hour inspection completed on 19 November 2010 and there was no record of unresolved deficiencies. The weight and center of gravity were within prescribed limits at the time of the accident. The aircraft was equipped and certified for IFR flight, flight into known icing and could carry a pilot and 5 passengers (see Photo 1).

Photo 1. Occurrence Aircraft C-GABL

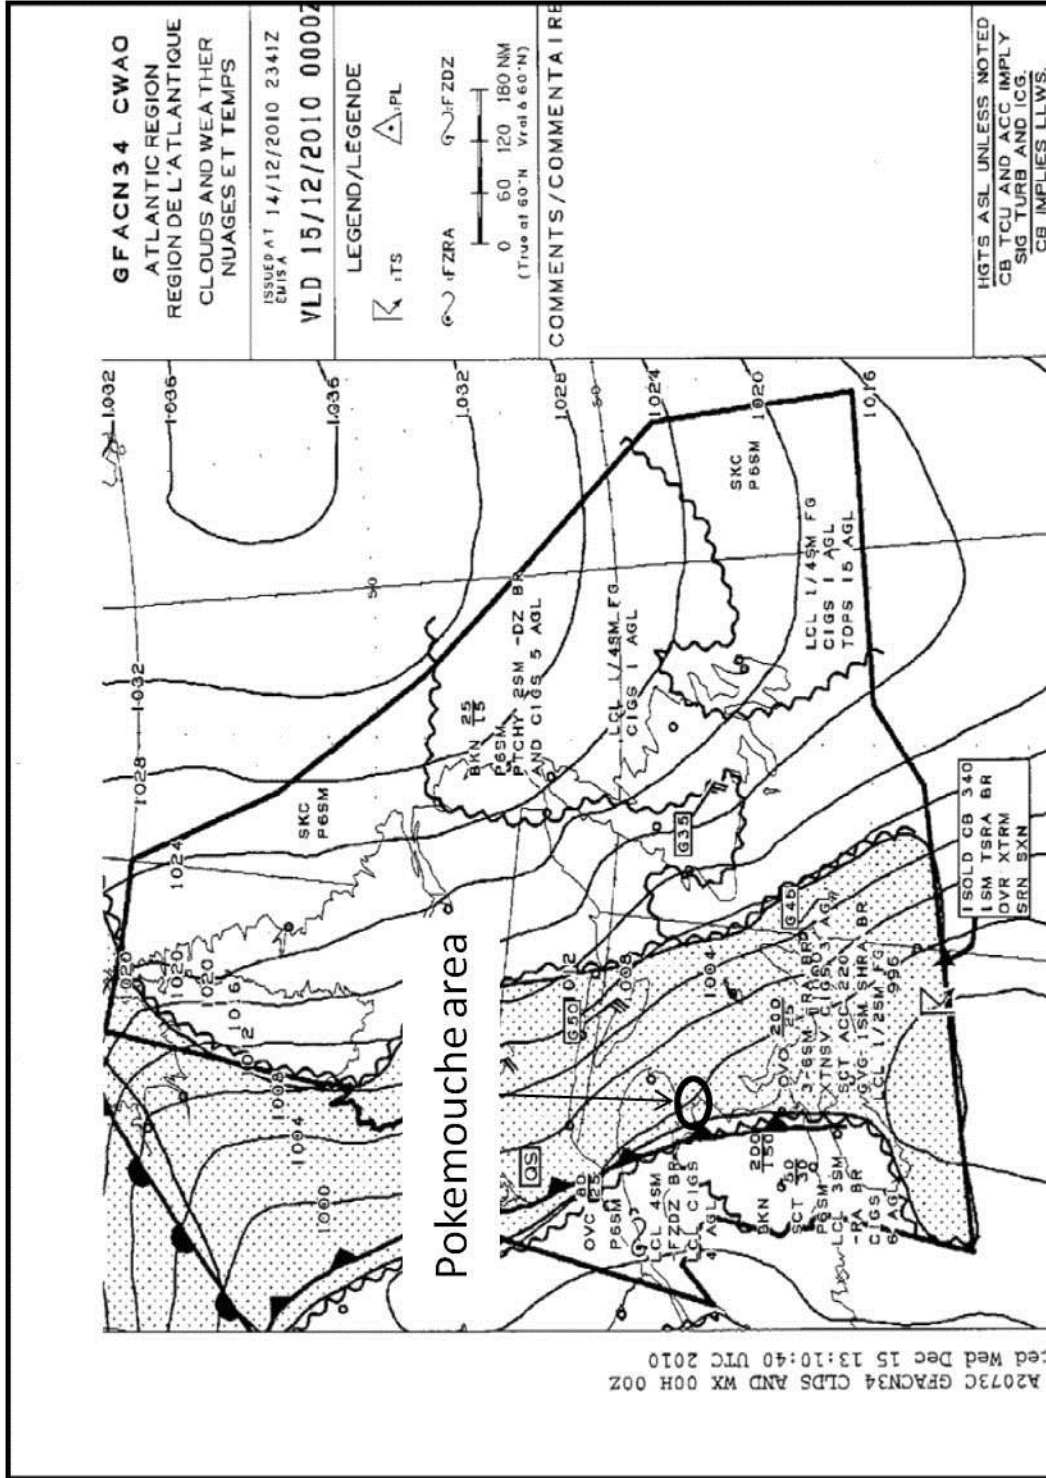
Appendix A - Graphical Area Forecast

and mist. In addition, extensive ceilings based at 300 feet agl with scattered altocumulus castellanus clouds topped at 22 000 feet were forecast, reducing visibility to 1 sm in rain showers and mist with some local conditions of ½ sm visibility in fog. The enroute icing conditions were forecast to be nil to light rime in cloud. A quasi stationary cold front was lying north to south directly over CZBF with these forecasted conditions east of the cold front (see Appendix A).

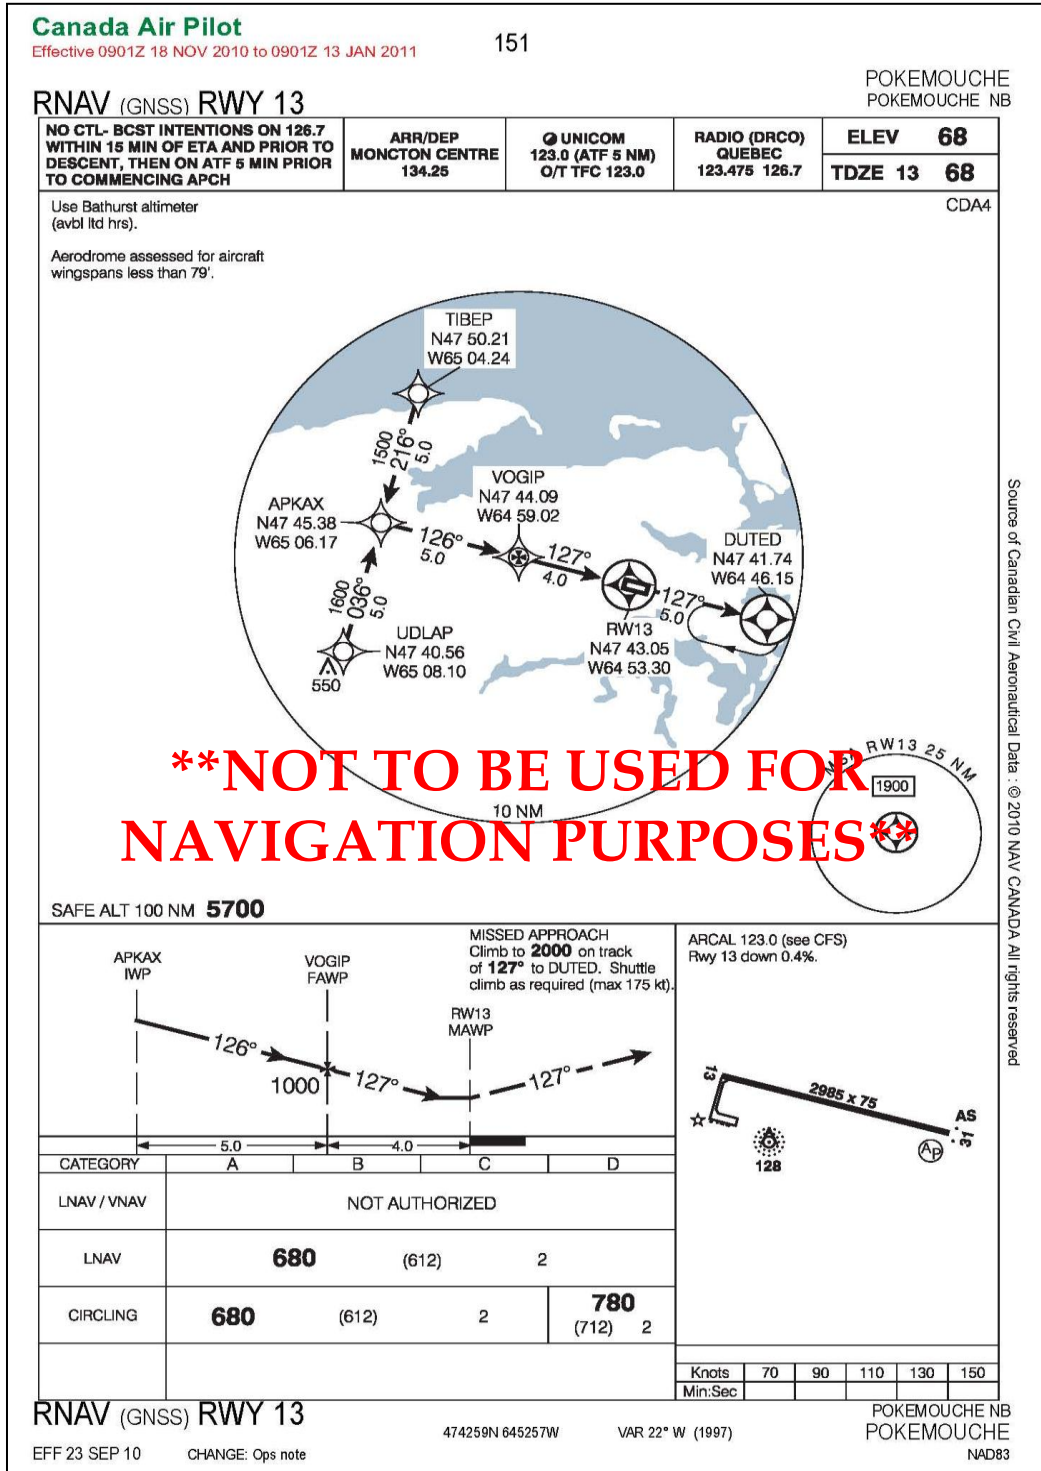
Appendix B – Pokemouche Airport Instrument Approach Chart

CDA4 is a registered aerodrome, located in uncontrolled airspace at an elevation of 68 feet above sea level (asl). The only published approach for Runway 13 is an RNAV (GNSS) approach (see Appendix B). The minimum safe altitude within 25 nm of the airport published on the approach chart is 1900 feet asl. Crossing the UDLAP initial entry point for the approach, an aircraft can descend to a minimum altitude of 1600 feet asl. From the aircraft's last recorded radar position, approximately 15 nm from UDLAP at an altitude of 4400 feet asl and a ground speed of 180 knots, a descent rate of approximately 500 feet per minute would be required to cross UDLAP at 1900 feet for the GPS approach. Once an aircraft reaches APKAX, it can descend to 1000 feet asl until 4 nm from the airport, at which point the final descent may be initiated. The highest terrain between APKAX and Runway 13 is 130 feet asl. There are 2 other published approaches for the Pokemouche Airport, a GPS and a non-directional beacon approach, both on Runway 31. The descent minimum on all 3 approaches is 680 feet asl.
