**AVIATION INVESTIGATION REPORT  
A10Q0218**

**ENGINE FAILURE AND HARD LANDING  
ESSOR-HÉLICOPTÈRES INC.  
BELL 206B (HELICOPTER), C-GIFV  
CAP-CHAT, QUEBEC  
09 DECEMBER 2010**

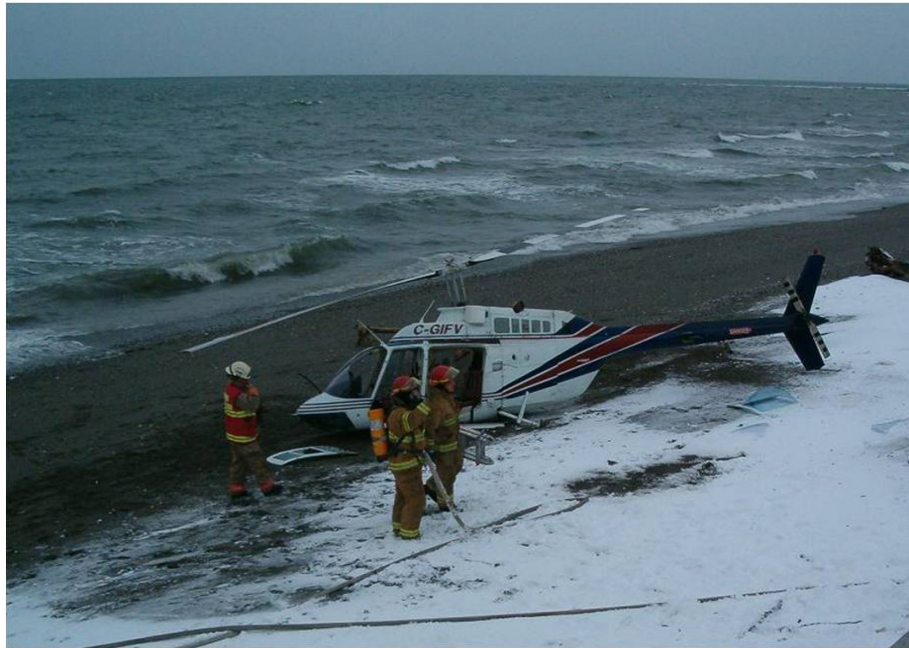
At 1042, C-GIFV landed on the shore of the Saint Lawrence 1 nautical mile (NM) north of Matane Airport and the pilot shut off the engine. At 1104, the helicopter resumed the survey flight, heading northeast. Approximately 27 minutes later, when the helicopter was 120 feet above the river and 75 feet from the shore, travelling at 70 knots, there was a bang and the aircraft briefly yawed right. A few seconds later, another bang was heard. The pilot immediately lowered the collective and turned right to land on the beach into the wind. The low rotor rpm warning horn sounded during the descent. The aircraft landed hard on the sand and the landing gear broke (Photo 1).

**Photo 1.** View of the wreckage

The aircraft had forward speed when it crash-landed on the beach. The skids sank into the sand, causing rapid deceleration and then the rotor mast and gearbox to topple forward. The movement of the gearbox broke the forward joint of the gearshaft connecting the engine to the main gearbox. This movement also caused the hydraulic pump housing and shaft to break. Examination of the aircraft revealed that all damage observed on the fuselage, rotor assembly, flight controls, and power train resulted from the impact with the ground.
