**AVIATION INVESTIGATION REPORT  
A11C0102**

**RUNWAY OVERRUN  
BEAVER AIR SERVICES LIMITED PARTNERSHIP  
(MISSINIPPI AIRWAYS)  
CESSNA 208B, C-FMCB  
PUKATAWAGAN, MANITOBA  
04 JULY 2011**

Report Number A11C0102

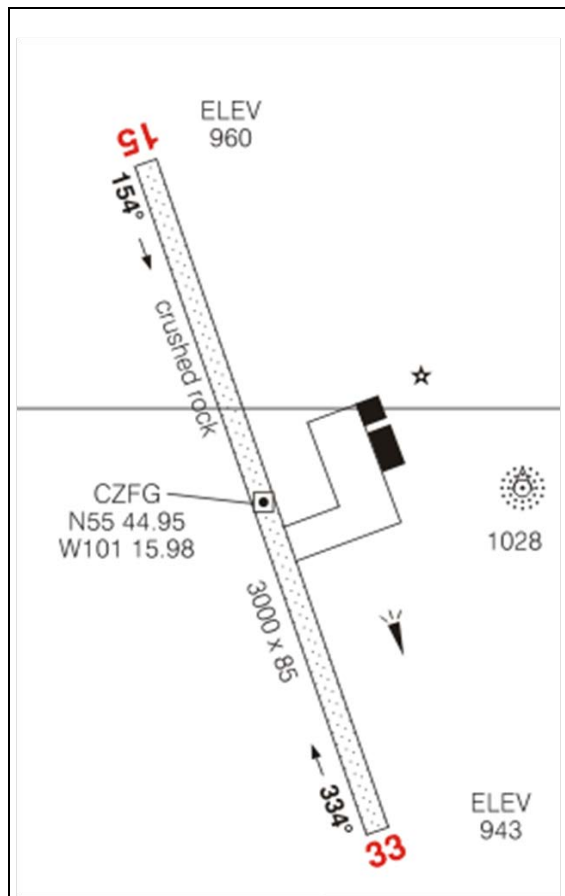
**Figure 1.** Pukatawagan Aerodrome diagram (Source: NAV CANADA, *Canada Air Pilot*, Effective 10 April to 29 July, 2011)

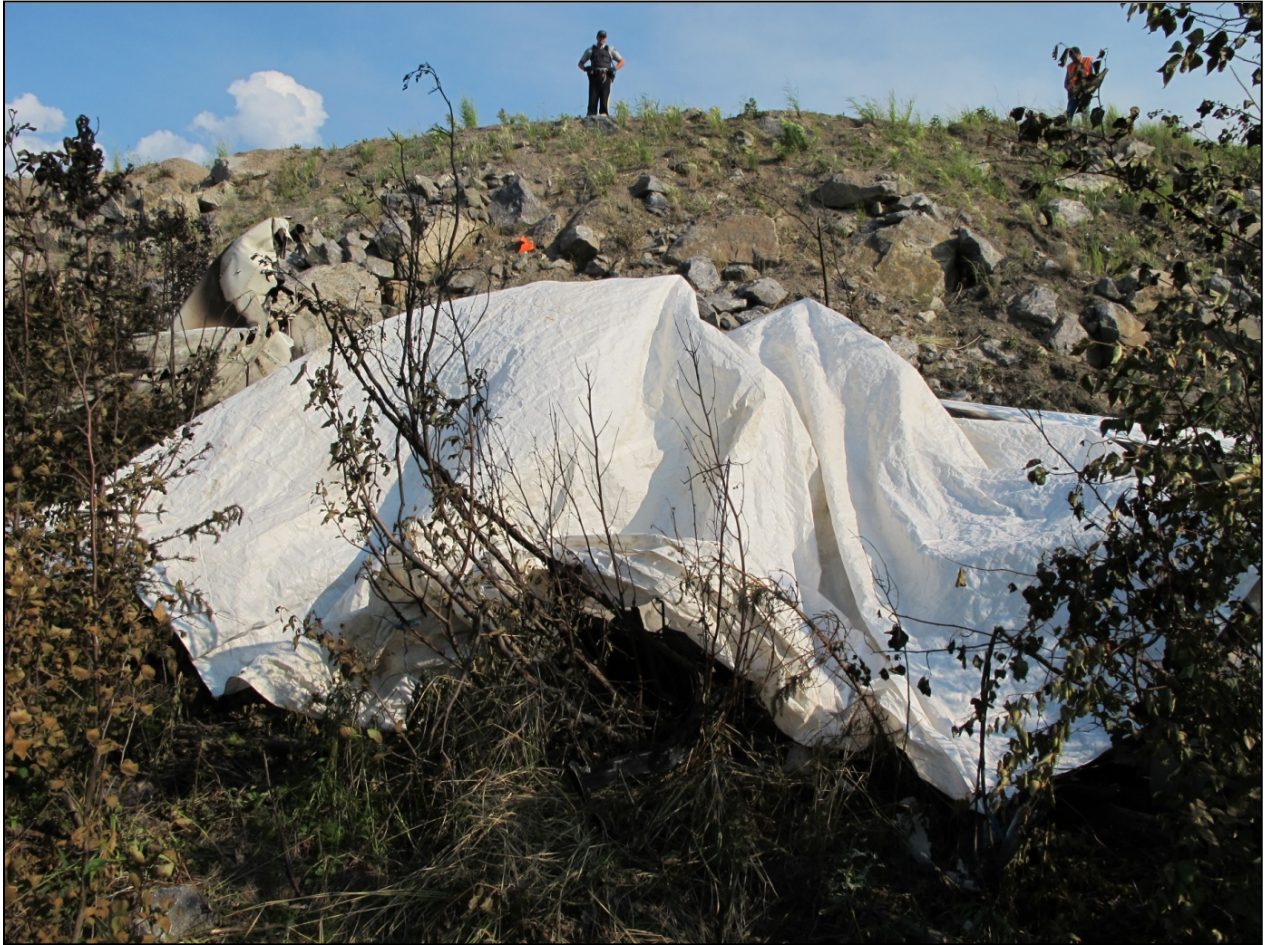
**Photo 1.** Accident site, looking back at the end of Runway 33 (Pukatawagan Airport)

Beyond the turnaround area, the prepared surface gives way to an embankment which descends into a ravine. The slope of the embankment is approximately 30° to 45° and is comprised of gravel, rocks, and large boulders. The slope descends about 20 feet vertically, and then reverses sharply into the contour of a ravine.

The airport runway had been used successfully for Cessna 208 and other aircraft operations for some time. However, during the runway overrun, the steep 20-foot drop-off and sharp slope reversal contributed to the impact damage that led to the deceased passenger's injuries and the fuel system damage that in turn caused the fire. The aircraft's orientation at the bottom of the slope exacerbated the heat effect and the speed at which the fire spread. The hostile terrain at the end of Runway 33 contributed to the occupants' injuries and fuel system damage that in turn caused the fire. This complicated the passenger evacuation and prevented the rescue of the injured passenger.

3. The steep drop-off and sharp slope reversal at the end of Runway 33 contributed to the occupant injuries and fuel system damage that in turn caused the fire. This complicated passenger evacuation and prevented the rescue of the injured passenger.
4. The deceased passenger was not wearing the available shoulder harness. This contributed to the serious injuries received as a result of the impact when the aircraft reached the bottom of the ravine and ultimately to his death in the post-impact fire.
