**RAILWAY INVESTIGATION REPORT
R11E0063**

MAIN-TRACK COLLISION

**CANADIAN NATIONAL RAILWAY COMPANY
FREIGHT TRAIN Q10131-21
MILE 262.76 WAINWRIGHT SUBDIVISION
EDMONTON, ALBERTA
23 JUNE 2011**

Report Number R11E0063

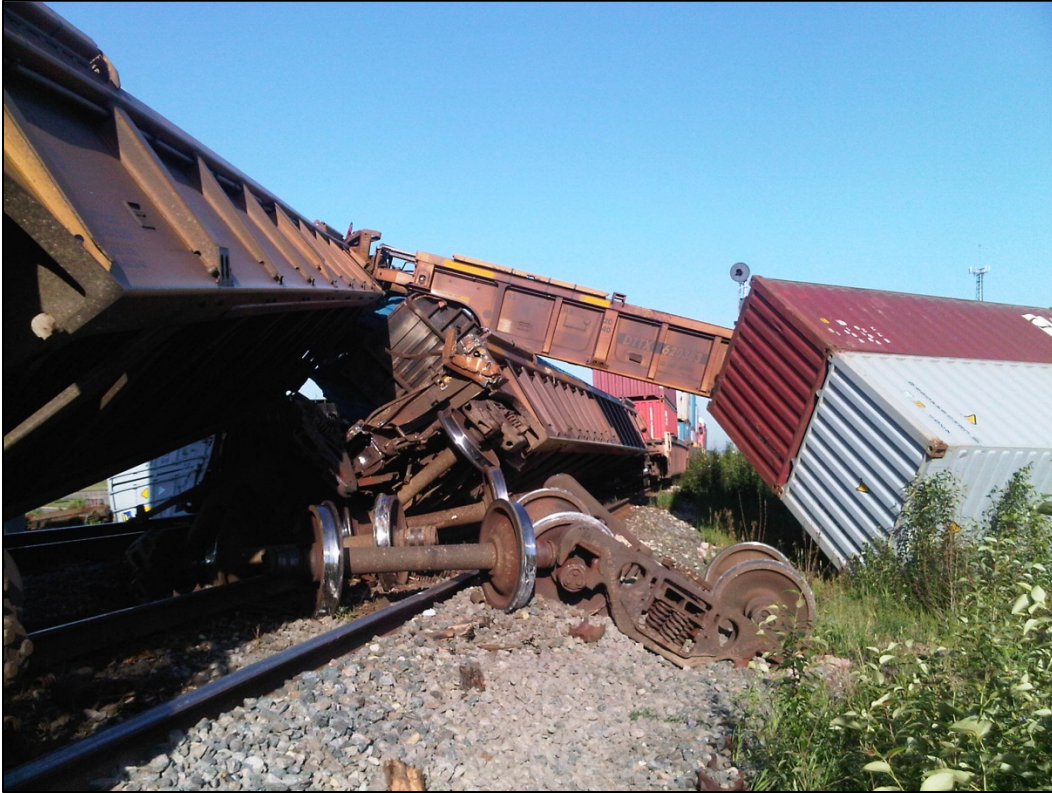
At 0625¹ on 23 June 2011, train Q10131-21 (train Q101), proceeding westward on the north main track of the Wainwright Subdivision collided with the tail end of stationary train A41751-23 (train A417) at Mile 262.76 in Edmonton, Alberta (Figure 1). The collision resulted in the derailment of 2 intermodal flat cars of train 417 (3 platforms) and locomotive CN 2234 of train Q101 being damaged. In total, 6 empty containers and 2 containers loaded with waste paper and metal scrap were damaged (Photo 1). No dangerous goods were involved.

Photo 1. Derailed cars from train A417 looking east

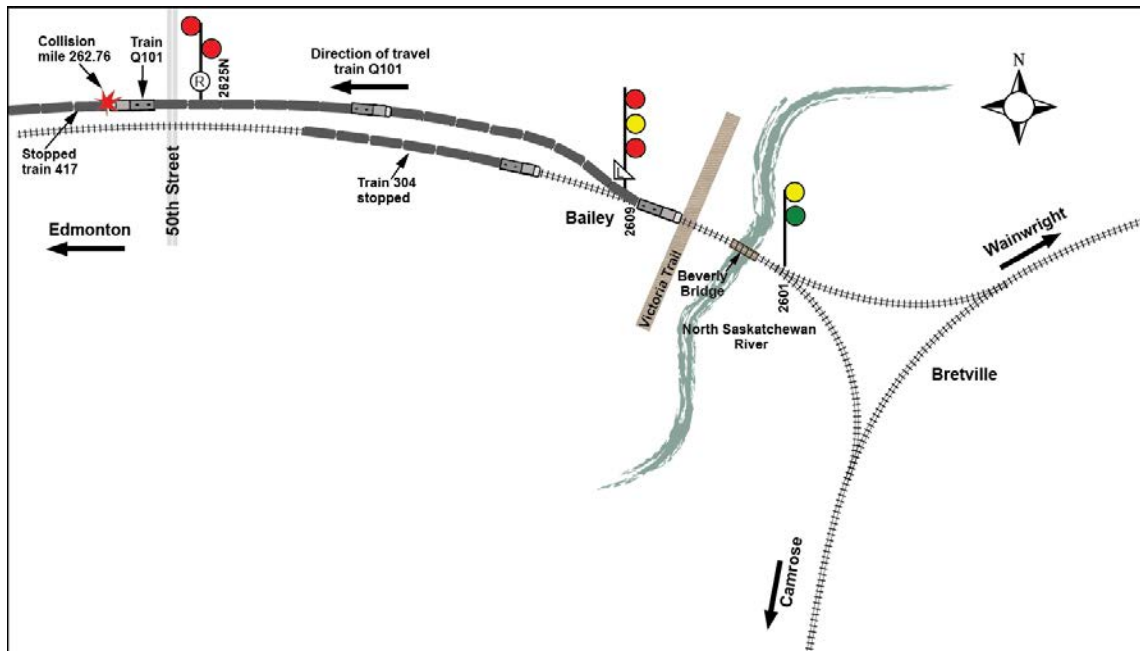
Train A417 originated in Clover Bar Yard in Edmonton and was travelling westward on the north main track to Walker Yard, also in Edmonton. As it had stopped for instructions from the Yardmaster, the tail end of train A417 was situated just west of the 50th Street overpass. Signal 2625N was situated just east of the overpass (Figure 2).

Figure 2. Track and signal layout at the collision/derailment location (map not to scale)

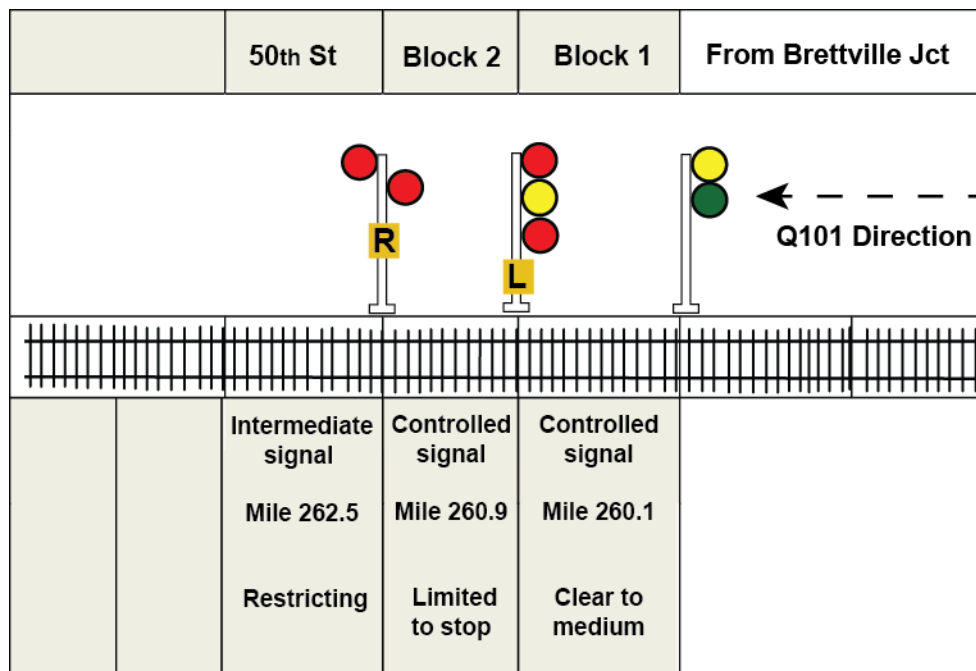
track switch at Bailey was lined for a westbound train to enter the north track, and there was a simulated track occupancy just west of signal 2625N, the signal indications would have been displayed as follows (Figure 3):

- the controlled signal, 2601, at Brettville Junction displayed a Clear-to-medium indication (yellow over green);
- the controlled signal, 2609, at Bailey displayed a Limited-to-stop indication (red over yellow over red with an L letter plate on the mast); and
- the intermediate signal, 2625N, just east of the 50th Street overpass displayed a Restricting signal (red over red staggered, with an R letter plate on the mast).

Figure 3. Signal indications encountered by train Q101 before the collision
