**RAILWAY INVESTIGATION REPORT  
R12E0008**

**MAIN-TRACK DERAILMENT**

**CANADIAN NATIONAL RAILWAY  
FREIGHT TRAIN M30141-20  
MILE 149.21, WAINWRIGHT SUBDIVISION  
FABYAN, ALBERTA  
21 JANUARY 2012**

Report Number R12E0008

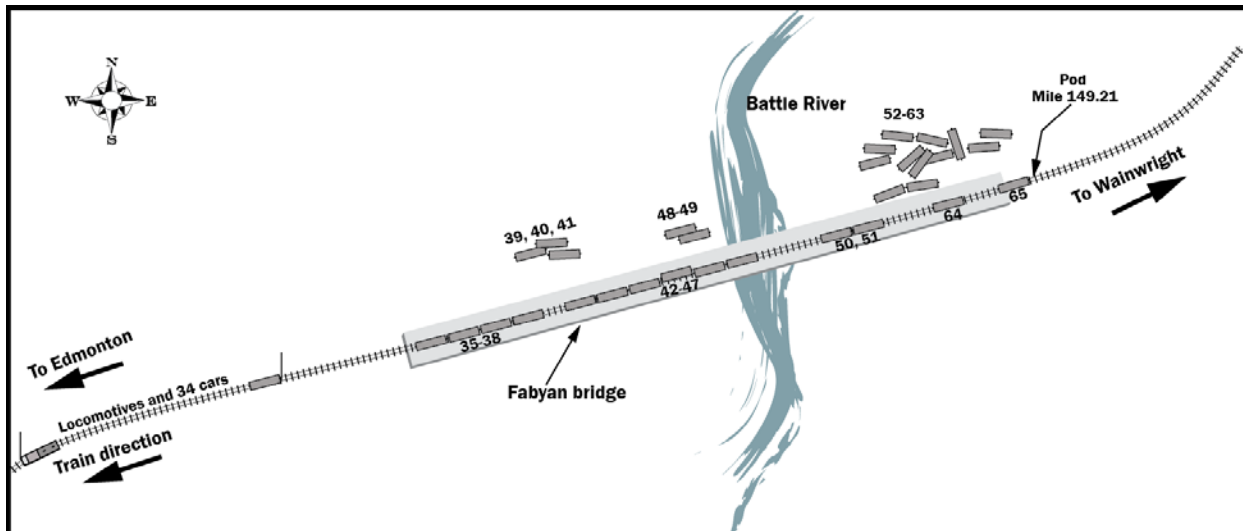
Of the 31 derailed cars, 13 remained on the bridge (Figure 2). The first 4 derailed cars on the bridge were the 35<sup>th</sup> to the 38<sup>th</sup> cars:

Figure 2. Derailment site

All other derailed cars that remained on the bridge derailed in the same manner as the 37<sup>th</sup> and 38<sup>th</sup> cars. Table 1 provides a summary of the location of the derailed cars.

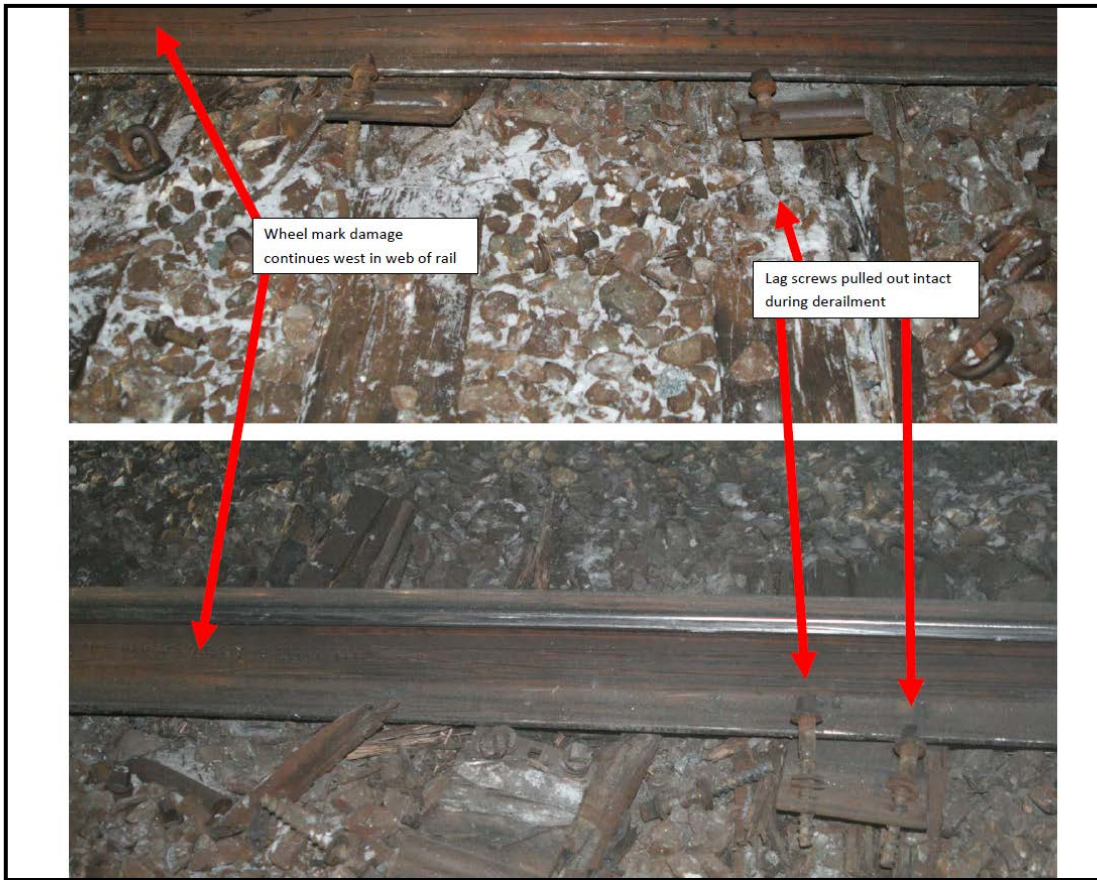
- Lag screw fasteners had been pulled out of a number of ties on the high rail (Photo 1).
- The high rail had rolled over at this location.
- Wheel marks observed on the flange and web of the high rail indicate that the point of derailment (POD) was approximately 67 feet east of the east bridge abutment (Photo 1).
- Plate-cut ties <sup>4</sup> were observed, along with many missing and broken screws, as well as bent and broken plates.
- Some clips were missing, and not all fastener holes appeared to be filled where the rail was not rolled.
- Many “missing” lag screws had broken off in the ties.
- There were some cracked and broken tie plates.

Photo 1. Track damage on high rail

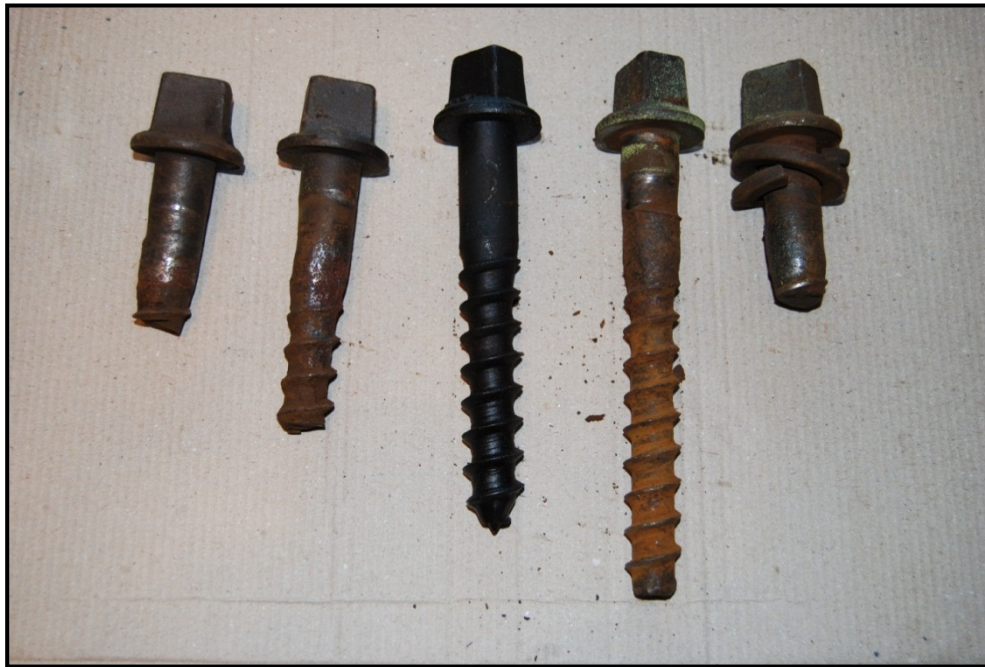
Seventy-four broken and damaged lag screws were collected and sent to the TSB Laboratory for analysis (Photo 2).

Photo 2. Broken 8.5-inch lag screws, new 7.5-inch lag screw (middle) and old 8.5-inch lag screw (2<sup>nd</sup> from right)

The 74 failed lag screws submitted for examination were produced from 4 different batches and supplied by 3 different manufacturers. The presence of several batches and manufacturers was due to the ongoing replacement of broken screws with newer stocks. The laboratory analysis determined that:

- The strength of the lag screw steel met specifications in effect at the time of manufacture.
- The fatigue cracks in the lag screw started in the upper portion of the threaded shanks.
- There were multiple fatigue origins, suggesting that fatigue initiation was caused by a general stress condition rather than any material defect.
- The age of fatigue cracks in different screws varied from many years to shortly before the occurrence.

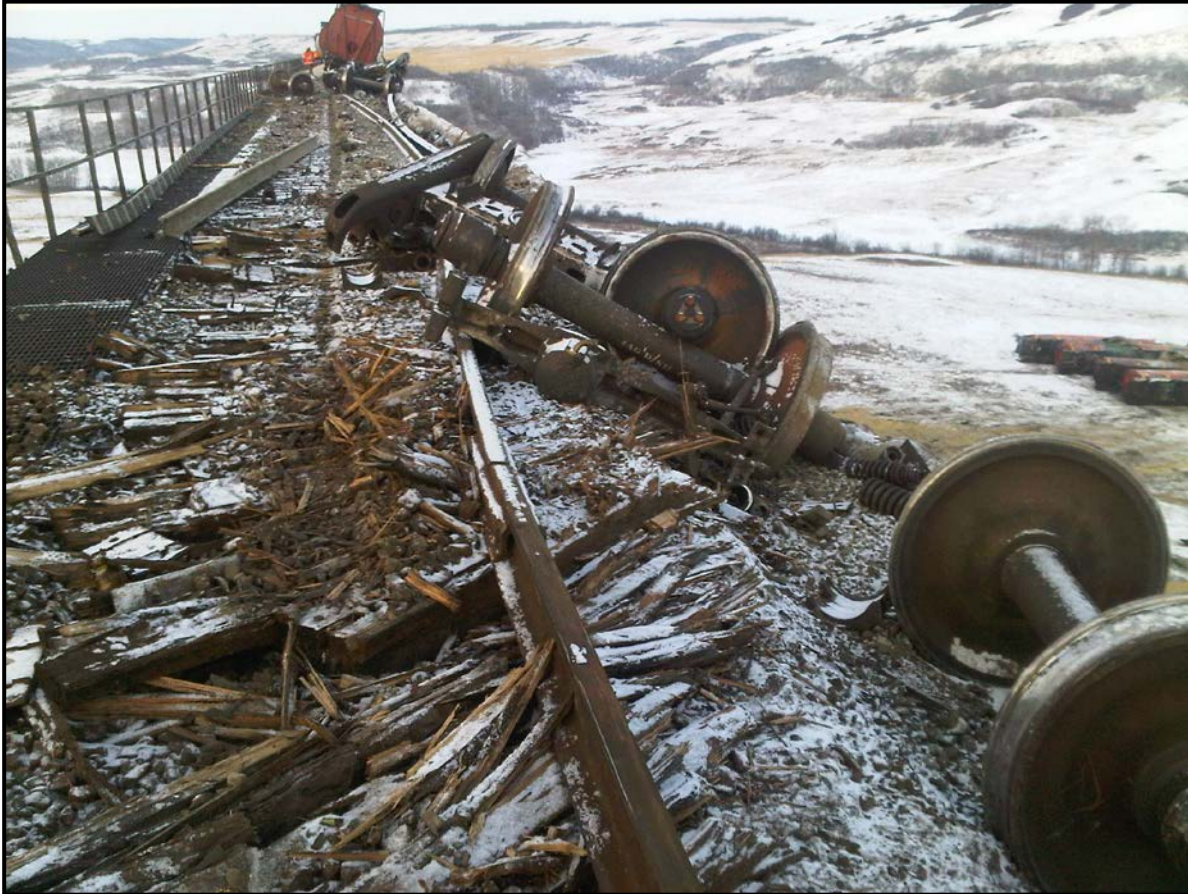
Approximately 1760 feet of track was destroyed during the accident (Photo 3). There was also damage to various components of the bridge, which included the north top section of the east wing wall that detached and fell to the ground; walkway gratings; north side concrete curbs between spans 2 and 31; north tower legs and bracing of bents 1, 2, 5, 15 and 16; bent stiffeners on the north girders of spans 5, 6 and 8; and various other structural members.

**Photo 3.** East end of bridge

Track restoration required the installation of 45 new track panels. Bridge repairs took longer than the track restoration work. During the repairs, rail traffic was rerouted over CN's Prairie North Line. The track was reopened on 26 January 2012, 5 days after the occurrence.

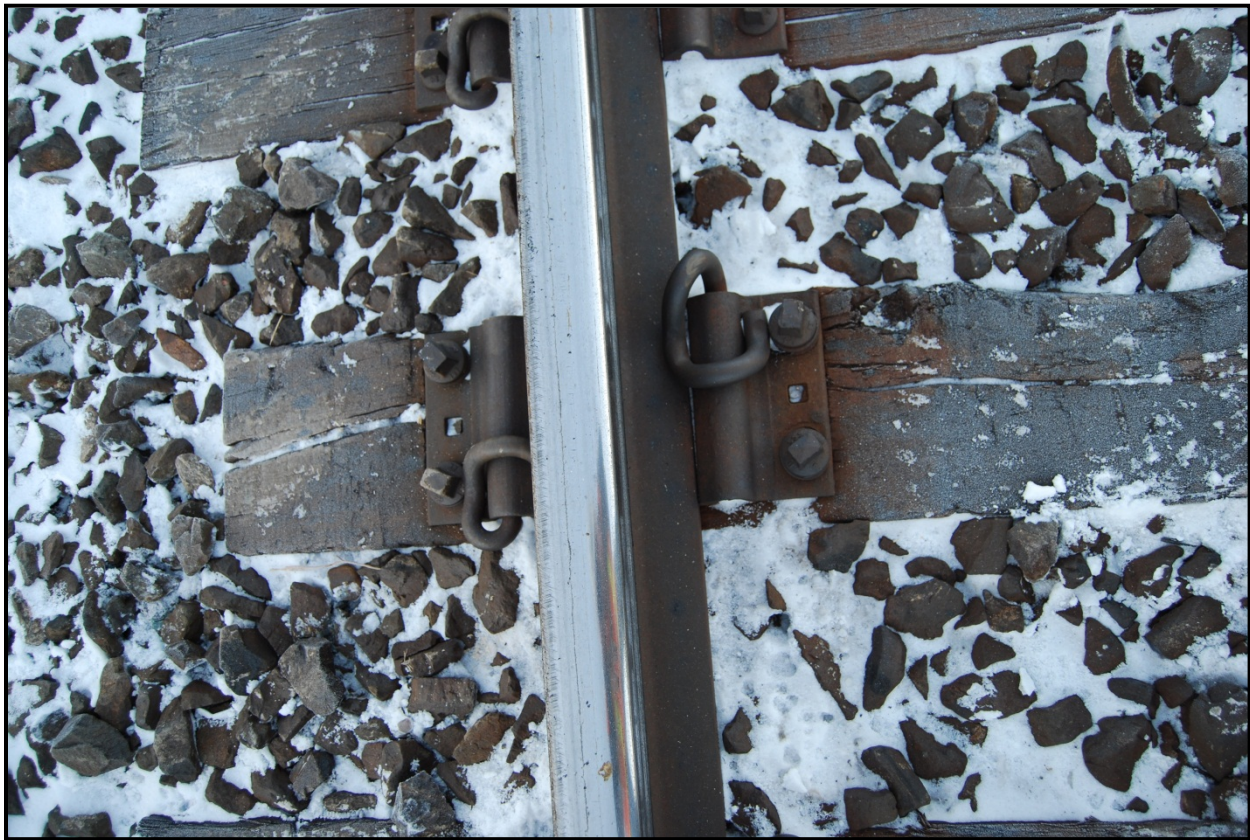
The derailment occurred at Mile 149.2, which is located in a 4° right-hand curve at the east approach to Fabyan Bridge. The curve had an average of 3.6 inches of superelevation, which was balanced for the 40 mph posted track speed. The rail through the curve was 2002 NKK 136-pound fully head-hardened (FHH) continuous welded rail (CWR). Within the curve, the rail was secured onto 16-inch rolled tie plates with elastic fasteners. The tie plates were attached to hardwood ties with 4 screws per plate (Photo 4). The rail was box-anchored every tie. The

**Photo 4.** Rolled plate fastener system

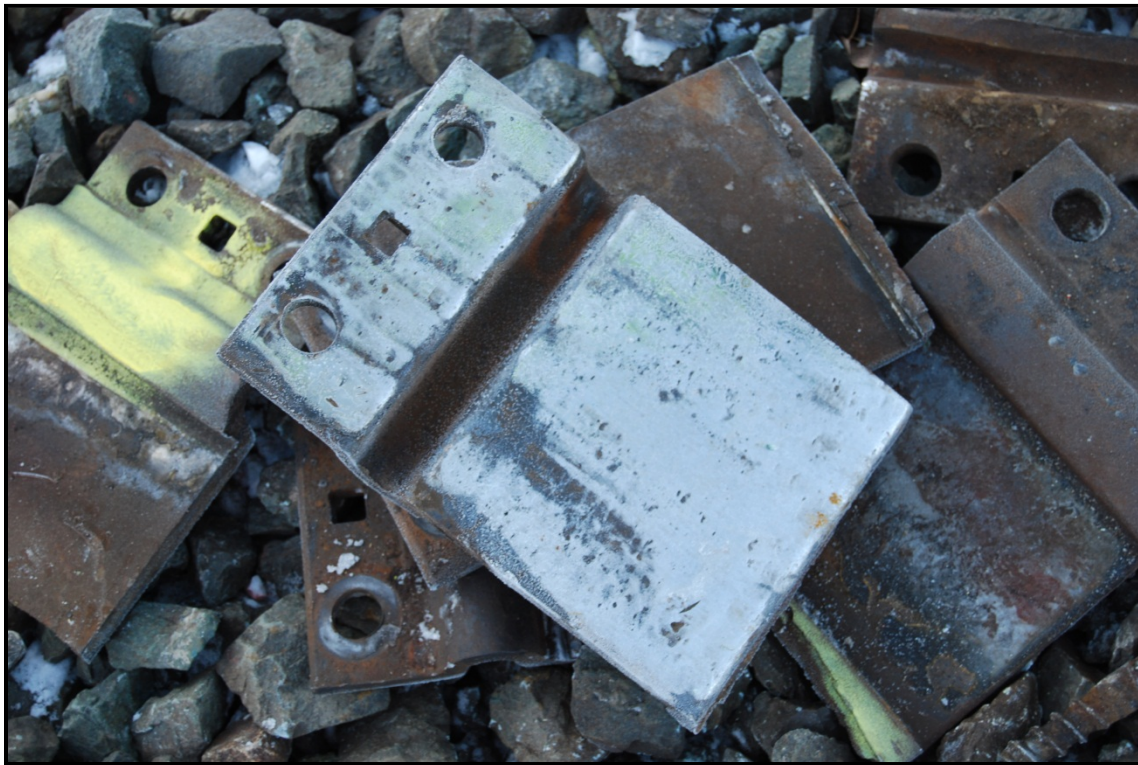
If the screws are tight on the rolled plates, the clamping force produces friction between the plate and the tie, providing lateral resistance to gauge-widening forces in the curve. If the screws are loose, they act as pins, providing the sole lateral resistance. When this happens, the flat bottom rolled plates move under load and can break (Photo 8). Failure of the screws is usually due to a combination of shear and bending, as all screws do not receive even loading.

**Photo 8.** Shiny bottom of broken rolled plate

In this occurrence, a number of lag screws in the vicinity of the POD broke off in the tie. The breaks, which occurred over a considerable period of time, were due to fatigue at the transition point between the shank and the threads, where the cross-sectional area is reduced. Even with broken lag screws, there was little indication that the curve was under stress, as track gauge was maintained by the lag screws that did not break. The remaining intact lag screws experienced much higher lateral curving forces. The derailment occurred when the remaining screw fasteners were insufficient to resist the lateral curving forces; the high rail then rolled under the train, resulting in wheels falling into gauge at the east end of Fabyan Bridge.
