**MARINE INVESTIGATION REPORT**  
**M09W0141**

**TUG GIRDING AND CAPSIZING**

**TUG *NORTH ARM VENTURE* WHILE TOWING THE BARGE  
*NORTH ARM EXPRESS*  
ENTRANCE TO SECHELT RAPIDS, BRITISH COLUMBIA  
19 JULY 2009**

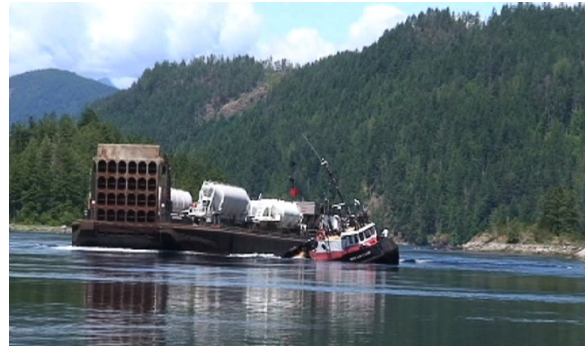
Pulled starboard by the force from the towline, the tug girded on its starboard side (see Photo 2) and quickly capsized at approximately 1250 in position 49° 44.5' N, 123° 54' W.

**Photo 2.** Tug in early stages of girding. <sup>7</sup>

With the tug on a heading of approximately 136° True (T), and the barge on approximately 220° T, and given the shortened towline, the barge quickly covered the distance to the tug's stern at an approximate right angle. Although the shortened towline was intended to improve manoeuvrability, with the vessels in this position, it pivoted such that its force was acting athwartships on the tugboat, and no longer directly behind it. This resulted in the tug capsizing to starboard.

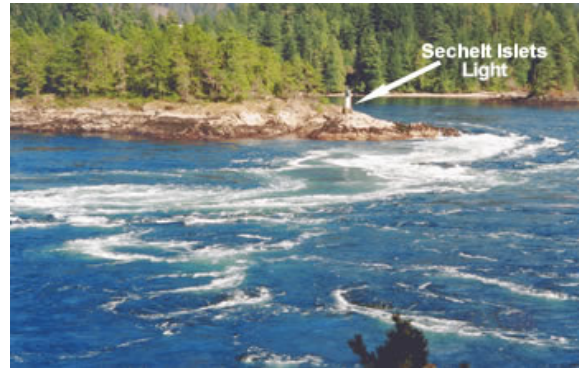
The strongest ebb stream occurs just west of Sechelt Islets light (see Photo 3), with a strong cross-channel set towards the west-northwest. A large back eddy occurs to the north of the light, and whirlpools form close to the light.

**Photo 3.** Sechelt Rapids looking southeast at maximum ebb tide

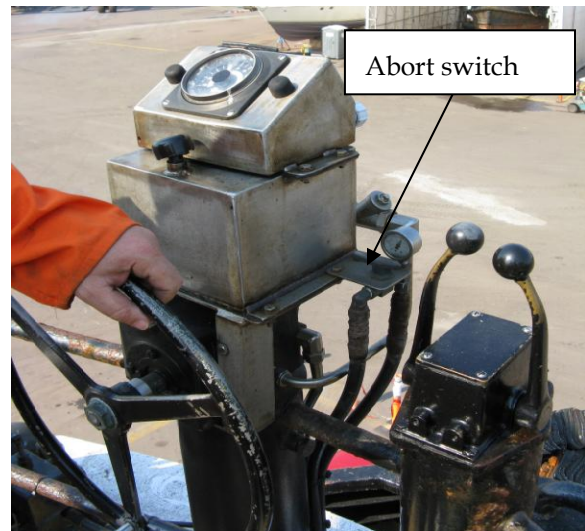
The *North Arm Venture* was fitted with an abort switch that could be activated from any of the vessel's three steering positions and could be reset after activation to stop the full length of the tow line from running off the drum (see Photo 4).

**Photo 4.** Abort switch on top of wheelhouse
