**MARINE INVESTIGATION REPORT
M11L0050**

TAKING ON WATER AND ABANDONMENT

**SMALL FISHING VESSEL *LADY JACQUELINE*
OFF CAP DU PHARE, ÎLES-DE-LA-MADELEINE, QUEBEC
21 MAY 2011**

Report Number M11L0050

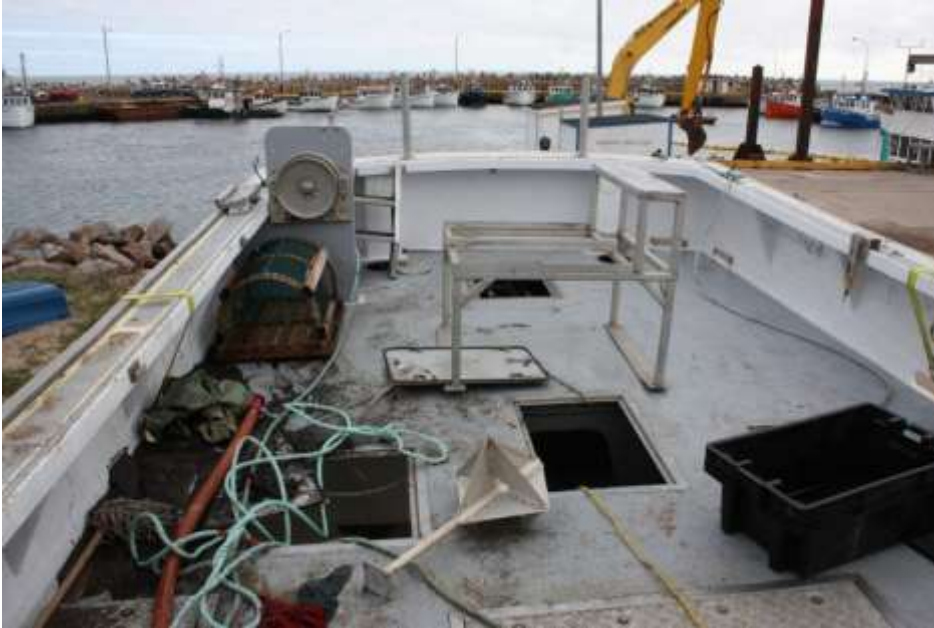
After recovery, the hull was examined and was found to be intact, but the machinery and equipment had extensive water damage. The lobster tanks were lost overboard. Only one of the 2 hatch covers to the engine compartment (the aftermost) was found to be secured to the deck opening. The remaining unsecured covers were found on deck, attached by their safety chain, but not in place (Photo 2). The vessel was subsequently repaired and put into operation.

Photo 2. Working deck of *Lady Jacqueline* upon recovery, showing hatches with covers not in place

It was regular practice on board the *Lady Jacqueline* to leave the hatch covers unsecured. When the vessel was salvaged, all the hatch and handhole covers, except one, were found unsecured. Thus, at the time of the occurrence, the shipped water that was retained on deck washed the covers out of position and allowed the water to downflood more rapidly into the bilges. The bilge pumps were unable to keep up with the combined ingress of water from below deck and the downflooding through the hatch openings, and the vessel was swamped.

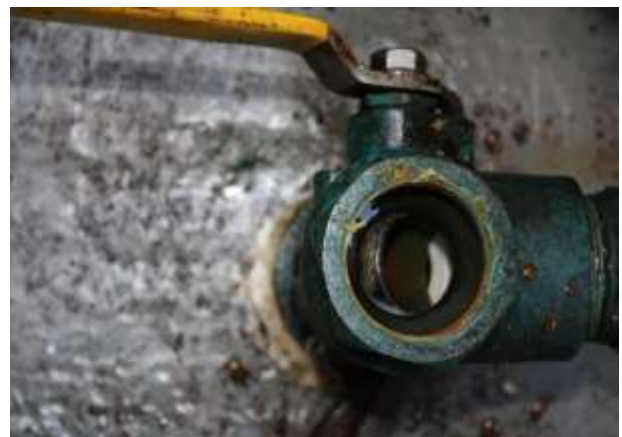
Photo 4. Three-way valve partially open to the sea

Furthermore, the 3-way valve was found open 20% to the sea and 80% to the bilge. In this position, when the pump was not running, water continuously leaked into the bilge since there was no non-return valve on the bilge suction line. The watertight integrity of the hull was therefore compromised.

1. The *Lady Jacqueline* left l'Étang-du-Nord with its 3-way valve partially opened to the sea. The vessel was continually taking on water below the waterline, through the valve and the bilge suction line, which was not fitted with a non-return valve.
2. While the crew hauled lobster traps, the vessel was manoeuvred with its stern exposed to the wind and the waves, which were in excess of 2 m, causing water to wash the deck through the freeing ports.
3. The electrical pump ceased to function because it was partly clogged and had a corroded circuit board. Water accumulated in the bilges without the crew being aware.
4. As the water level rose in the bilges, the trim increased by the stern, the freeboard reduced, and water accumulated on the deck.
5. Water progressively downflooded into the bilges through the unsecured hatch covers and the crew was forced to abandon the vessel.

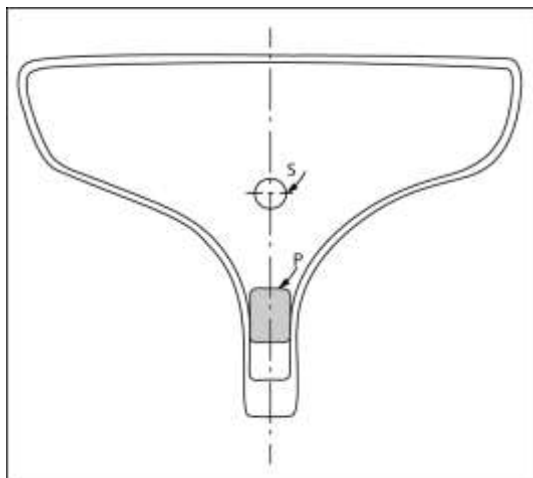
During the 2003 inspection, there were 2 electrical pumps fitted on the vessel. At the time of the occurrence, only 1 electrical pump was fitted on the keel, low in the skeg in a narrow space underneath the propulsion shaft. The position of the pump is shown in Figure 2 and Photo 5.

Figure 2. Position of electrical pump (P) beneath the propulsion shaft (S)

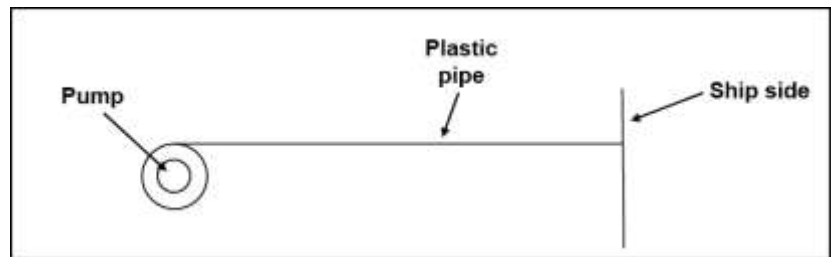
When the pump was installed, the mounting base was removed because of the reduced space available in the skeg. Examination of the pump after the occurrence found that the mounting base was not in place and the electrical pump was jammed into place. The overboard discharge for the pump was not fitted with a non-return valve (Figure 3).

Figure 3. Sketch showing electrical pump arrangement

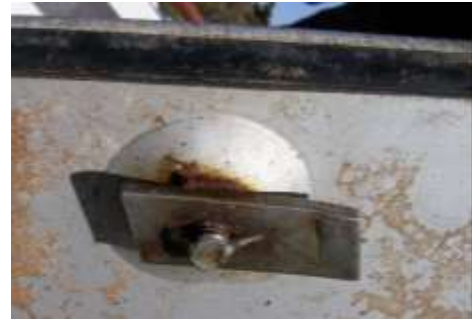
Photo 10. Underside of *Lady Jacqueline* hatch cover showing typical dog used for securing, found in open position
