MARINE INVESTIGATION REPORT

M11W0063

FIRE AND SINKING
SMALL FISHING VESSEL *NEPTUNE II*
BROKEN ISLANDS, JOHNSTONE STRAIT,
BRITISH COLUMBIA
09 MAY 2011

Report Number M11W0063

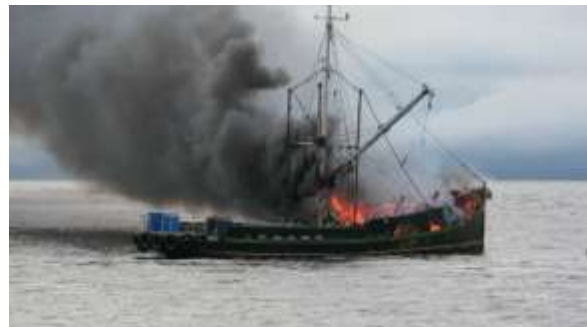
Photo 1. The *Neptune II*

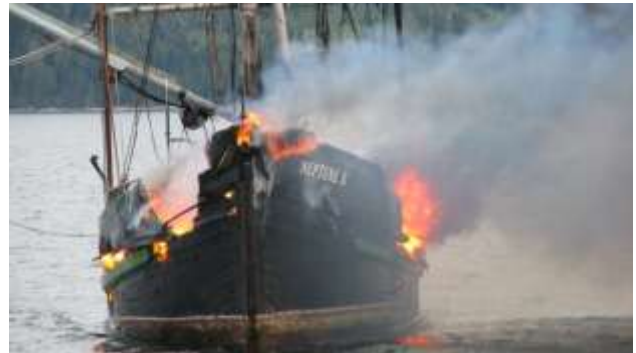
While the crew was fighting the fire, the vessel was under power, making way, and turning slowly to starboard. As a result, the vessel was repeatedly enveloped by smoke from its continuously changing direction, forcing the crew to circle the deck to stay out of the smoke (Photos 1 and 2).

Photo 2. Fire fully engaged

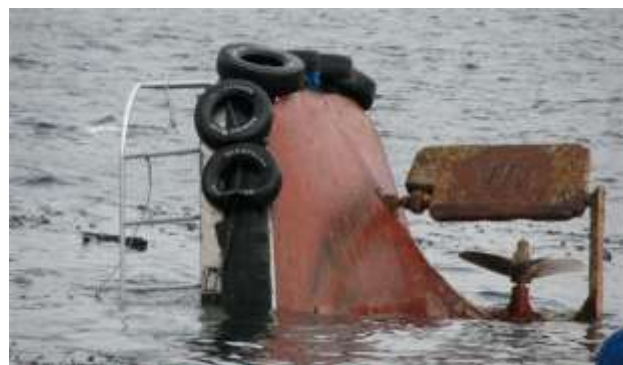
Photo 3. *Neptune II* sinking

At 0758, the CCGS *Point Race* arrived on scene. By this time, the vessel was fully engulfed. The vessel eventually sank at 0938

in position 50°28'12" N, 126°09'36" W (Photo 3). (Appendix B)

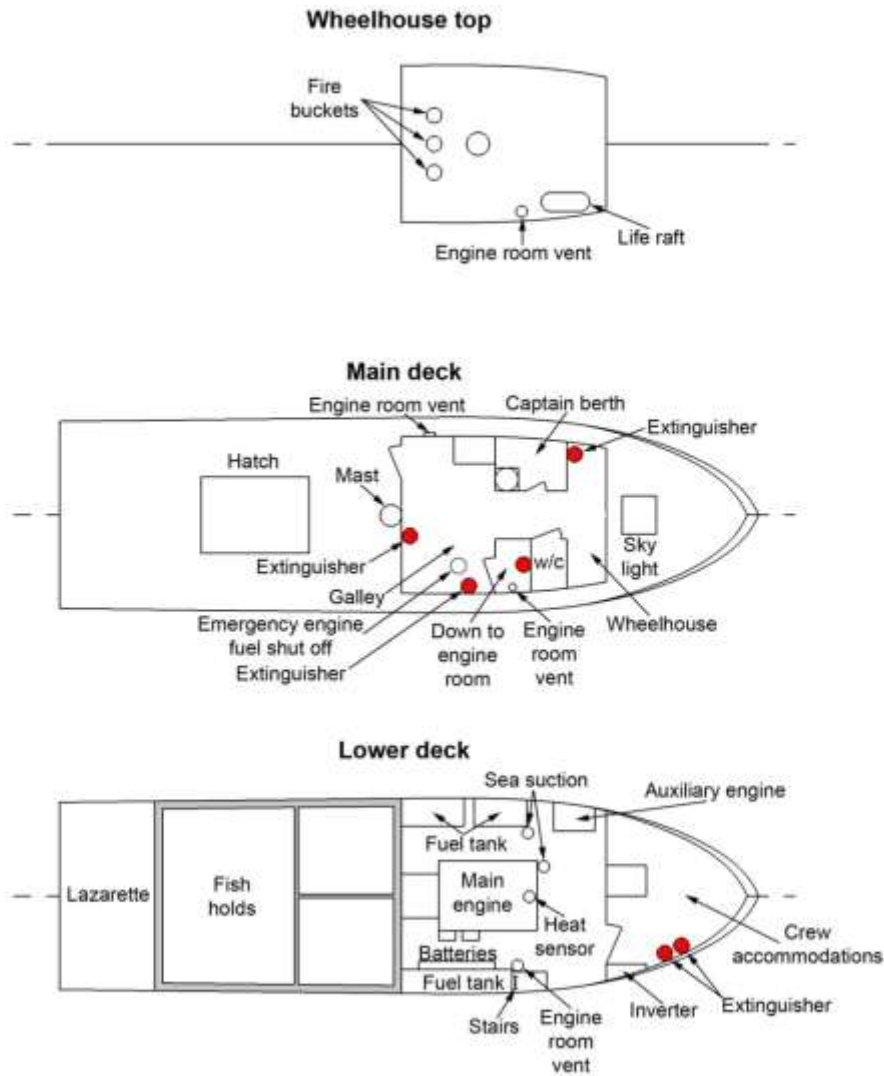
Appendix A – General arrangement of the Neptune II (diagram not to scale)

The hull below the main deck was subdivided by 4 transverse bulkheads that enclosed (from forward) the crew accommodation, the engine room, the fish hold and the lazarette (See Appendix A).

In both scenarios the fire most likely started in the aft end of the engine room and spread rapidly, making it impossible for crew members to enter the engine room and fight the fire.
