PIPELINE INVESTIGATION REPORT P09H0083

NATURAL GAS PIPELINE RUPTURE

**TRANSCANADA PIPELINE LIMITED
762-MILLIMETRE-DIAMETER PIPELINE
LINE 100-1 – MAIN LINE VALVE 111A-1
FROM KILOMETRES 11.12 TO 11.16
NEAR MARTEN RIVER, ONTARIO
26 SEPTEMBER 2009**

Report Number P09H0083

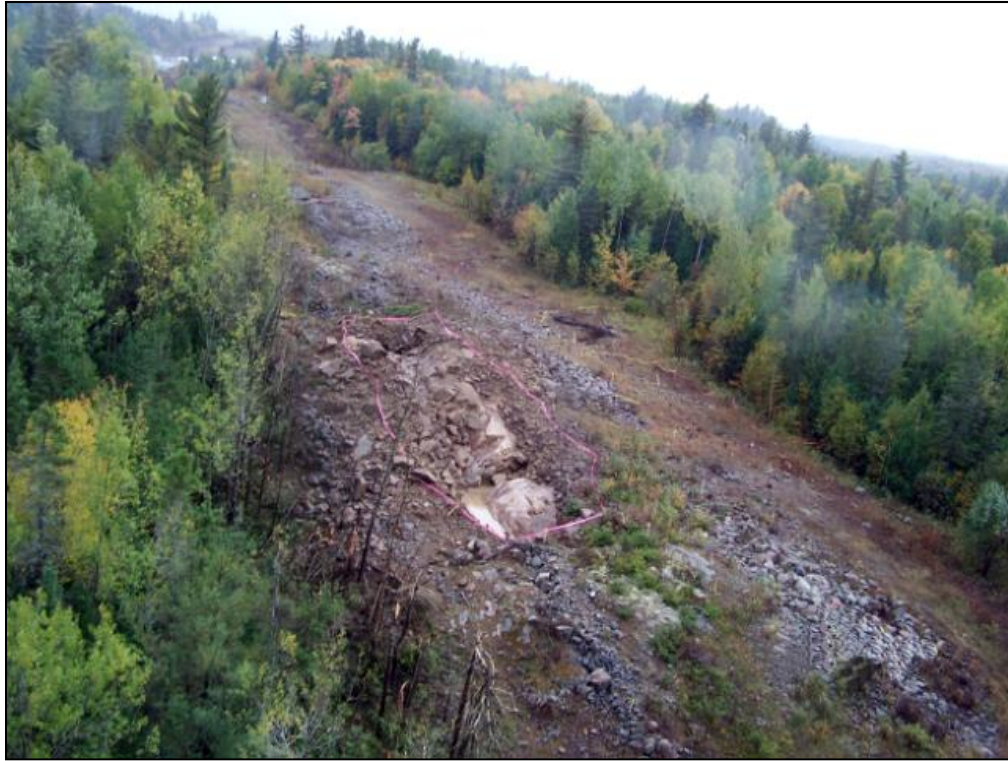
During the rupture, a section of pipe separated from the pipeline and was scattered throughout the area in more than 40 pieces of varying sizes (see Photo 1). The upstream and downstream joints of the pipe were severely damaged (see Photos 2 and 3). Pieces of pipe were found up to approximately 100 m away from the site of the rupture.

Photo 1. Aerial photo of the Marten River occurrence site.

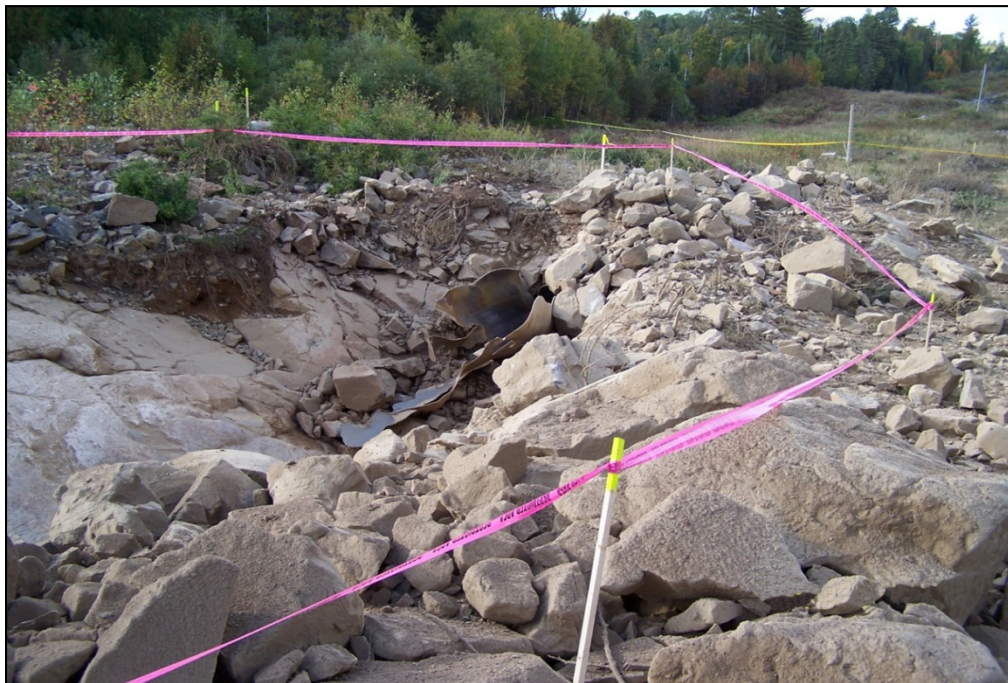
Photo 2. Line 100-1, upstream section of Line 100-1 at the Marten River occurrence site.

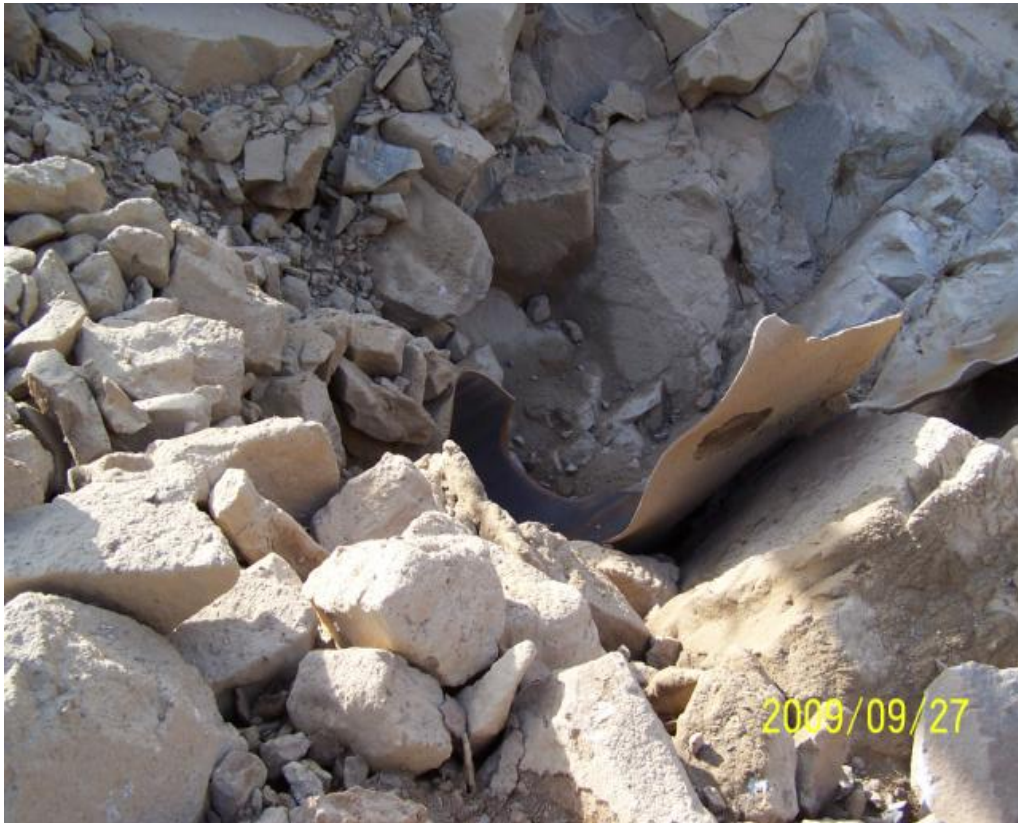
Photo 3. Line 100-1, downstream section of Line 100-1 at the Marten River occurrence site.

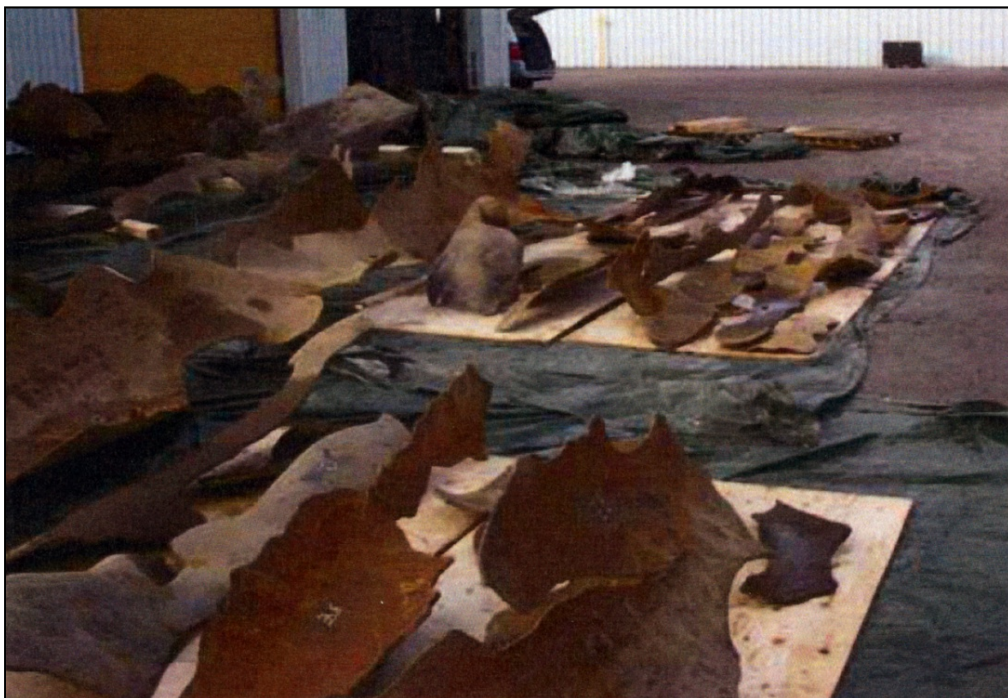
The upstream and downstream fracture arrests were cut off the ends of the pipe and retained for further examination. More than 40 pieces of pipe were also collected (see Photo 4).

Photo 4. Line 100-1, pipe pieces from the Marten River pipeline failure.

- A hard spot² on the pipe surface of one of the pieces was identified as the location of the rupture initiation. The hard spot would have been formed as a result of local quenching of the steel plate, immediately following the final hot rolling pass, and had been present in the steel surface since the time of its manufacturing.

- The rupture in TransCanada's Line 100-1 was the consequence of a one-time failure event resulting from the combination of a hard spot in the pipe, a tensile stress caused by the internal gas pressure and the probable presence of atomic hydrogen in the steel at the rupture location.

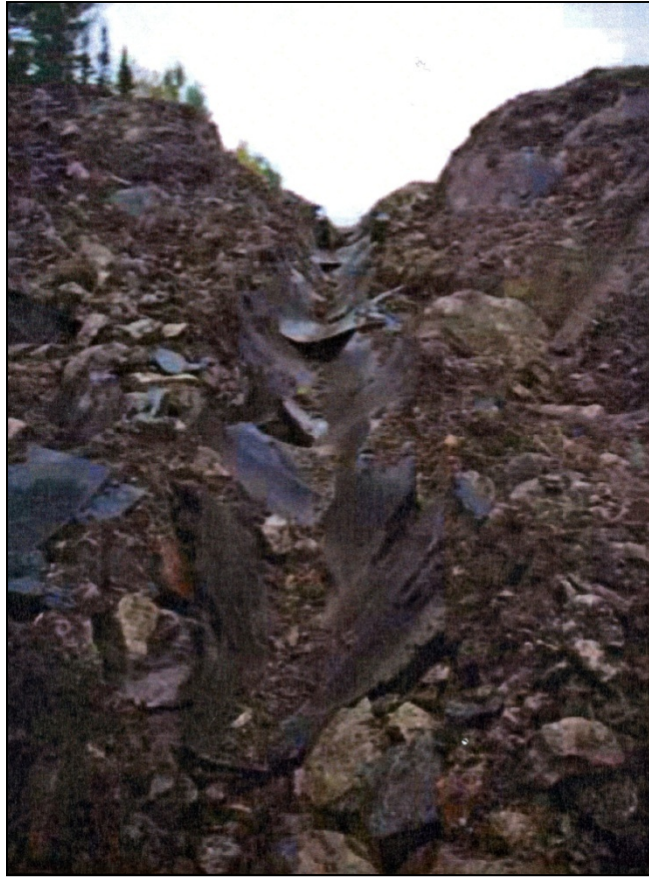
The exterior of the pipe at the occurrence site was coated in asphalt enamel. The exterior coating in the area where the pipe failed showed evidence of poor condition and extensive exterior coating disbondment (see Photo 5).

Photo 5. Line 100-1, disbonded exterior coating found in the ditch after the rupture.
