Issue 2/2012

Canadian Aviation Service Difficulty Reports

TP 6980E
(6/2012)

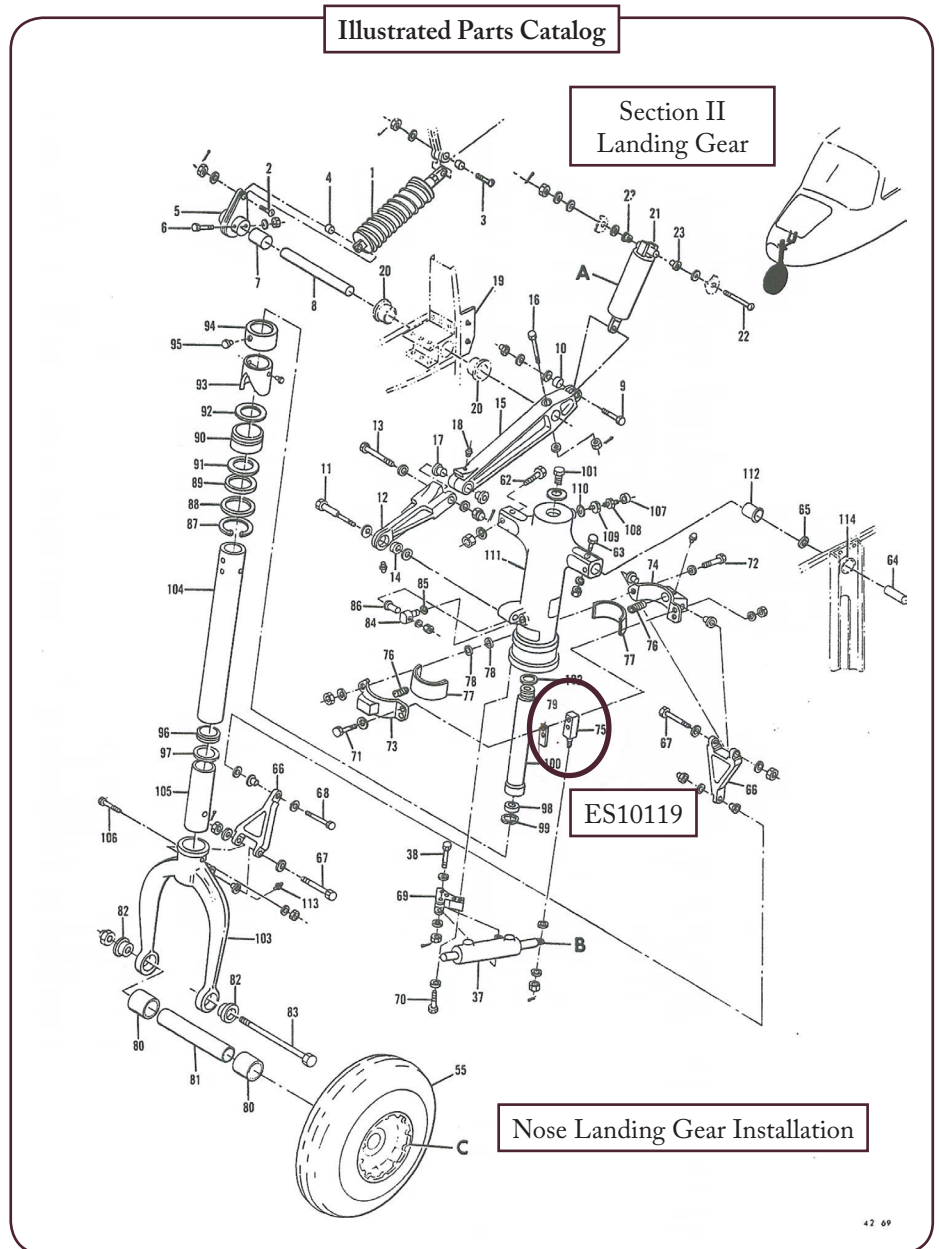
The maintenance investigation revealed that a bolt that connects to the nose wheel steering actuator to the nose gear was missing. The actuator end spacer shaft (IPC Page 2-81, Fig 2-19, Item 75) was missing. The shaft is held into the spacer with a roll pin which was found sheared and had fallen out thereby leaving the nose wheel free and uncontrolled.

It appears that an incorrect installation was the root cause factor in this event, which endangered the crew and occupants of this aeroplane.

The operator has taken the appropriate internal action to ensure that maintenance personnel strictly adhere to the manufacturers aircraft manuals. ✖

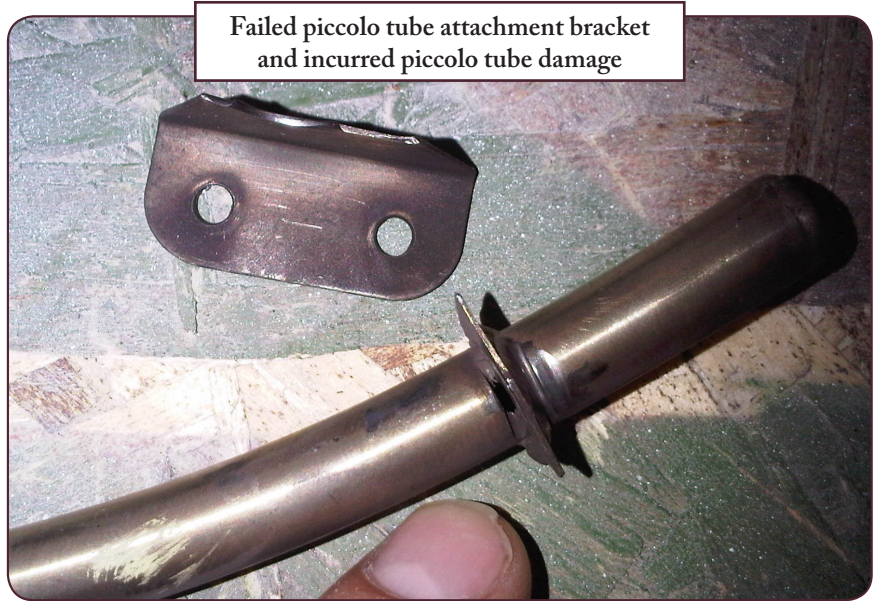
Nose Cowl Piccolo Tube Damage

During a heavy maintenance visit, the right hand engine intake cowl was removed, where upon further inspection of the cowl; loose rivets were noticed behind the intake lip. The technician proceeded to remove the intake lip to further assess the pulled rivets. It was discovered that the attachment brackets had cracked and chaffed through the piccolo tube.

Through research with the operator and BAE engineering, the cracking of the intake piccolo tube support brackets is a known issue and resulted in the release of an optional service bulletin 71-JA 930240 in 1993, which replaced the welded supports with new, flexible mounts.

The piccolo tube and attaching brackets were replaced and the aeroplane was made serviceable.

Transport Canada Civil Aviation would like to advise all owners, operators and maintainers of the availability of this service bulletin and the importance of its embodiment. ✂

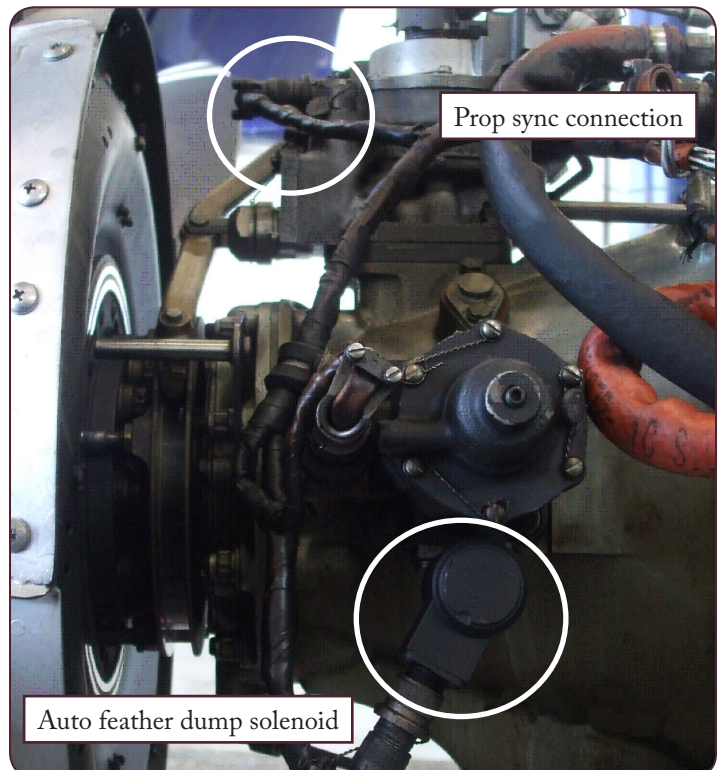
Propeller Canon Plugs – Reverse Connection

Shortly after departure, the aeroplane experienced an uncontrolled propeller pitch change from coarse to feather. Following an uneventful landing, maintenance personnel found that the cause of the problem was that the canon plugs for the propeller synchrophaser solenoid for the propeller governor and the auto-feather solenoid for the overspeed governor were found in reverse positions. These two canon plugs are within close proximity and identical in appearance, thus the mechanic must be very attentive when reconnecting these canon plugs. The Service Difficulty Report (SDR) submitter also stated that maintenance personnel had completed an engine change the previous day. It seems apparent that this is when these 2 canon plugs had been reversed. The subject aeroplane is powered with twin PT6A-65B engines and Hartzell HC-B4MP-3A propellers.

Minute (RPM). When these canon plugs are incorrectly reversed; the propeller synchrophaser control box sends a pulse voltage to the auto feather dump solenoid causing the propeller to momentarily feather.

The submitter also stated that the incorrect connection of these canon plugs could lead to a serious in-flight problem and even more perilously, if a dual engine change was carried out simultaneously.

Transport Canada Civil Aviation recommends strict adherence to Canadian Aviation Regulation (CAR) Part V – Standard 571.10 – Types of Work. Additionally, Transport Canada Airworthiness Notice C-010 publication “Inspection of Control Systems” provides necessary guidelines regarding maintenance releases. ✖

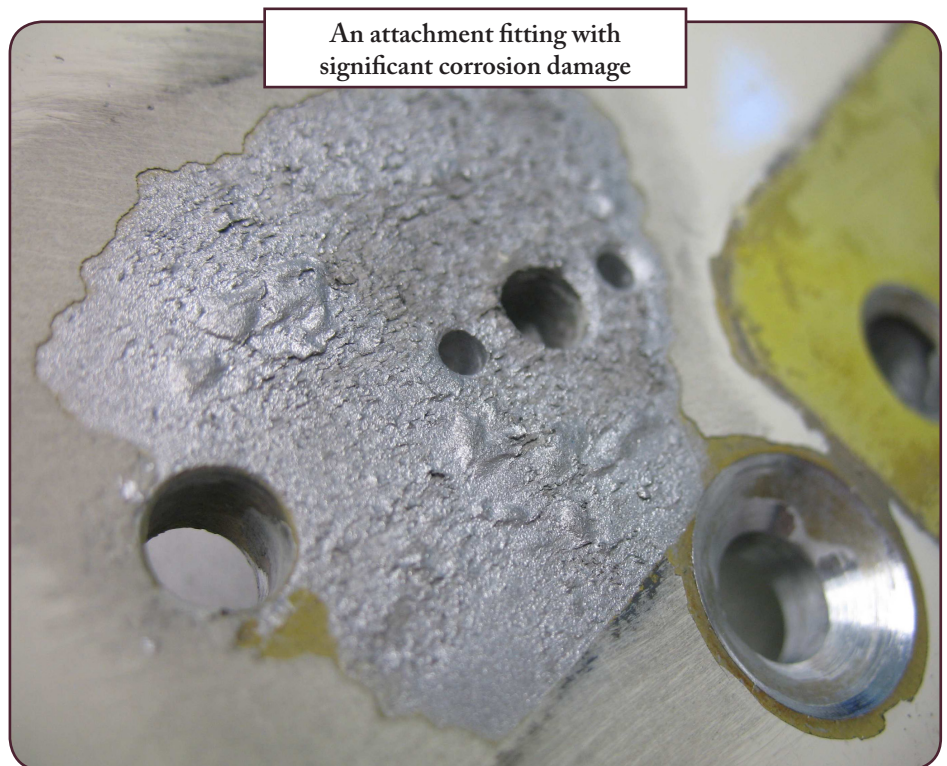
Maintenance personnel found Level III corrosion at both the upper and lower stabilizer attachment fittings.

The left-hand upper surface of the upper attachment fitting had chaffing and significant corrosion damage at the anchor nut location. Additionally, extensive corrosion damage was found at the lower fitting and at the anchor nut locations.

An attachment fitting with significant corrosion damage

A previous SDR reported severe intergranular corrosion and crack fitting in this same area. Always be attentive to the early signs of corrosion such as white/gray powdery deposits and pitting/etching damage, which can eventually lead to crack development. ✖

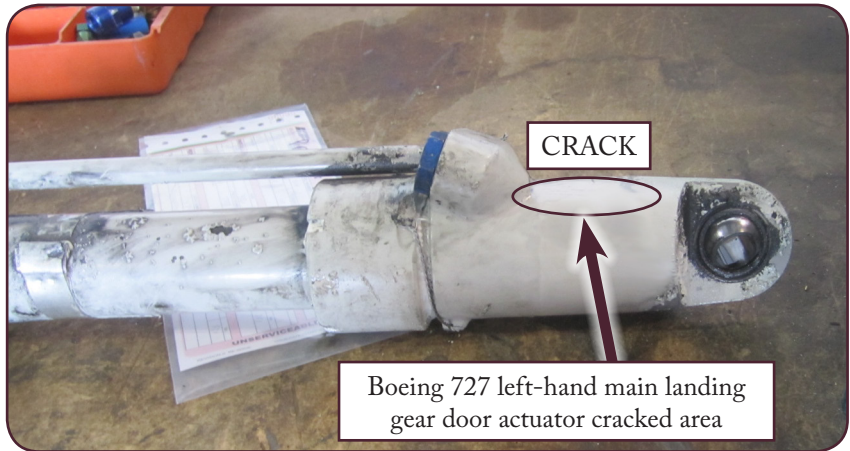
Hydraulic Fluid Loss

Maintenance inspection revealed that the left hand gear door actuator was cracked, allowing the loss of the hydraulic fluid.

It is suspected that there was prior evidence for the propagation of the crack on the door actuator through minor hydraulic fluid weeping in the area.

The actuator was replaced and the aeroplane was returned to service.

Transport Canada Civil Aviation would like to advise all owners, operators and maintainers to be adamant and thorough when trouble-shooting fluid leaks. ✖

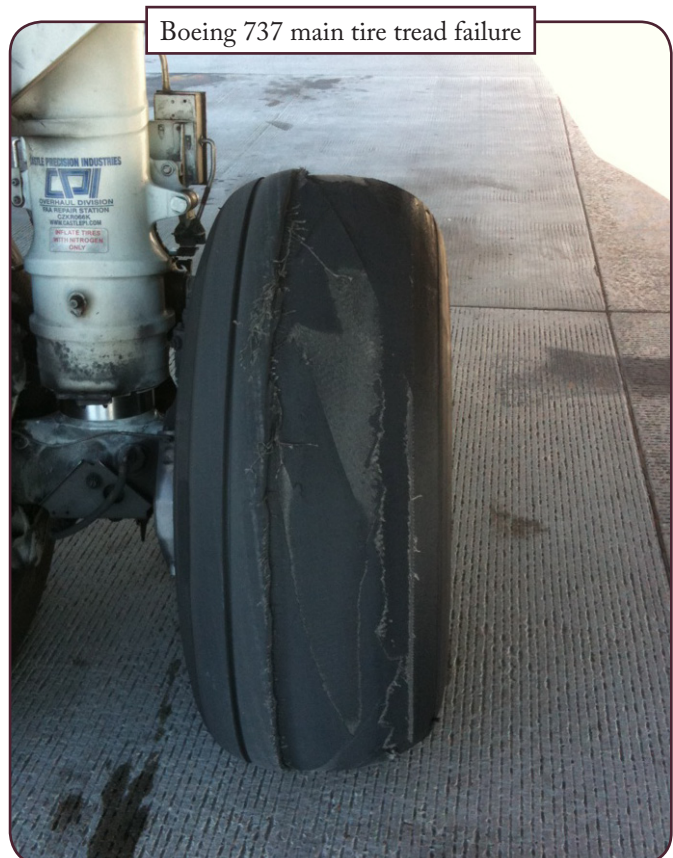
Tire Tread Separation

On take-off, what was described as a bang was reported to the captain by the cabin crew. No other issues were reported by the flight crew in cruise. Upon landing it was discovered that #2 main wheel received substantial tread separation on its previous takeoff. This caused damage to the inboard flap as well as the inboard spoiler.

Due to the importance for the correct operation of all aeroplane tires and the seriousness of this event, through the operators internal safety management system, it was determined that the possible frequency of retread could have been the cause of failure.

Both the #1 & #2 main wheels were replaced and all necessary repairs done to the flap and spoiler making the aeroplane serviceable.

Therefore a maximum limit of 3 retreads was put in-place for the overhaul of all main tires.

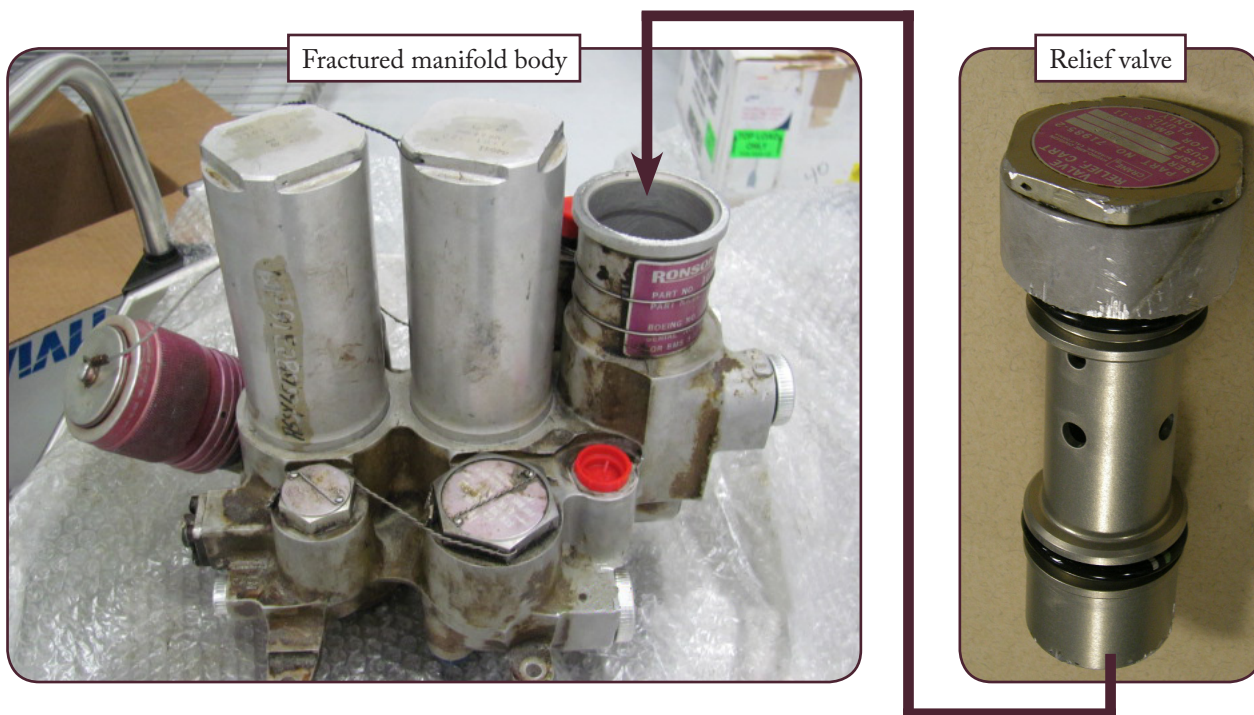
Hydraulic Failure

It is suspected that the failure of the hydraulic module body was due to the possibly imposed over-torque stress of the relief valve during its last installation, causing metal fatigue.

The failed hydraulic manifold was replaced, the hydraulic system serviced and the aeroplane was made serviceable.

Transport Canada Civil Aviation would like to advise all maintainers and AMO shop overhaul facilities of the importance to follow all Aircraft Maintenance Manual (AMM) and Component Maintenance Manual (CMM) installation torque values. ✖

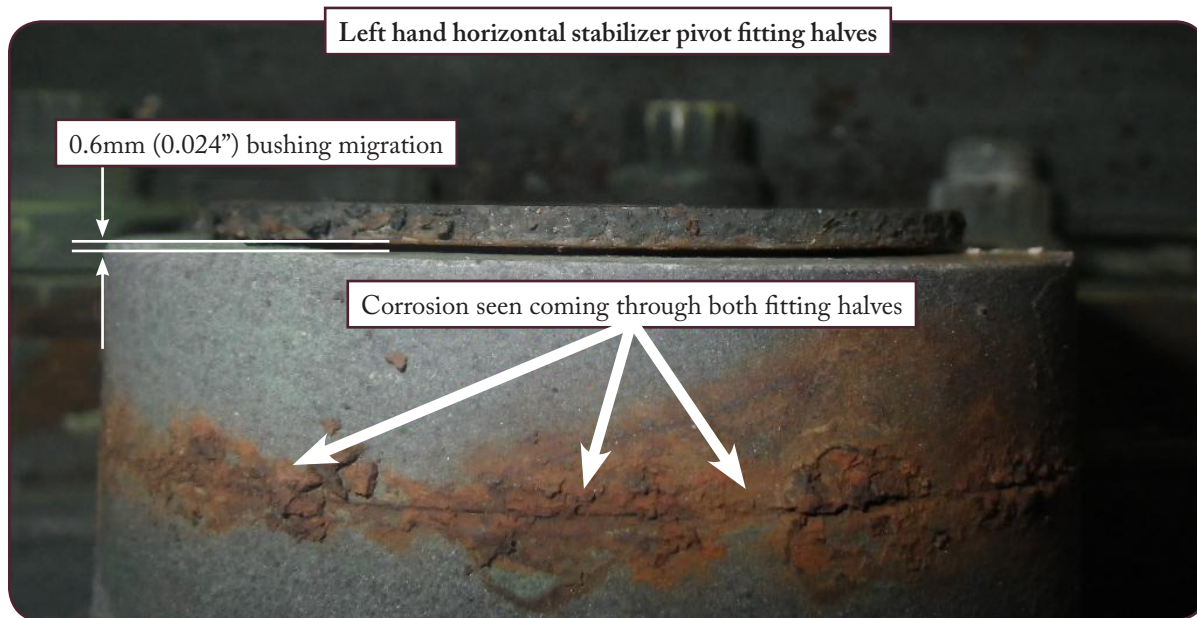
Horizontal Stabilizer Attachment Corrosion

While completing a detailed inspection of the horizontal stabilizer pivot fittings per task 55-320-502, iron oxide colored corrosion was observed coming through the fitting halves on both the left-hand and right-hand sides. Upon further inspection, the bushing in the left-hand horizontal stabilizer pivot fitting was found migrated 0.6 millimeters (mm) (0.024 inches).

Both fittings were replaced to correct the fault.

The repeat inspection of these stabilizer pivot fittings is set at 48 months or every 4 years. ✖

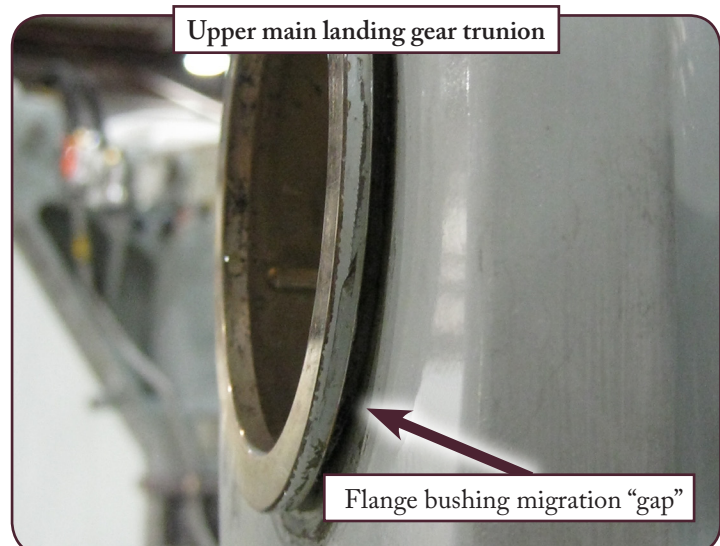
Main Landing Gear Trunion Bushing Migration

During a heavy maintenance check, the forward Main Landing Gear (MLG) trunion bushings were found to be migrated on both the left and right MLGs.

All operators and maintainers are asked to pay close attention to this area of the MLG trunion. ✖

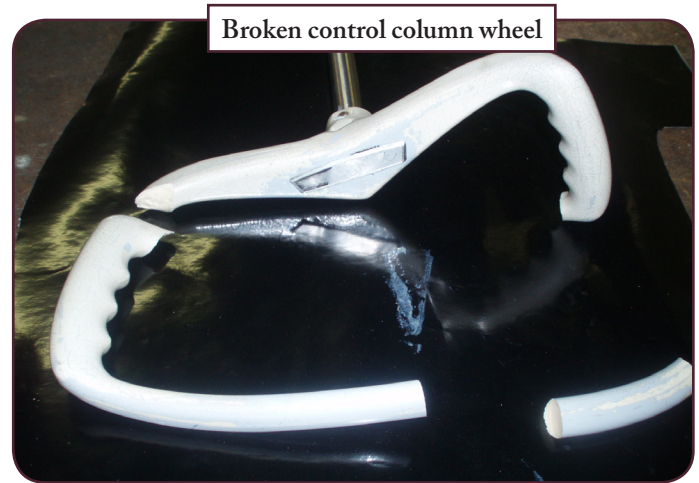
Control Column Wheel - Broken

During stall practice with very little yoke aft pressure being applied by the co-pilot (as the pilot was already applying most of the pressure); the control column wheel fractured. Following an uneventful landing, a technician applied a small amount of force on the control column wheel and another portion of the wheel broke off. It was found that the co-pilot control column was made from plastic and had broken in the upper left and lower right corners.

Cessna Service Letter (SL) 62-44 has been superseded by SL 64-8 that calls for a "pull test" inspection and specifies that the critical area is located at the bottom left corner. The SDR submitter stated that this particular aeroplane was out of service for 8 years, thus effects of sun-soaking may have been a factor in this failure.

Transport Canada Civil Aviation highly recommends compliance with Cessna SL 64-8. In particular, pay close attention to the inside upper corners of control wheels. Any control wheel that has a crack or fails the pull-test should be replaced before further flight with a metallic control-wheel. ✖

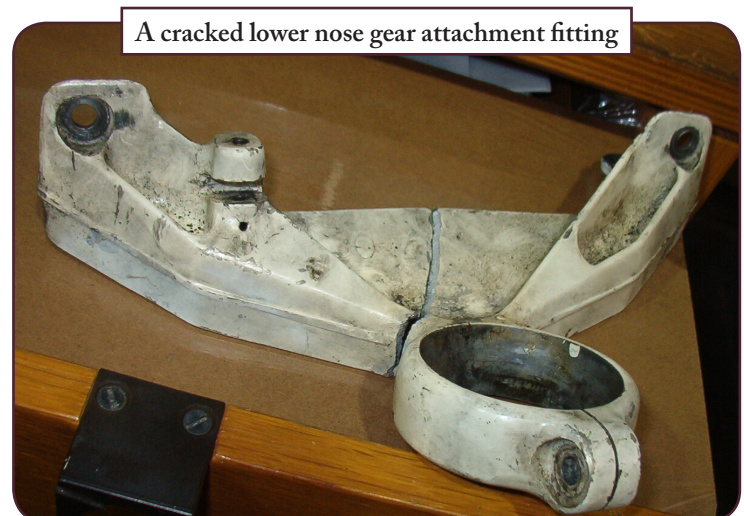
During routine inspection, the lower nose gear attachment fitting was found cracked behind the nose oleo attachment support.

This aeroplane had previously undergone a major rebuild some 150 hours ago, which included firewall, forward fuselage, nose gear upper attachment fitting and nose gear fork. It appears that the cracked fitting may not have been stripped of paint and subjected to Non-Destructive Testing (NDT) inspection at that time. The fact that the edges of the fitting are clean (no dirt or grime) supports the notion that this is a very recent fracture.

Owners and operators should closely examine and conduct appropriate inspection techniques. Closely inspect the landing gear area for various adverse conditions (cracks, nicks, corrosion) that can lead to stress concentrations and eventual failure. ✖

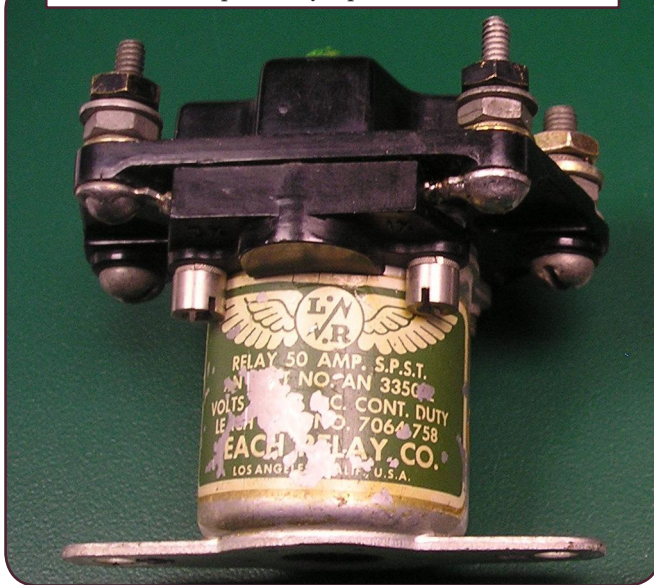
Correct 50 ampere relay - part number AN3350-2

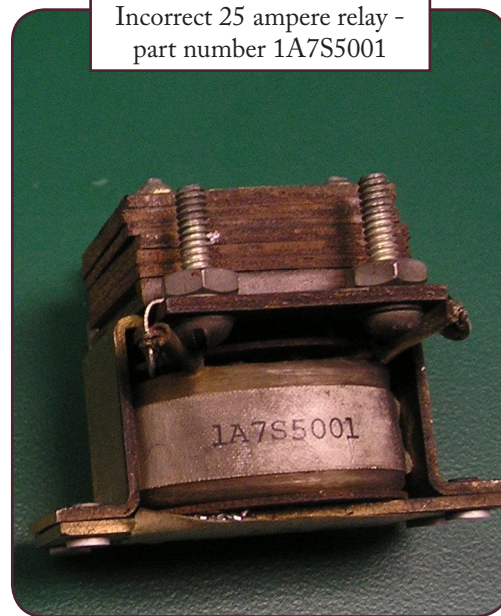
A maintenance investigation revealed that an incorrect 25 ampere (amp) electrical relay (part number 1A7S5001) was installed instead of the required 50 amp relay (part number AN3350-2). The circuit breaker in this system is a 60 amp breaker. Avionics personnel repaired the damaged

Incorrect 25 ampere relay - part number 1A7S5001

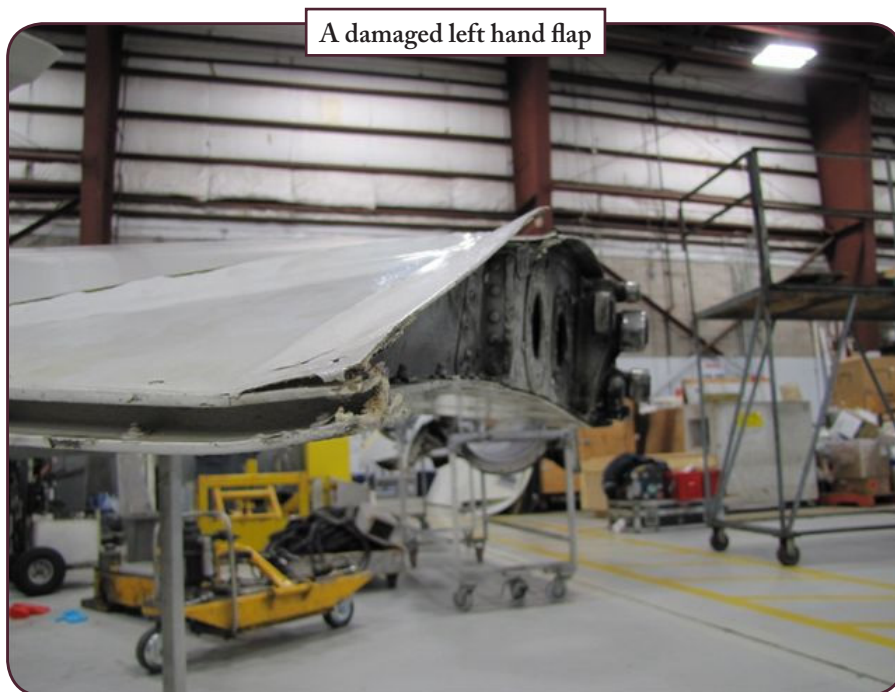
On approach for landing, the crew selected 35-degree flap extension; however flaps abruptly stopped at 15 degrees extension. Following an uneventful landing, the crew noticed the left inboard flap had extended asymmetrical thus causing the flap lower corner to contact and damage a fuselage composite panel. Additionally, the trailing edge of the inboard flap was also significantly damaged.

Subsequent investigation found the cause of this event was due to flap actuator screw jack failure (Time Since New (TSN): 50410, Part Cycles: 47244).

It appears the torque sensor unit would probably not have detected a differential flap torque from the primary flap drive and the secondary flap drive. This is because the primary flap drive would still be turning the worm gear inside of the failed unit, as if all was normal. In this case, even though the now worm gear was continuing to turn, it was not meshing with the now “worn” worm gear on the jackscrew itself and therefore not extending. In the meantime, the other flap jackscrew was working normally and thus extended.

A damaged left hand flap

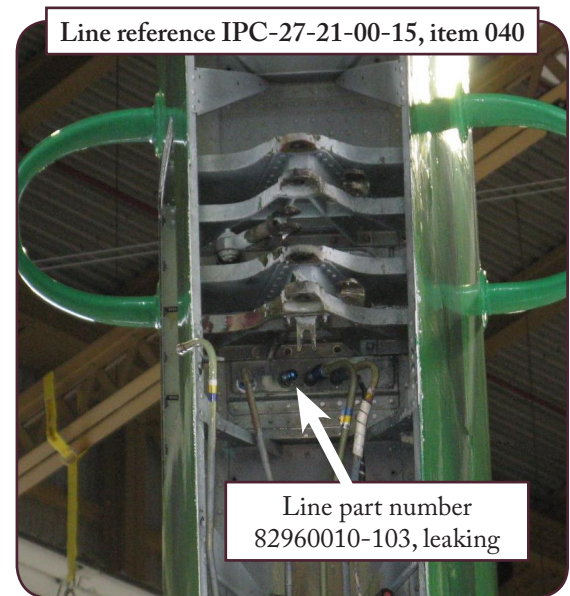
Maintenance personnel removed that rudder assembly to determine the source of the fluid leakage. It was found that the #2 system pressure tube assembly (P/N 82960010-15) had cracked at the bend radius. Additionally, in this same area, #1 hydraulic tube assembly was found significantly chafed (P/N 82960010-103).

In particular, tube assemblies tend to fail at the bend radius and/or fail due to chafing damage from adjoining parts. ✖

Both hydraulic tubes were replaced, #1 and #2 Hydraulic Systems pressure checked and the aeroplane returned to service.

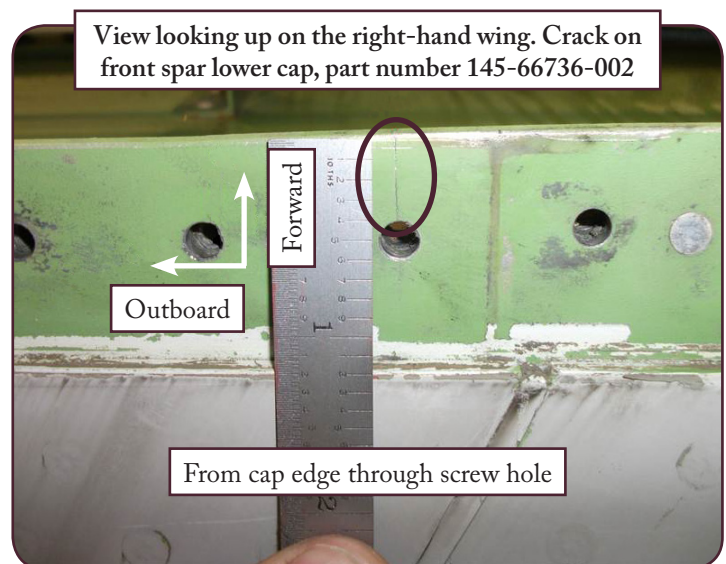
Wing Spar Crack

During a heavy maintenance visit while performing task card E57-22-00-220-808-2, the right-hand wing lower spar cap was found cracked at wing station 3815 (rib 9).

The crack emanated from the cap edge through a screw for a length of 2.159 centimeters (cm) (.850 inches).

The wing spar cap was repaired as per the applicable Structural Repair Manual (SRM) and the aeroplane was made serviceable.

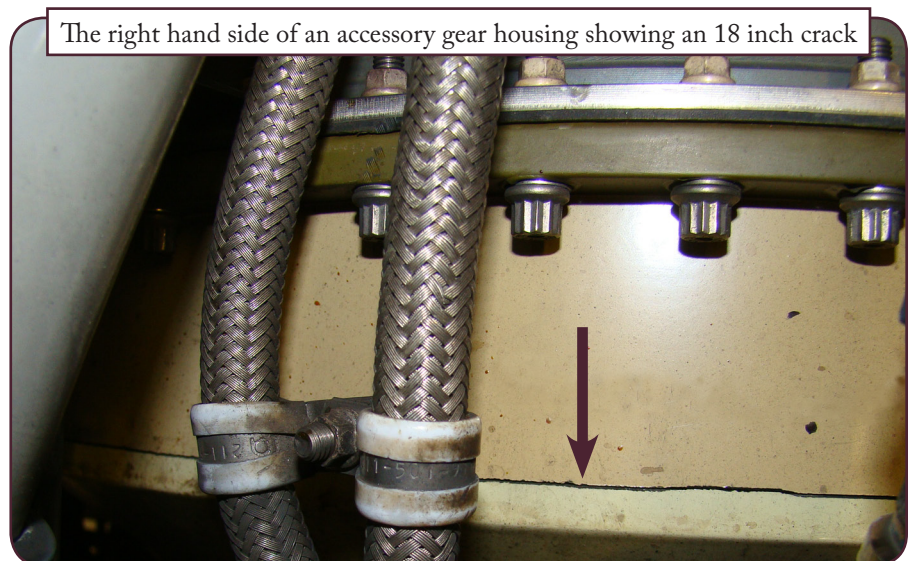
Cracked Engine Case

During troubleshooting of engine power issue, an 18 inch crack on the right hand side of the accessory gear case (magnesium housing), Time Since Overhaul (TSO):2119, was discovered. The crack extended approximately 180 degrees around the main diameter. This led to flexing of the engine case causing major internal rub damage to the rotating group and stationary components. The crack was found during trouble shooting of the engine running hot. The engine did not achieve target torque and was by-passing fuel at max Exhaust Gas Temperature.

It is possible that a previously installed engine truss assembly may not have been shimmed according to the Aircraft Maintenance Manual. This situation could create a stress loading on the engine case contributing to the crack. ✖
