KENO VALLEY/DUBLIN GULCH ENVIRONMENTAL BASELINE ASSESSMENT

VOLUME II: Keno Valley Sites #1 to #20

Prepared for
Waste Management Program
Indian and Northern Affairs Canada

By
Environmental Services
Public Works and Government Services Canada

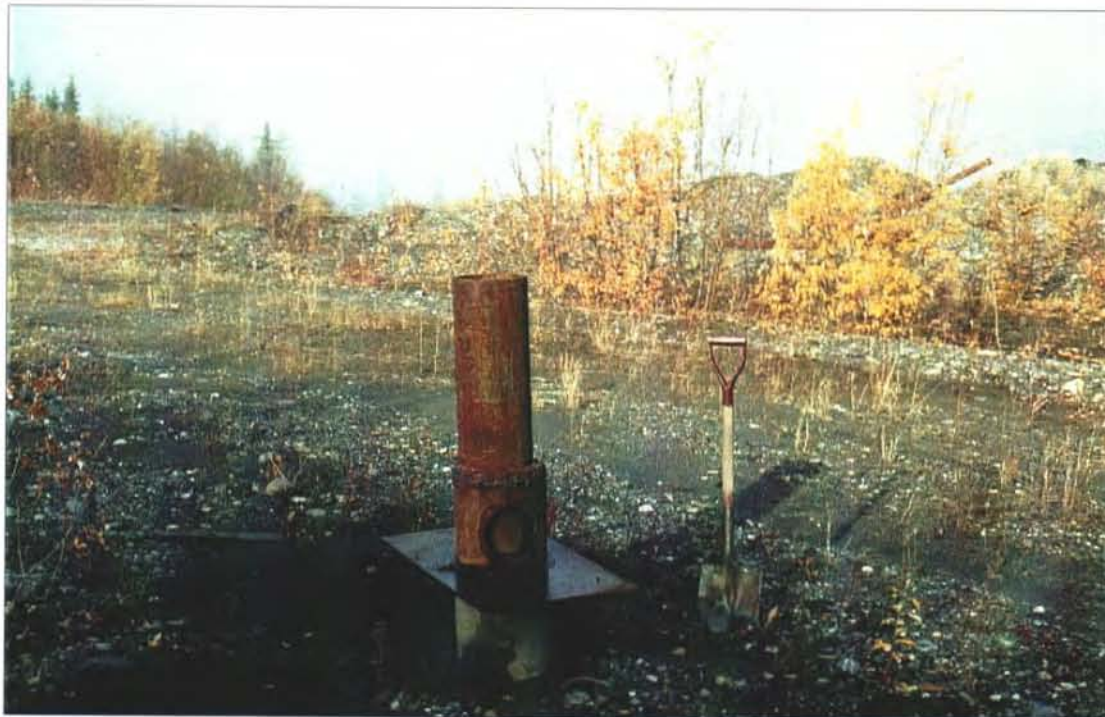
Photo 1-4 : Silver King. Backfill pipe, 100m south of the open pit. Looking northwest.
Note hydrocarbon stain at base of pipe (likely drill lubricant or hydraulic fluid).

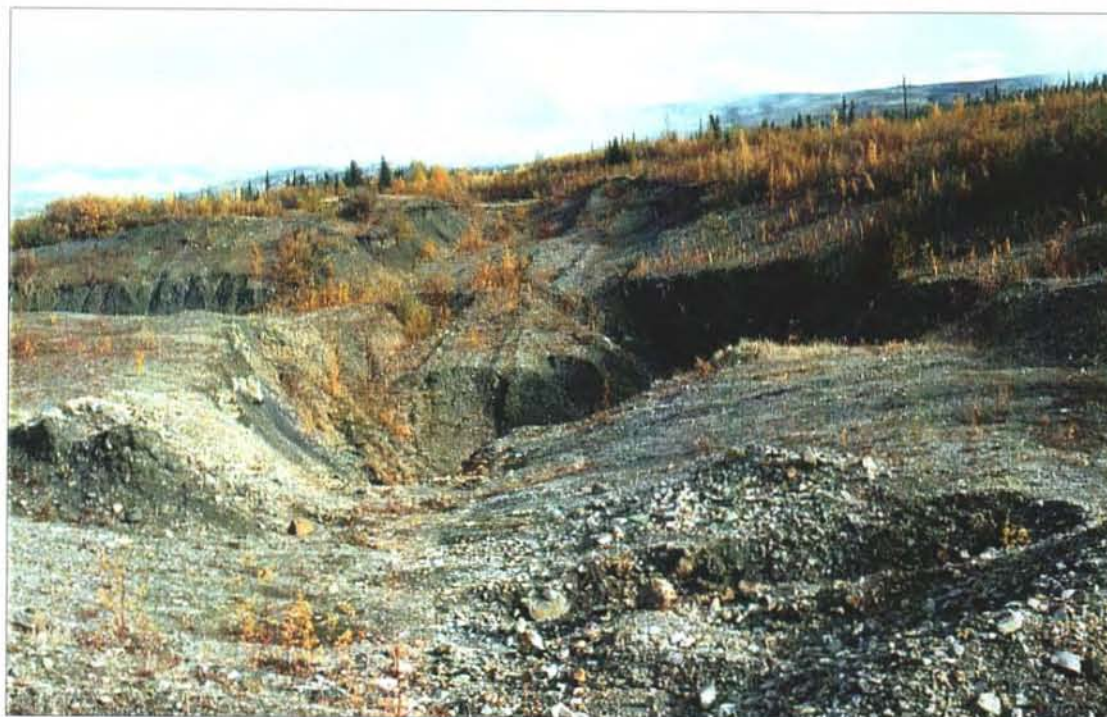
Photo 1-5 : Silver King. Silver King Pit, looking east-northeast. Note moderate pit wall slope, abundance of overburden versus outcrop, and natural revegetation.

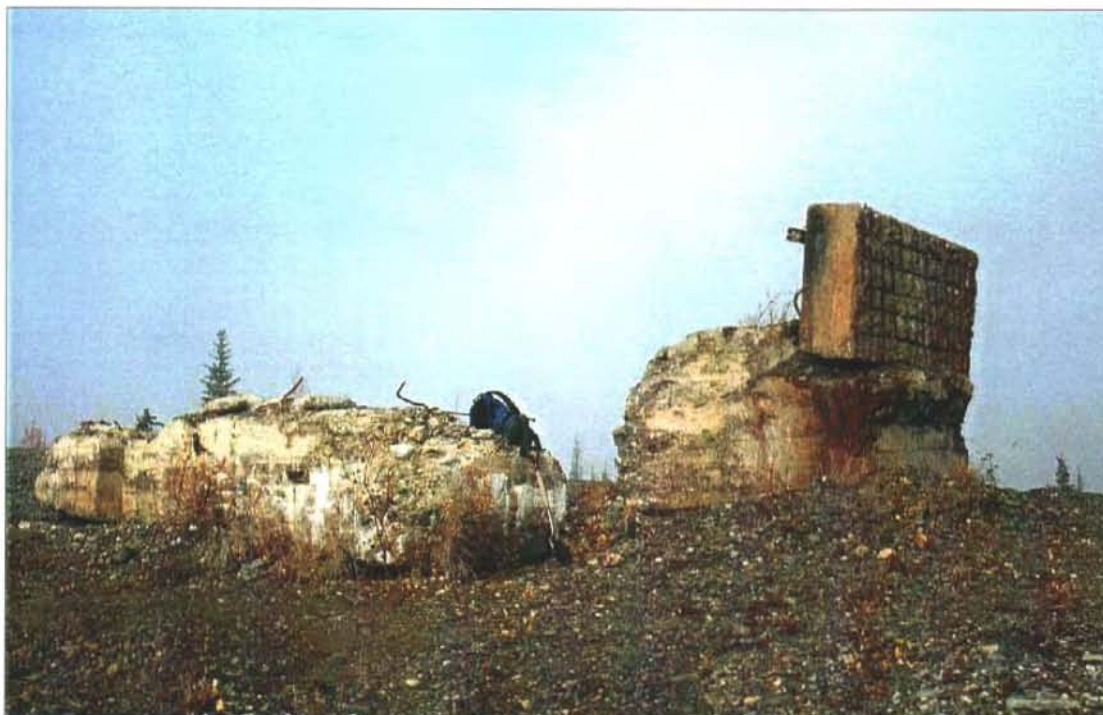
Photo 1-6 : Silver King. Concrete shaft hoist foundations. Looking northwest, northwest of the open pit.

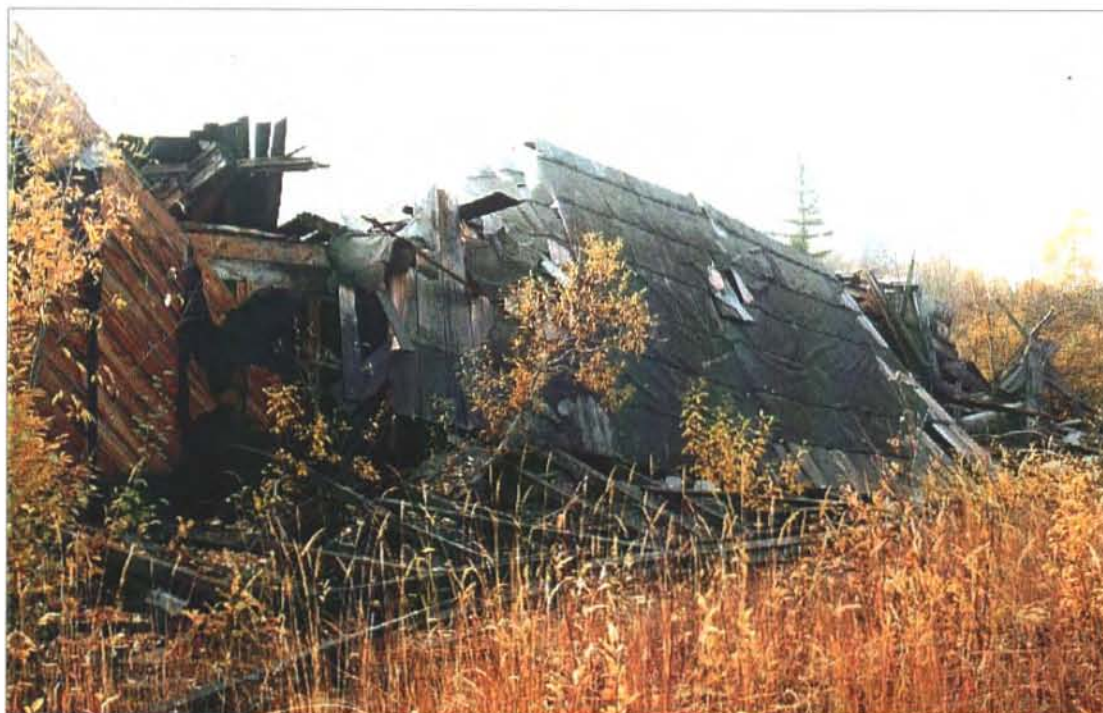
Photo 1-7 : Silver King. Large, collapsed storage shed. Looking south, near transformer station south of highway, west of Galena Creek.

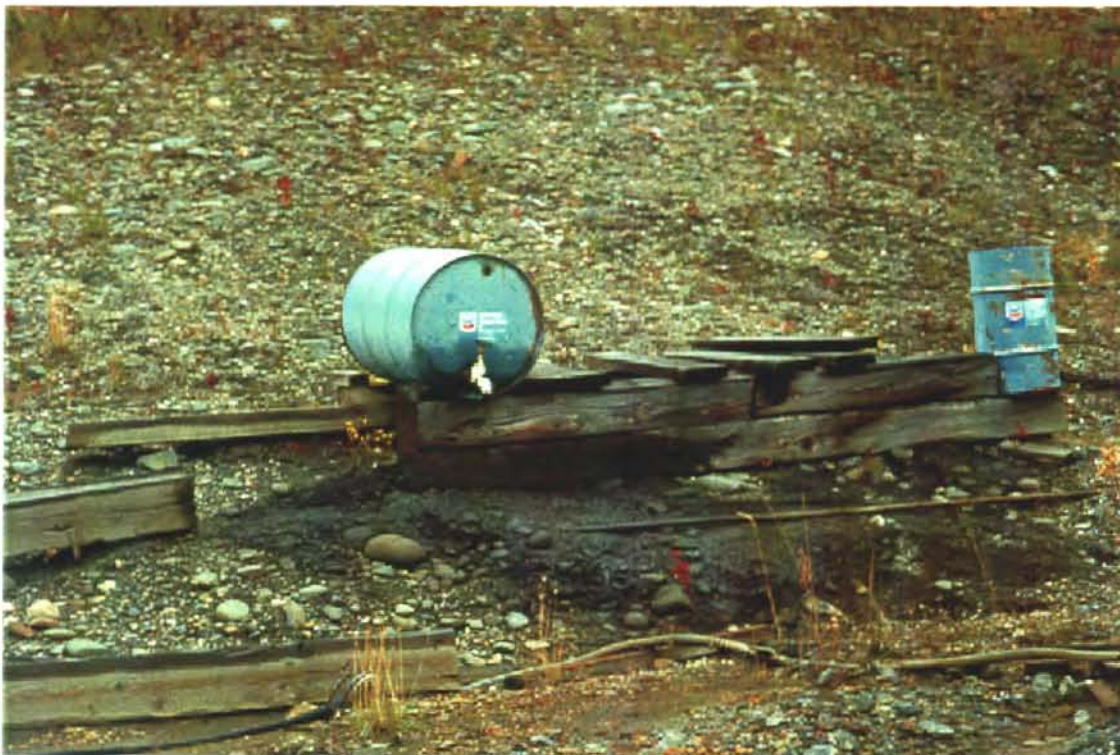
Photo 2-19: Torque fluid 200L staining is evident.

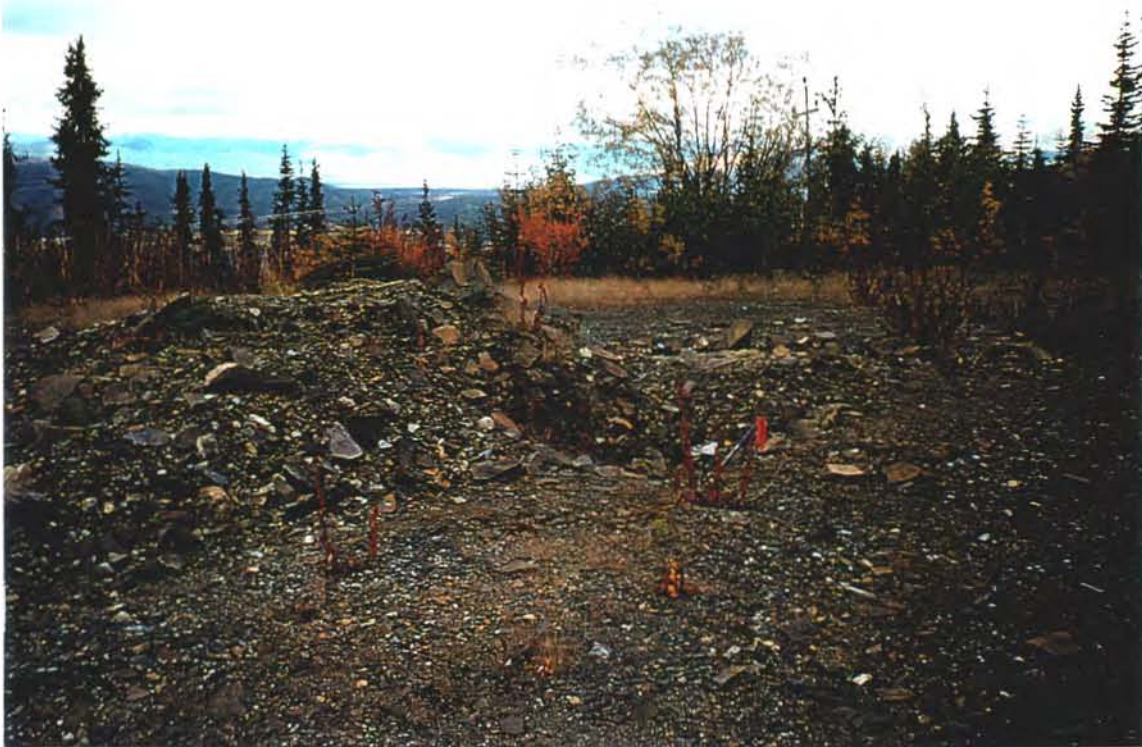
Photo 4-3: Eastern raise of the Dixie mine site. Magnesium staining is evident on the vein rocks. (Azimuth 25°)

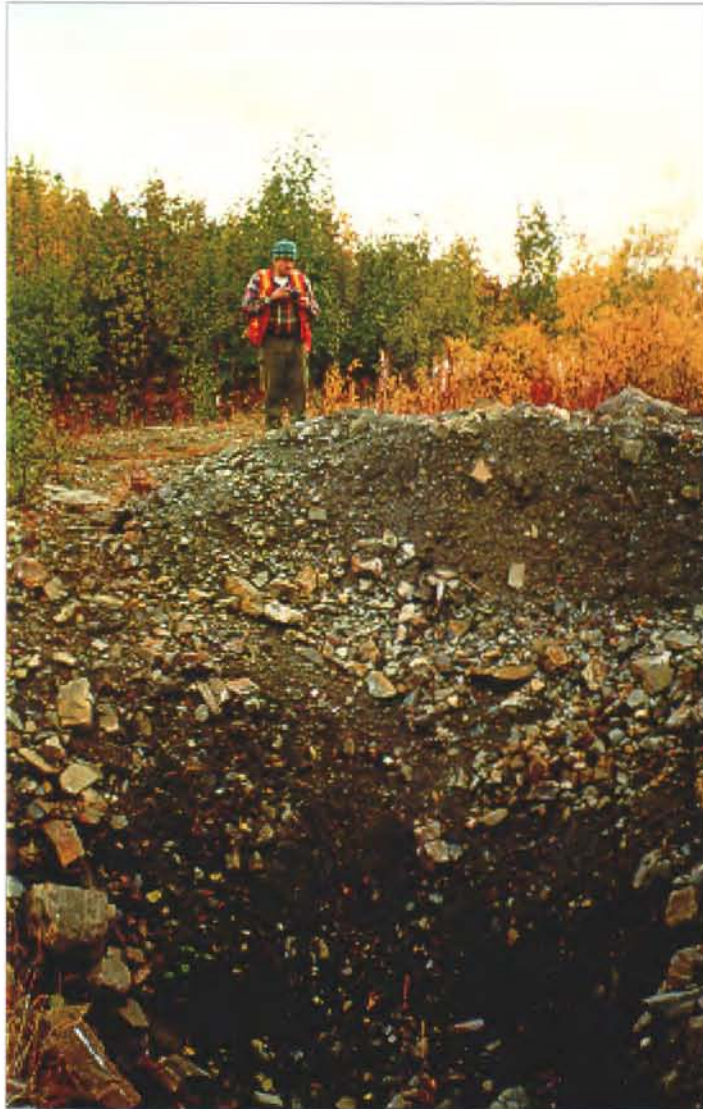
Photo 4-4: Photo of the collapsed western raise located directly above the main Dixie site. (Azimuth 210°)

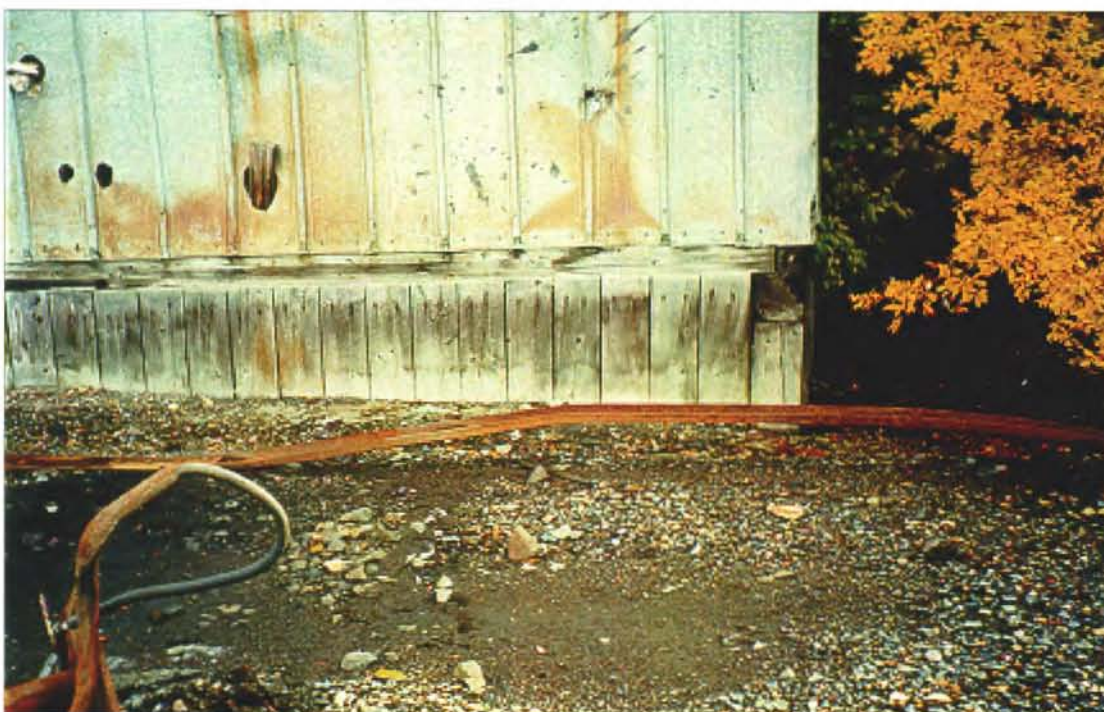
Photo 4-8: Stained soil on the west side of building 4A. (Azimuth 135°)

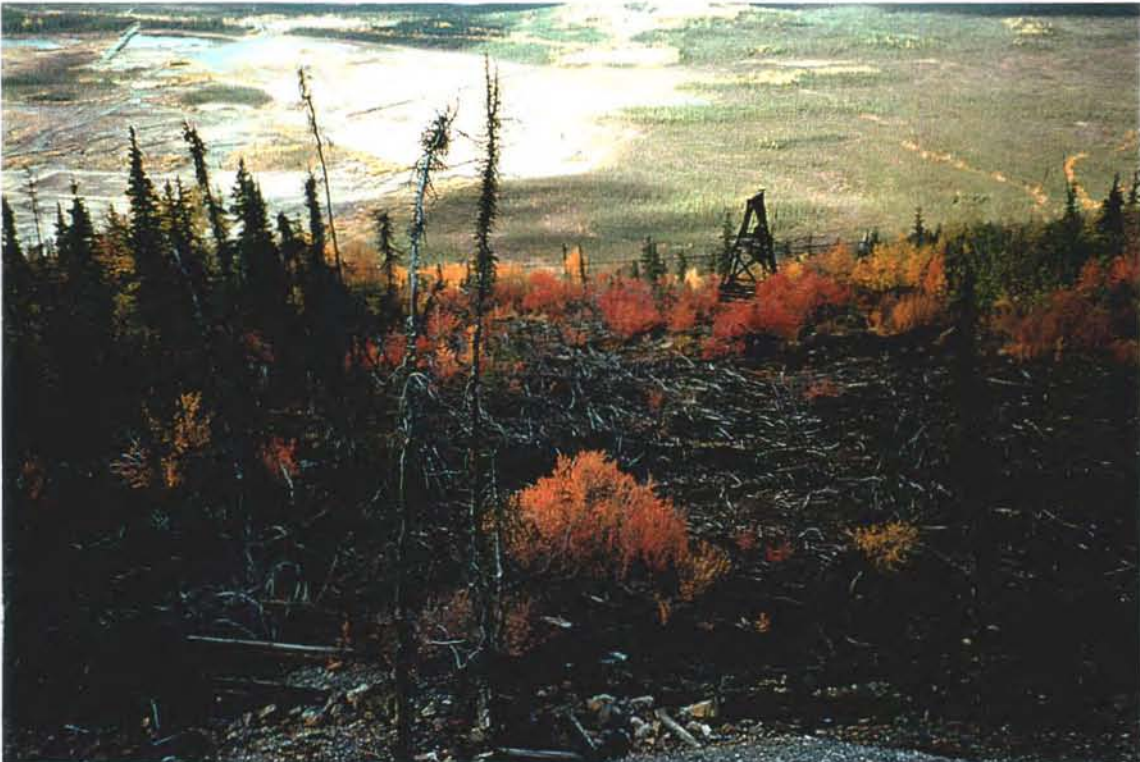
Photo 4-9: The kill zone associated with the waste rock dump site. (Azimuth 320°)

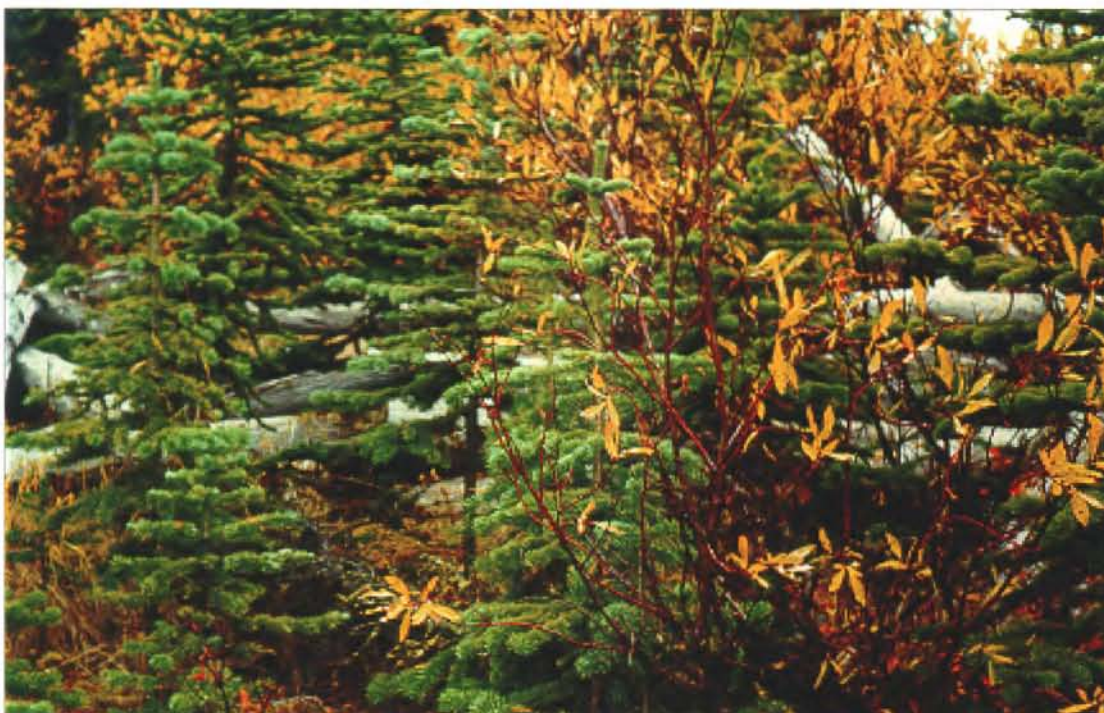
Photo 5-1: Building 5A - Building was of log construction has deteriorated and collapsed.

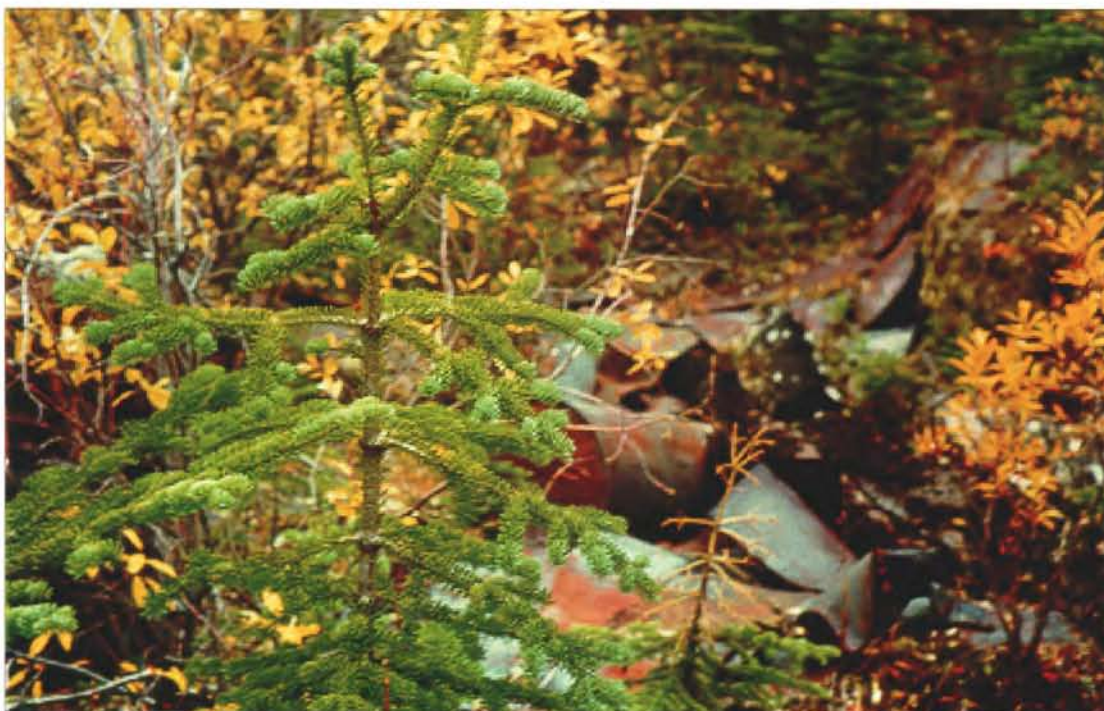
Photo 5-2: Building 5B - Building had collapsed and burnt - metal debris appeared to be burnt.

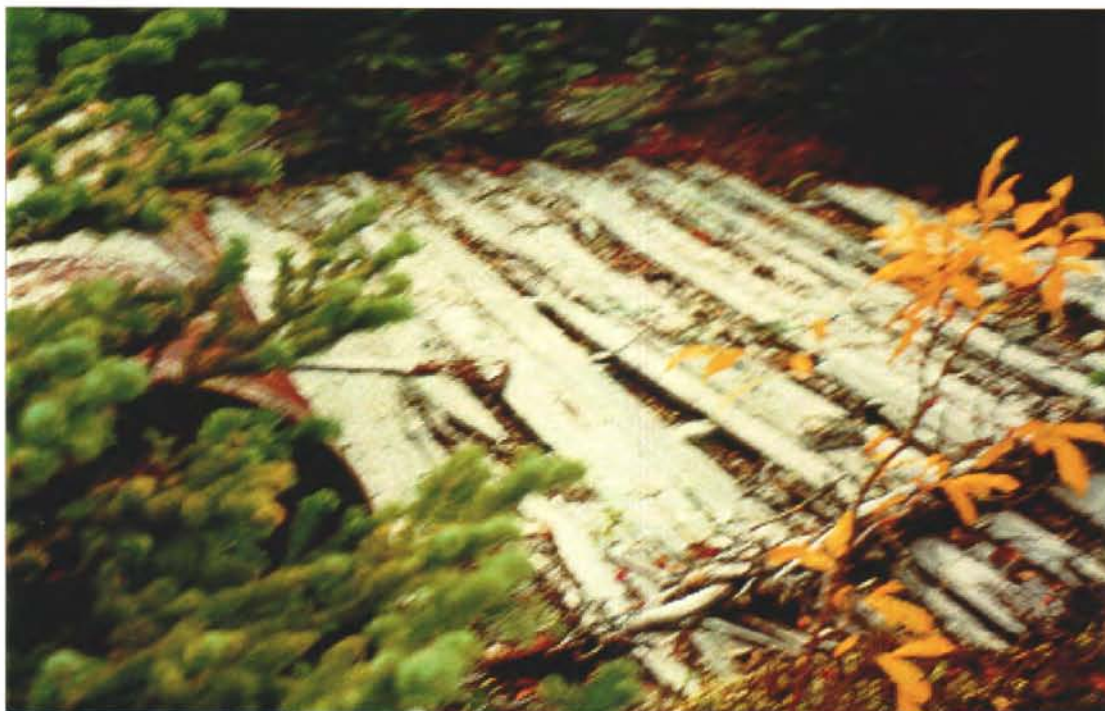
Photo 5-3: Building 5C - Building has collapsed and only plank flooring is evident.

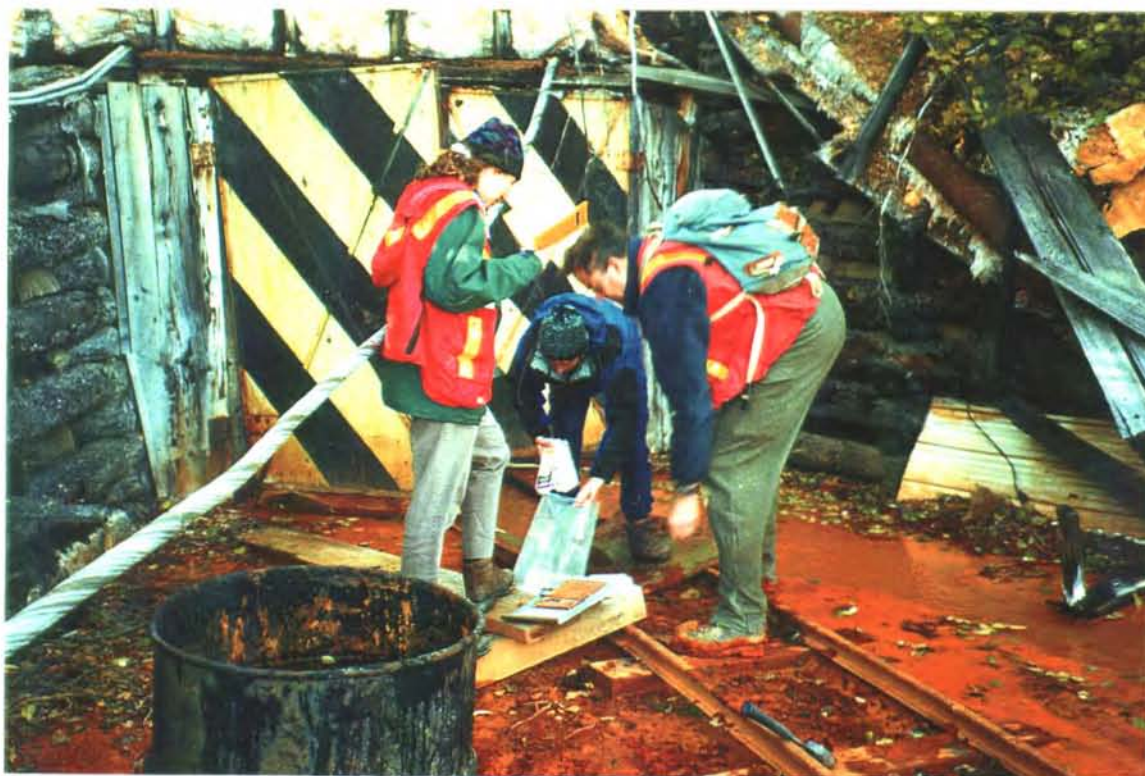
Photo 11-4. Galkeno 300 level adit. Note the iron oxidized (orange) laden water and precipitate. Also note the debris in the area.

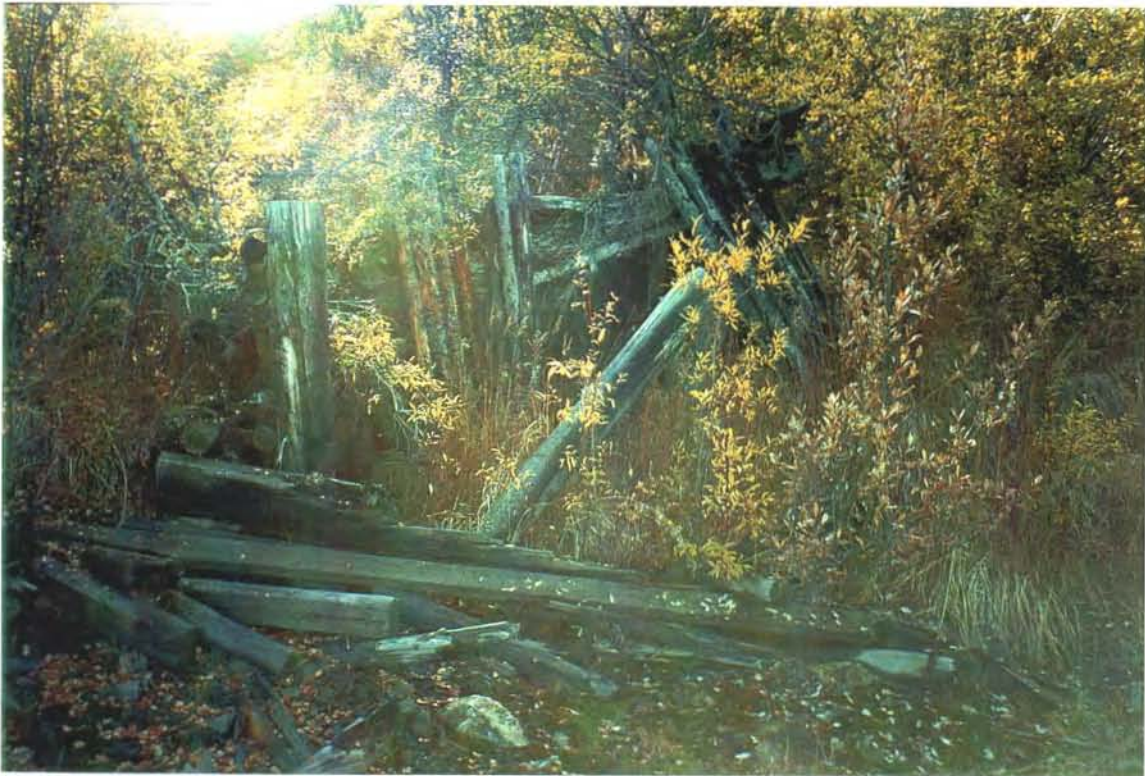
Photo 11-5. Galkeno 200 level adit. Portal is open but is unsafe. The timbers of the portal are collapsing.

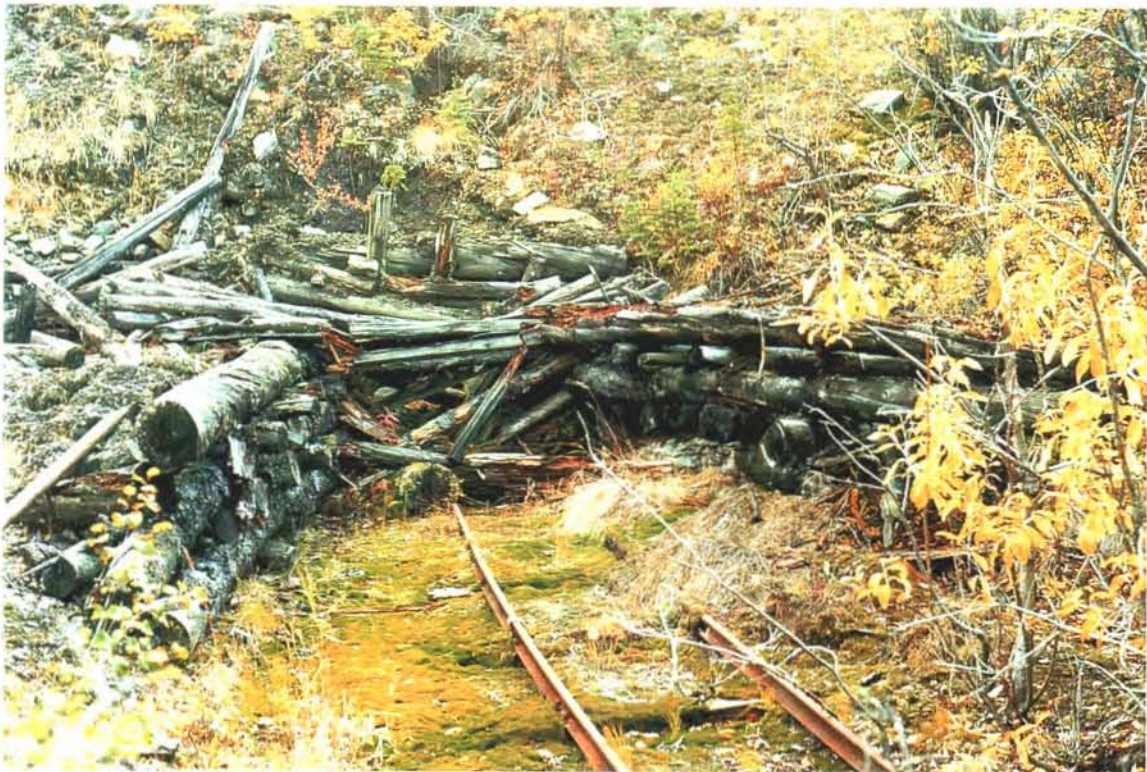
Photo 11-6. Galkeno 100 level adit. Portal is completely collapsed. Note rails exiting adit.

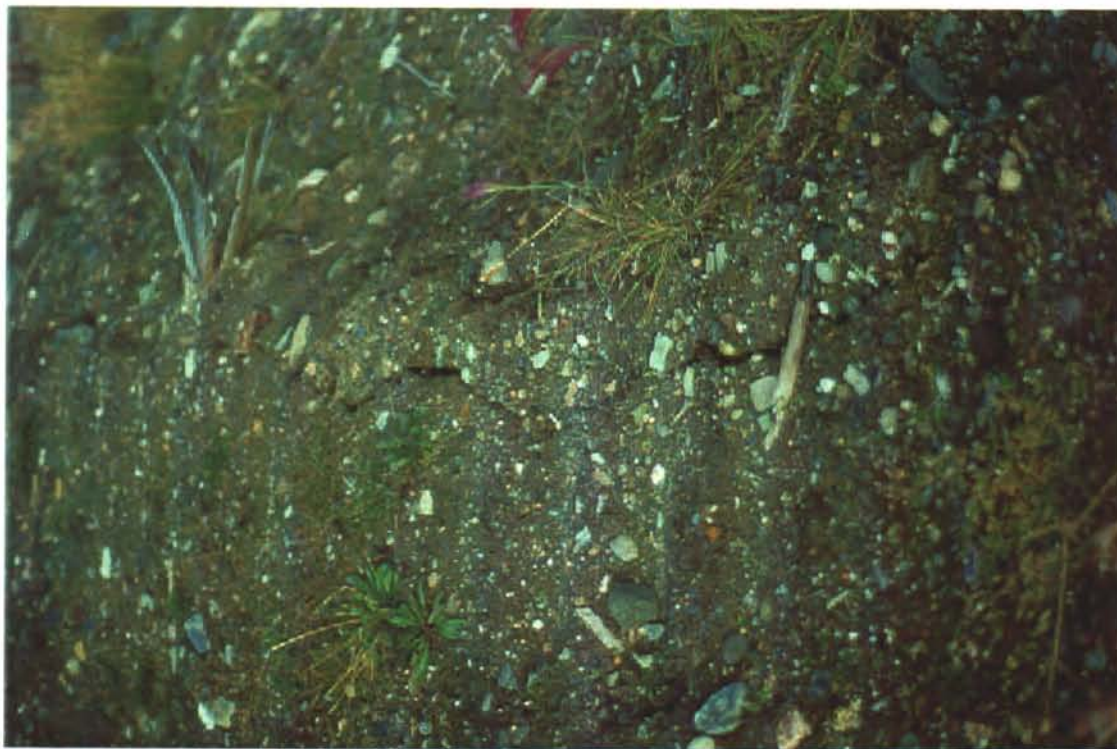
Photo 12-6: Tension cracks in the settling pond retaining wall. (Azimuth 000°)

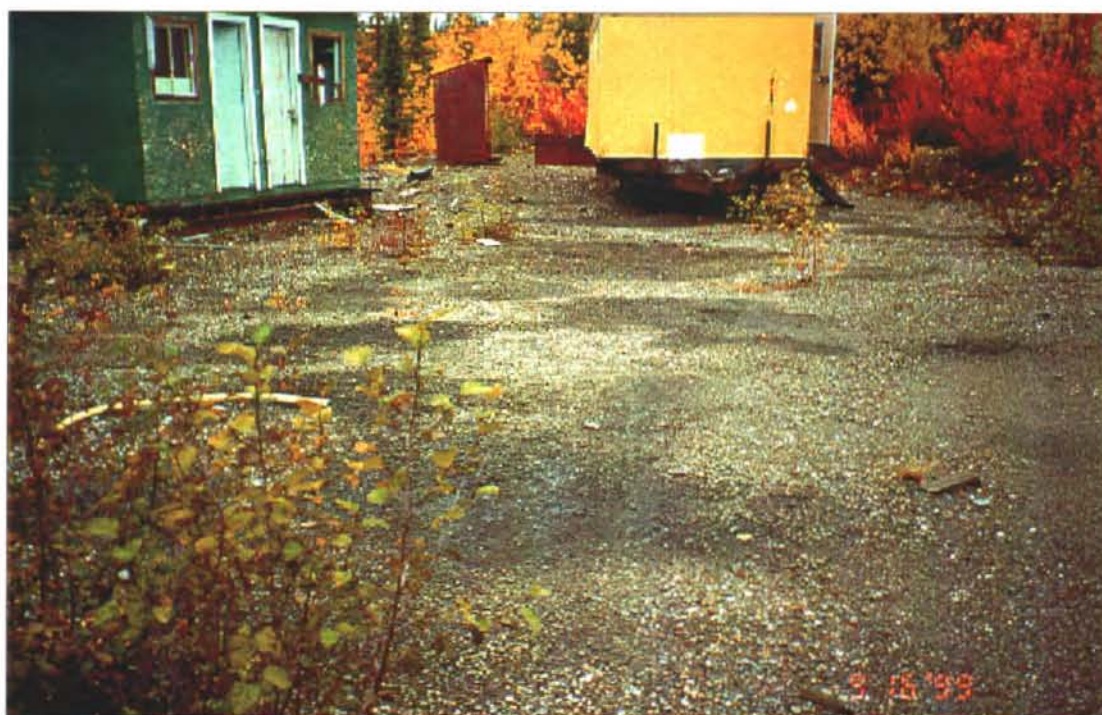
Photo 19-6: Buildings 19C & 19D at upper camp. Note oil staining in foreground.

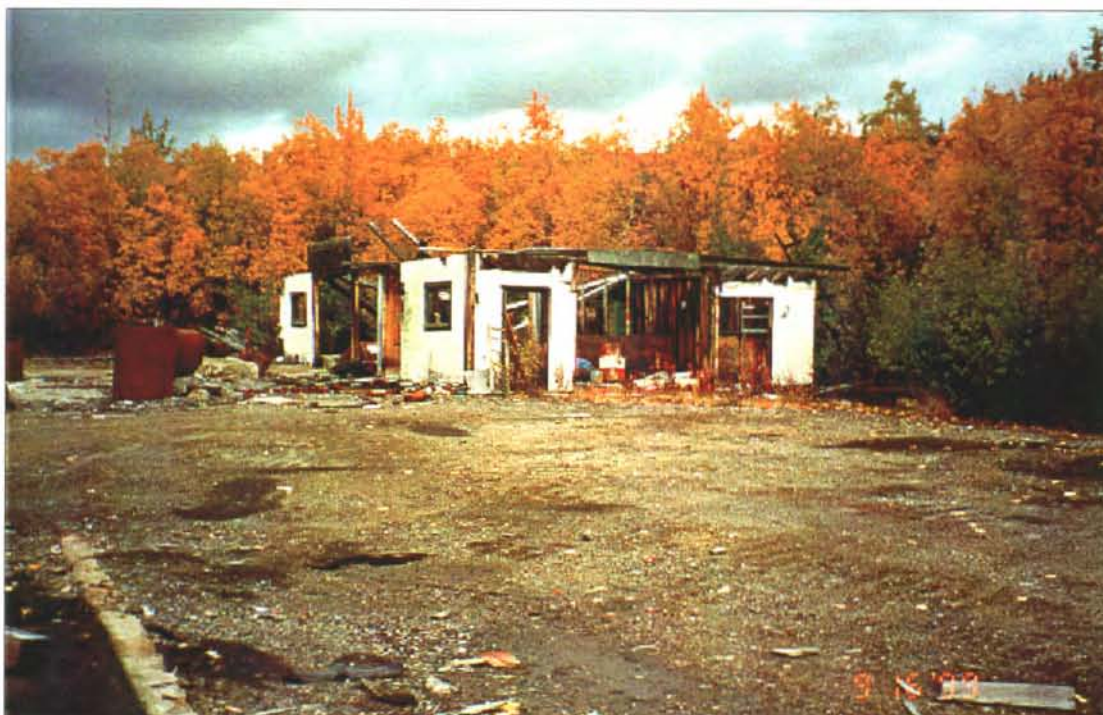
Photo 19-7: Remains of building 19E at lower area. Note oil staining in foreground.

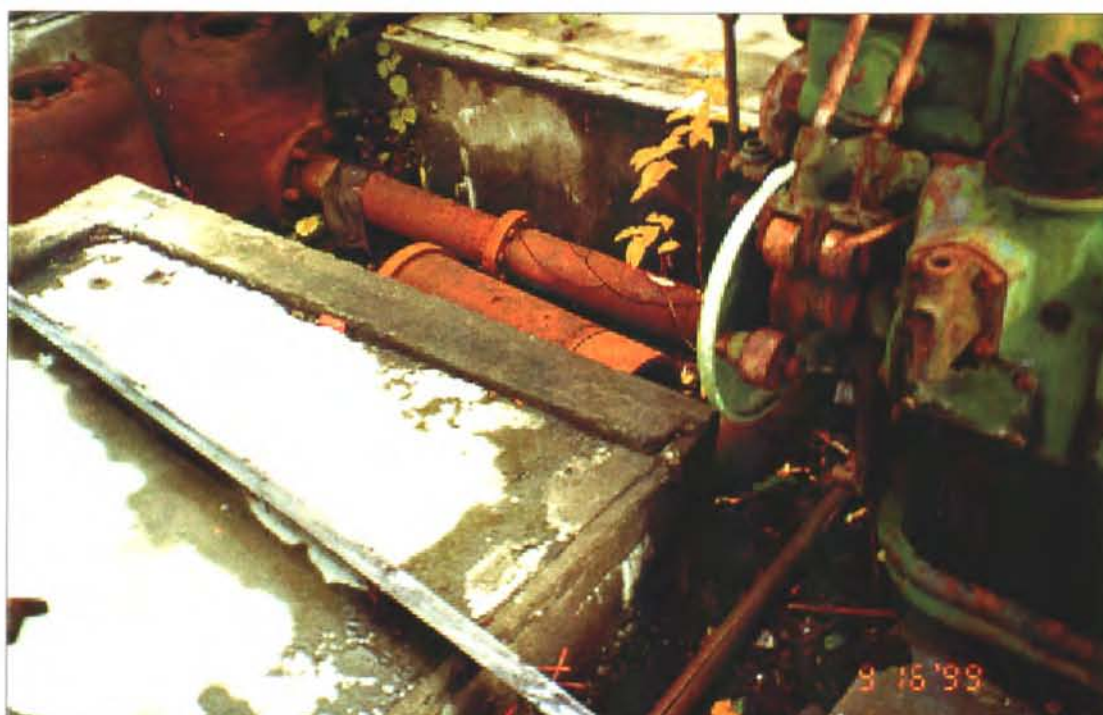
Photo 19-8: Equipment and staining in sumps at compressor building (19E).

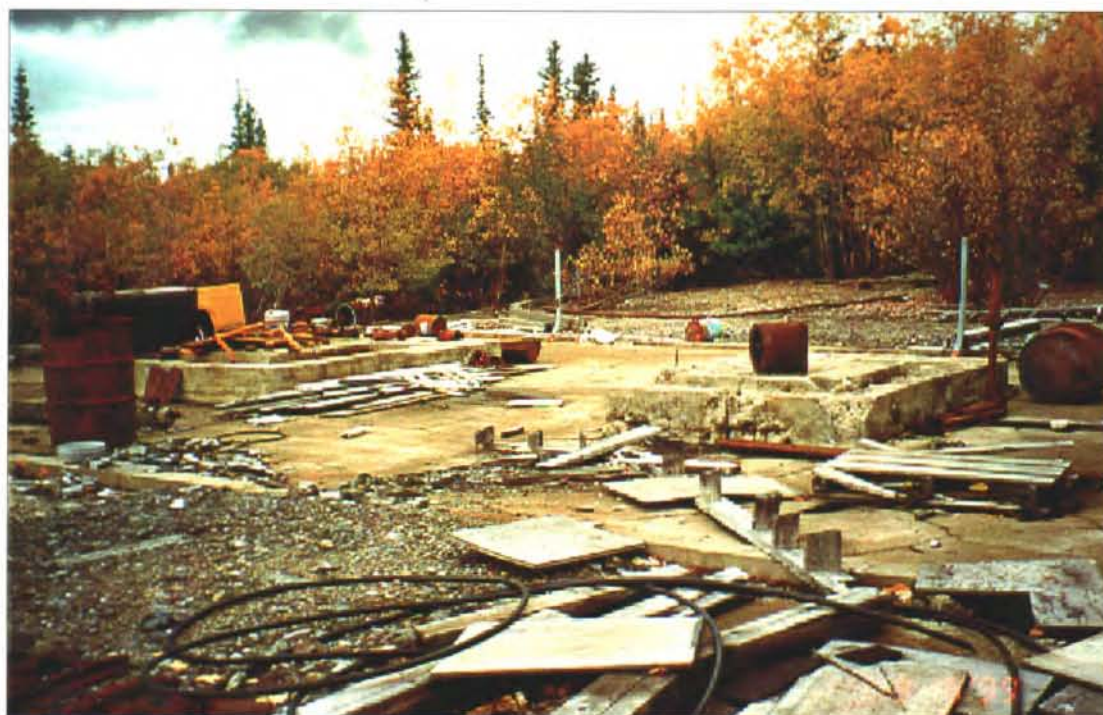
Photo 19-10: Concrete foundation (building 19F) with much metal and debris.

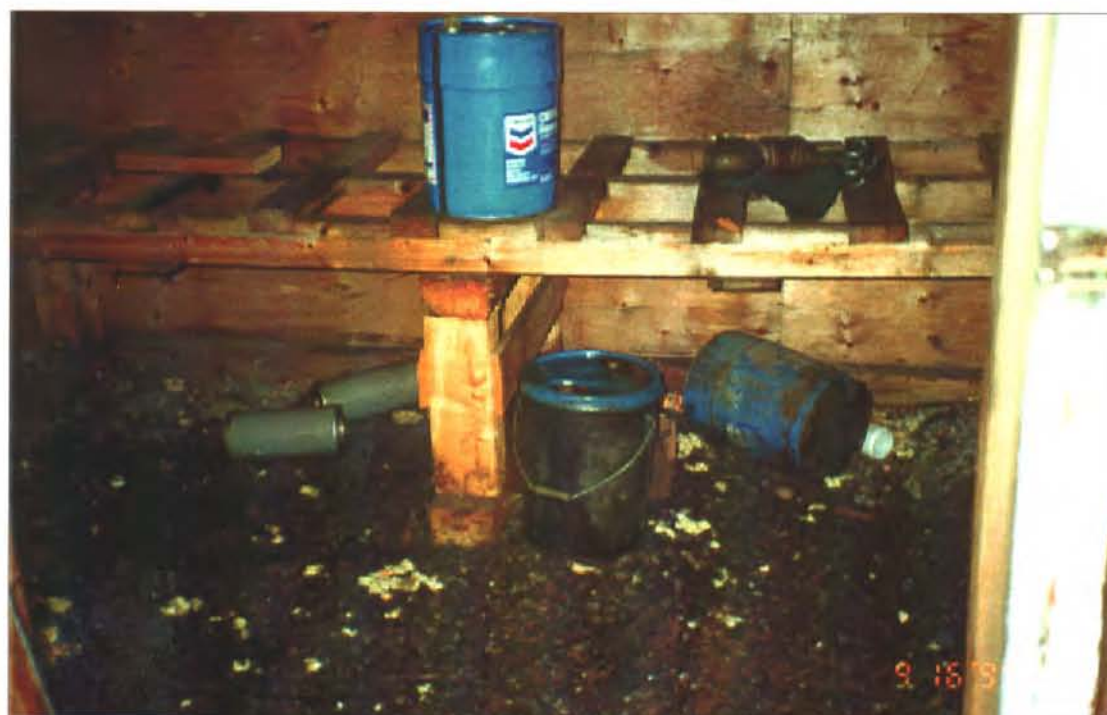
Photo 19-19: Hydrocarbon containers and extensive staining inside building 19C.

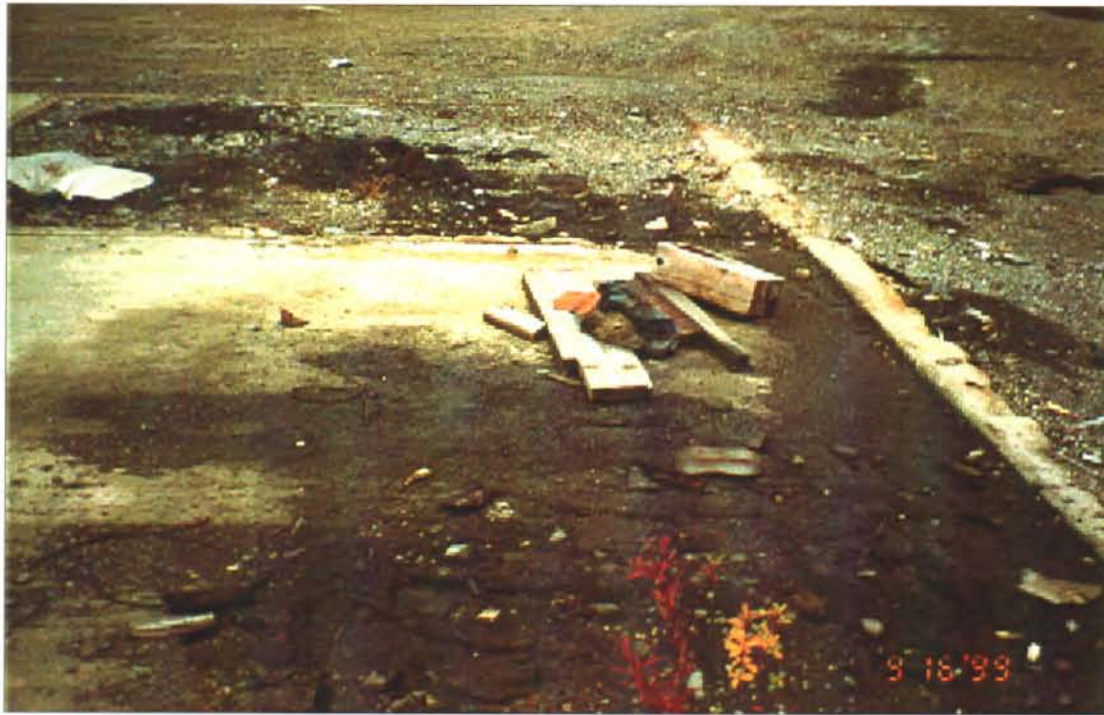
Photo 19-20: Extensive staining in sumps at building 19G.
