# KENO VALLEY/DUBLIN GULCH ENVIRONMENTAL BASELINE ASSESSMENT

VOLUME III: Keno Valley Sites #21 to #40

Prepared for  
Waste Management Program  
Indian and Northern Affairs Canada

March, 2000

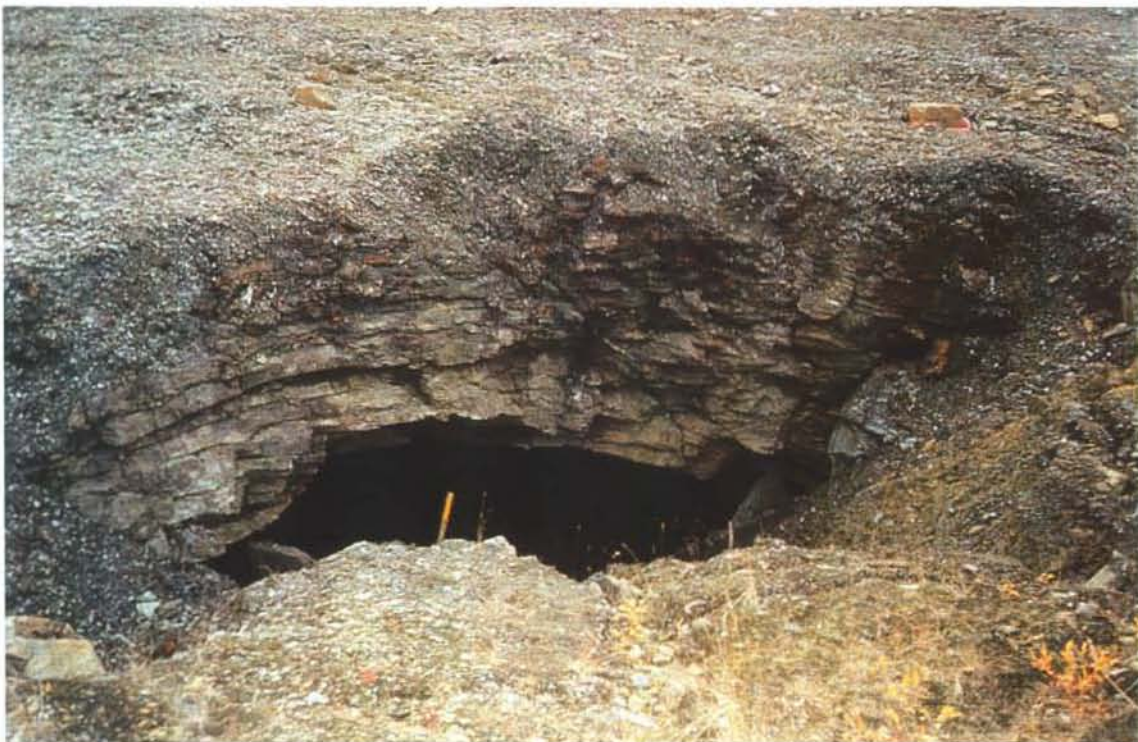
Photo 21-3: Open decline from recent (late 1980's) work. Note hazard from loose slabs in the roof resulting from horizontal foliation structures. (Azimuth 170°)

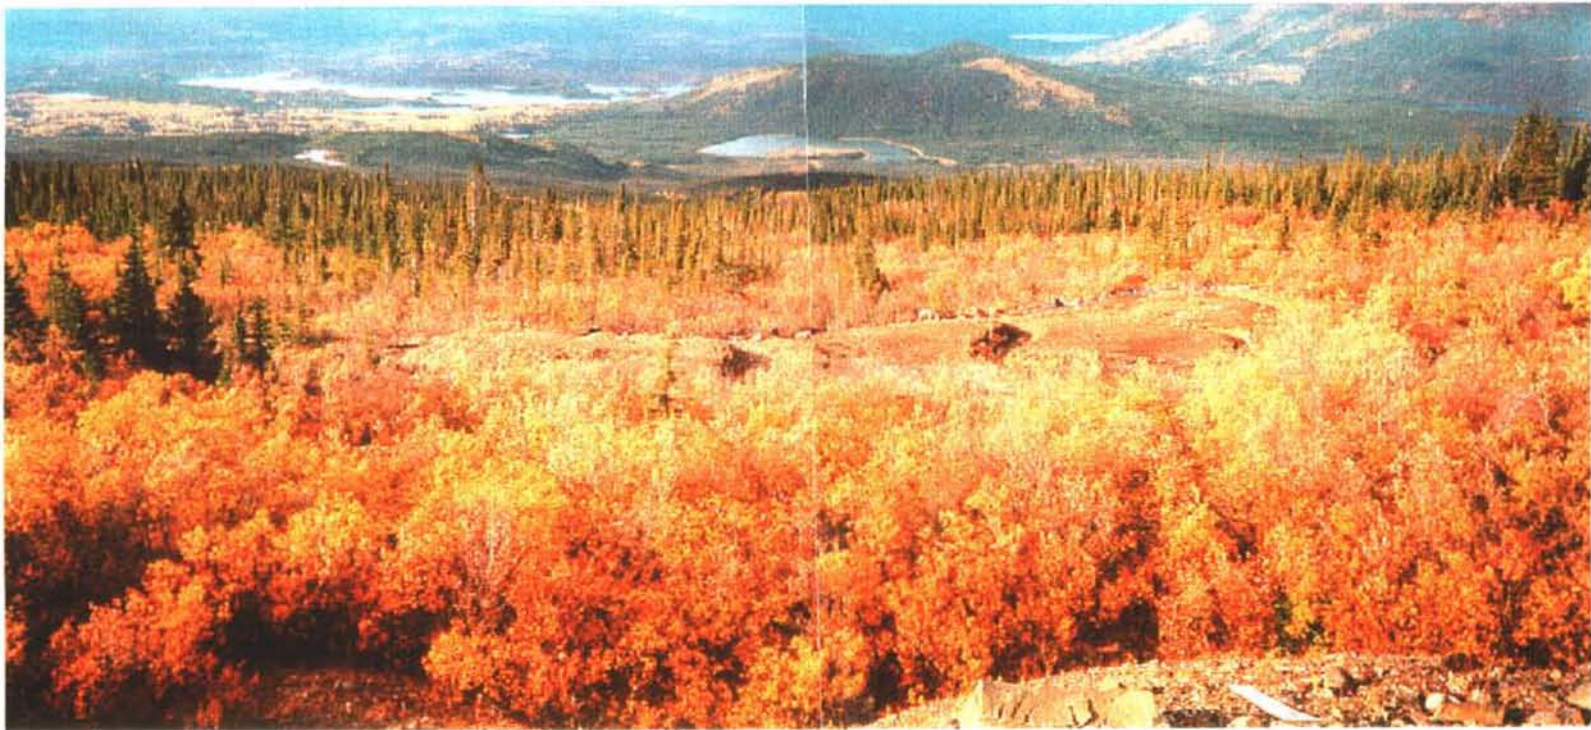
Photo 21-7: Mill tailings located below waste dumps. Note collapsed sheet metal impoundment structure and tailings delta in lake below at top-centre of photo. (Azimuth 335°)

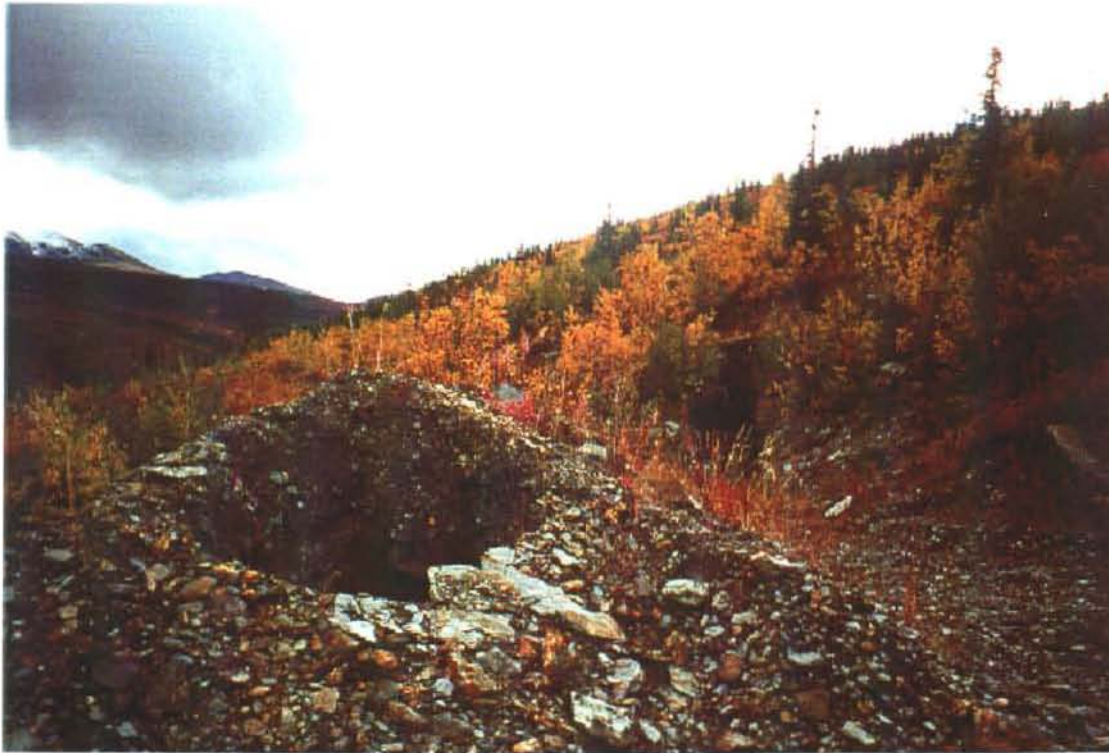
Condition: The shaft and stope remain unstable and could be prone to continued collapse.

Photo 22-16: Stope broken through to surface just below Eureka Shaft 1.

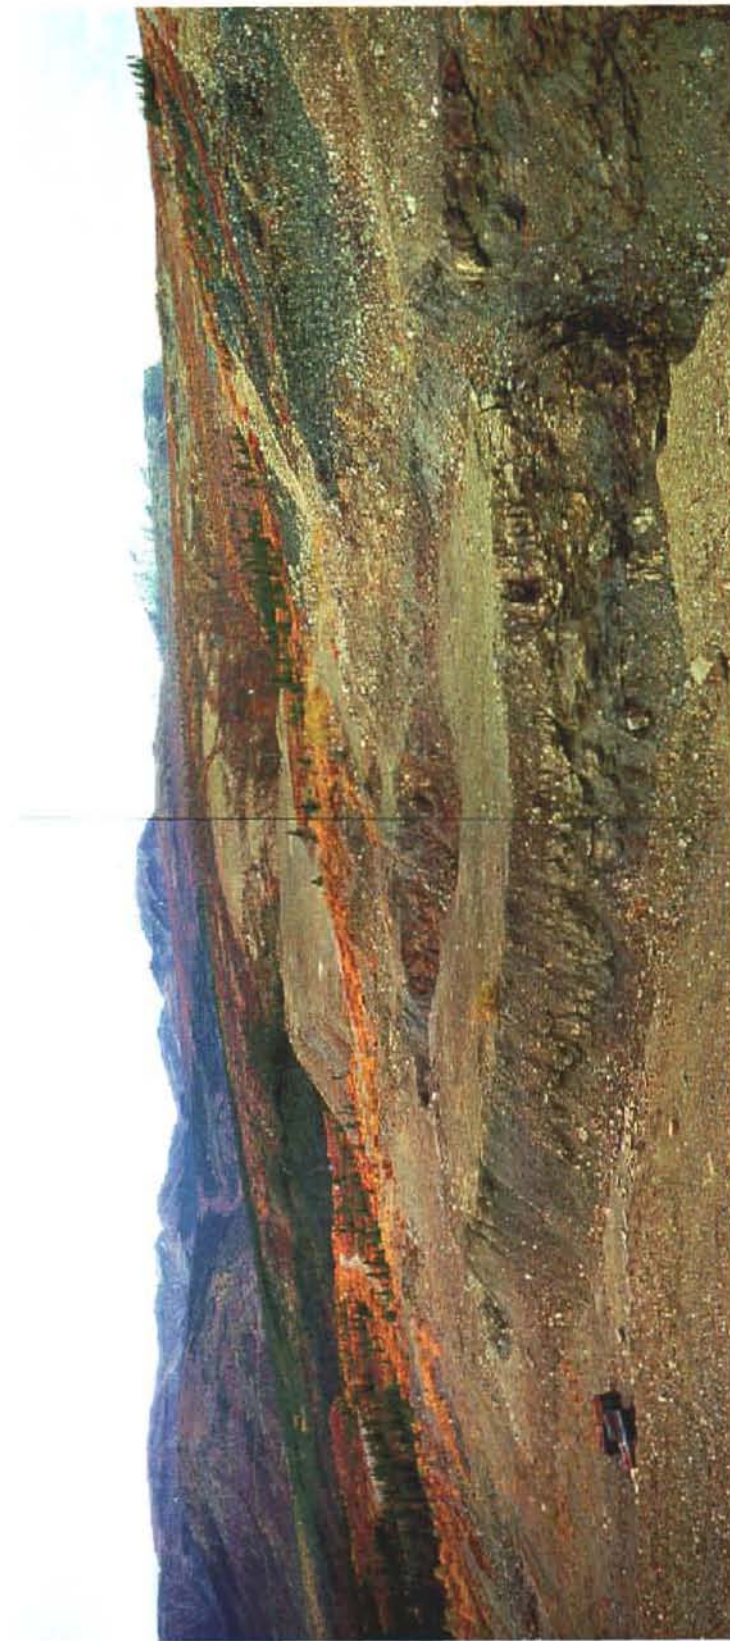
Photo 25-4: Upper Blackcap pit. Note unstable pit walls and recent rock debris at base.(Azimuth 340°)

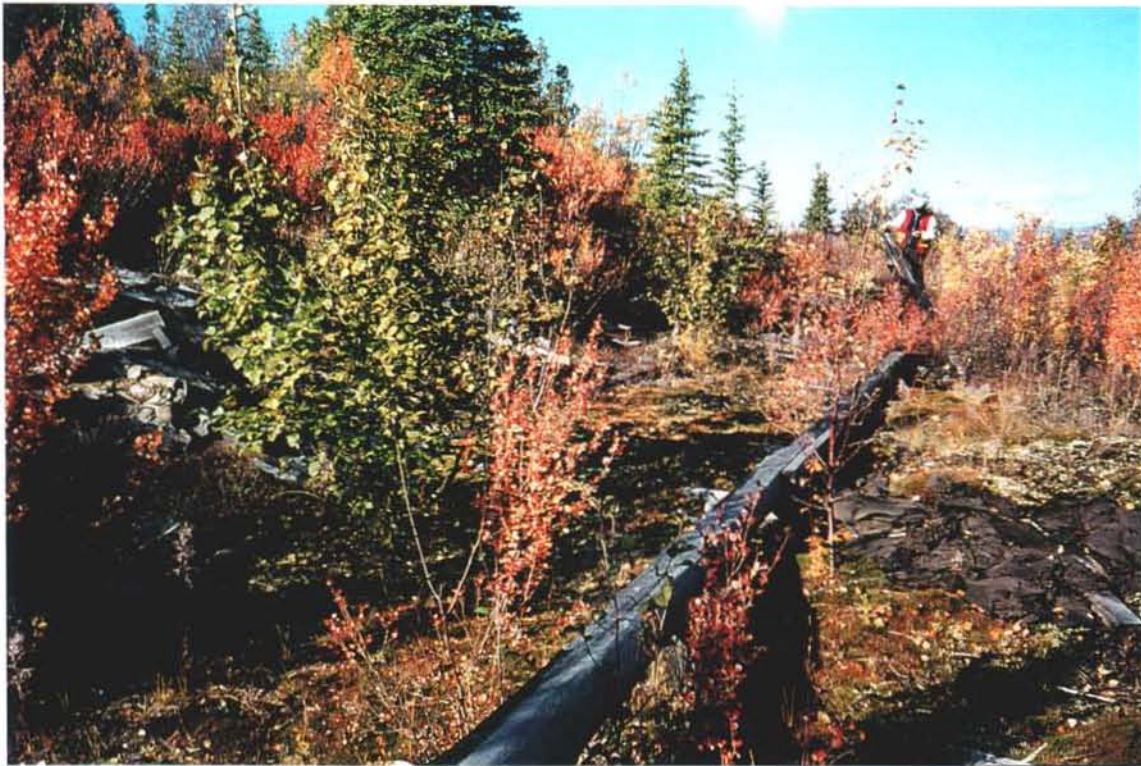
Photo 31-8: Demolished buildings (Bldgs. 31-C, D) along road west of Stone. Note discarded asbestos containing siding at right and in background held by field personnel. at depth in pit and abundant siderite vein cobbles.

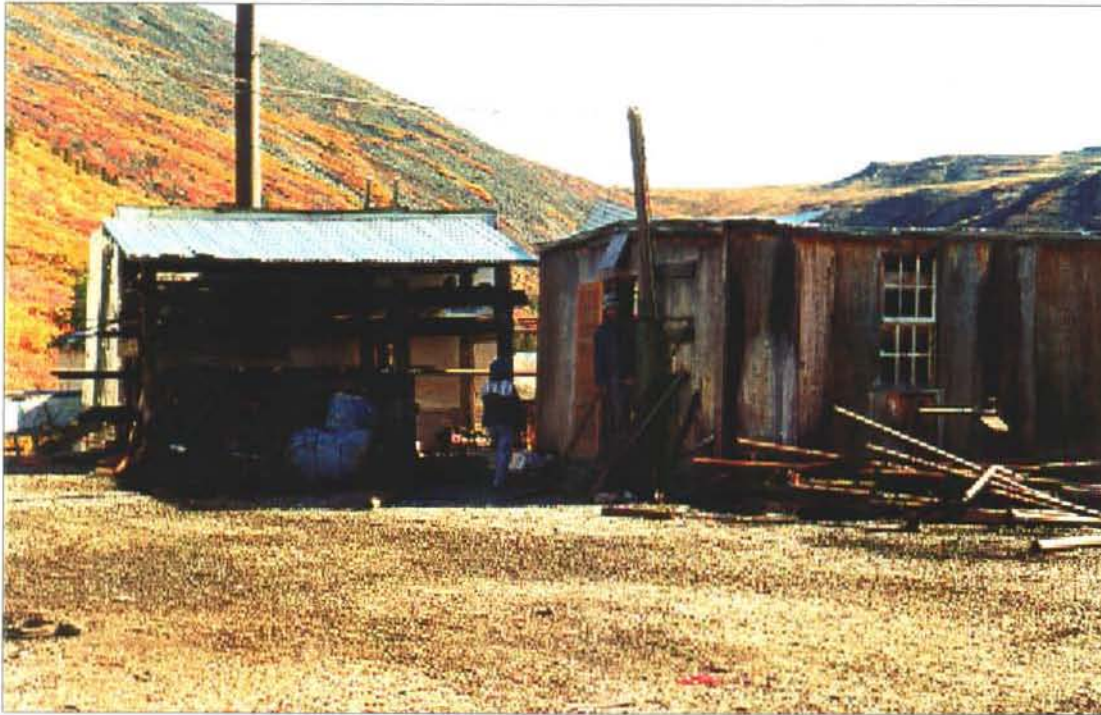
Photo 32-18 : Keno 700. Generator shack (building 9) looking north - oil staining in front.

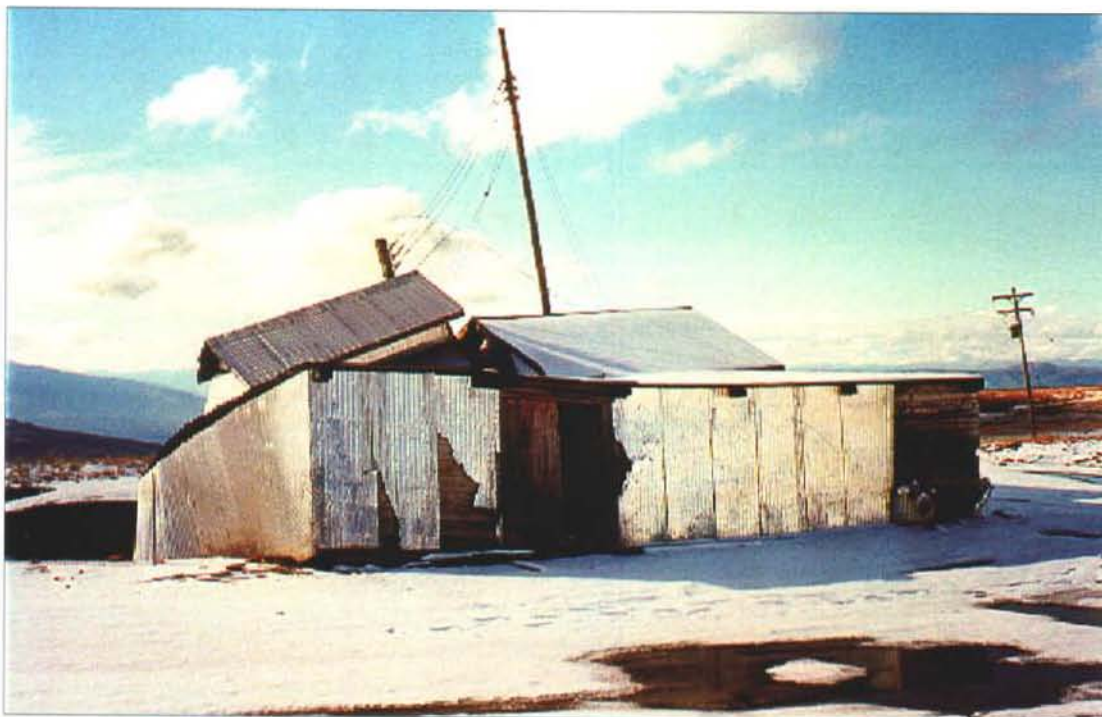
Photo 36-2 : Keno No.9 Shamrock J18 Vein Raise Building (36-A). Note collapse of building into failing underground workings and fencing around opening. Also, transformer on power pole in background. (Azimuth 290°).
