# KENO VALLEY/DUBLIN GULCH ENVIRONMENTAL BASELINE ASSESSMENT

VOLUME V: Keno Valley Sites #71 to #73, #75 to #81

Dublin Gulch Sites #85 to #86, #88 to #94, and #96

Prepared for Waste Management Program Indian and Northern Affairs Canada

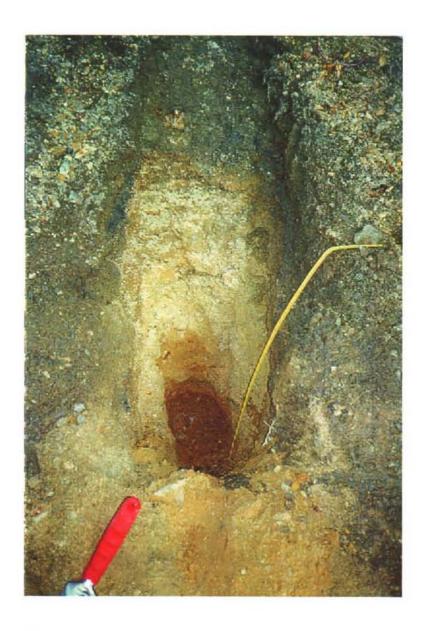
Photo 72-3: Waste rock sample pit for 72WR01-01 and -02. Note distinct colour change.

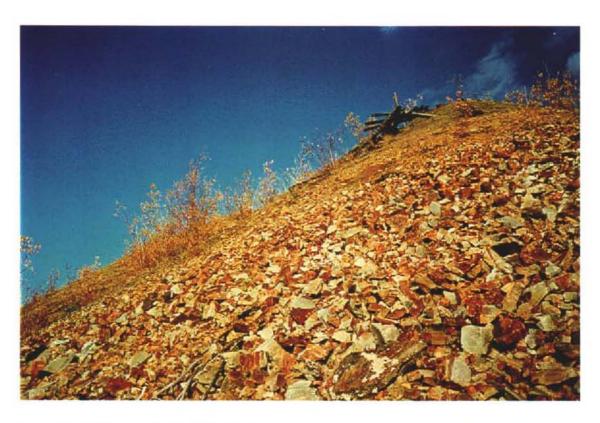
Photo 72-4: Waste rock pile 72WR02. Note rusty quartzite material and collapsed tressel structure. (Azimuth  $340^{\circ}$ )

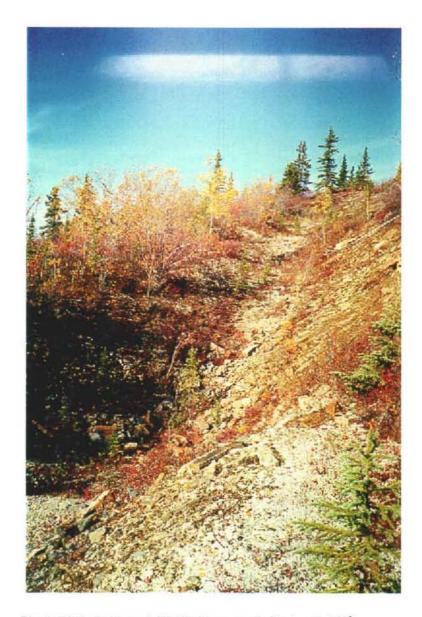
Photo 72-5: Cat trench TR03 above road. (Azimuth 340°)

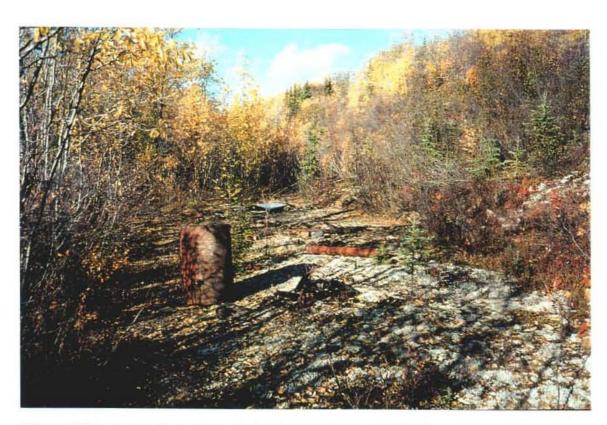
Evidence was found that a building once stood at the Ironclad site. Metal and wood debris are located in an area about 15 m west of Adit 1 (photo 72-6).

Photo 72-6: Levelled mine portal area showing metal and wood debris.

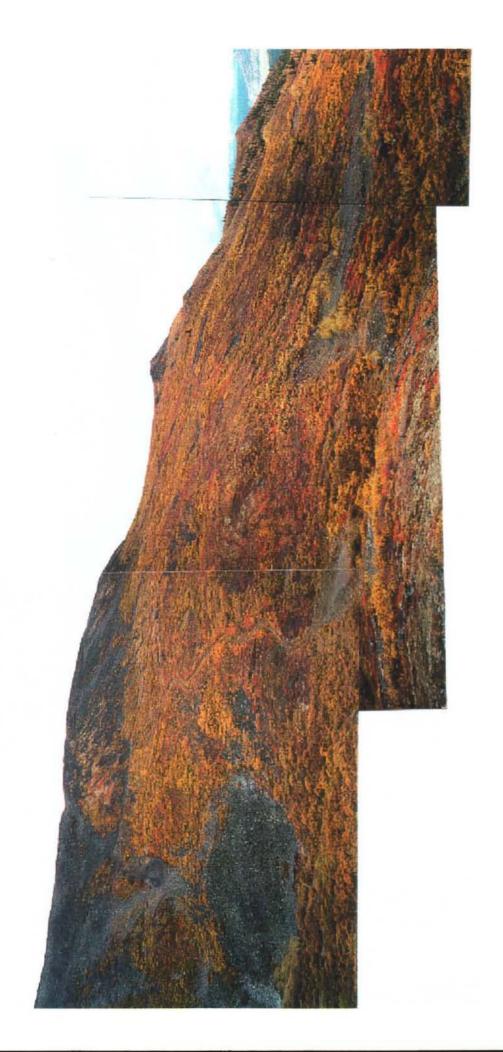
Photo 73-1: Overview of Gambler site showing mine workings to left, camp buildings left of middle, and more recent surface cat trenches at bottom.

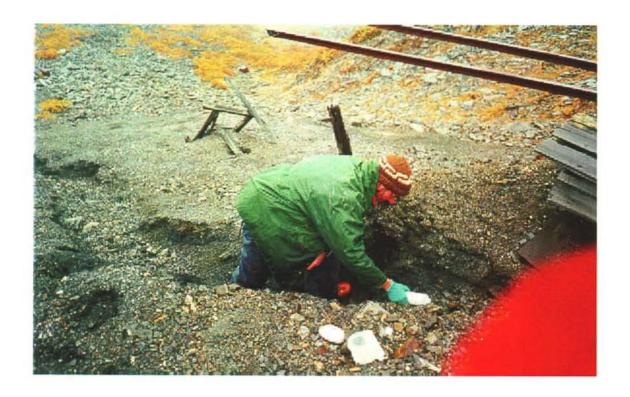
Photo 73-4: Lower Gambler adit drainage sample site (73-WQ-A01-01/-02). (Azimuth 070°)

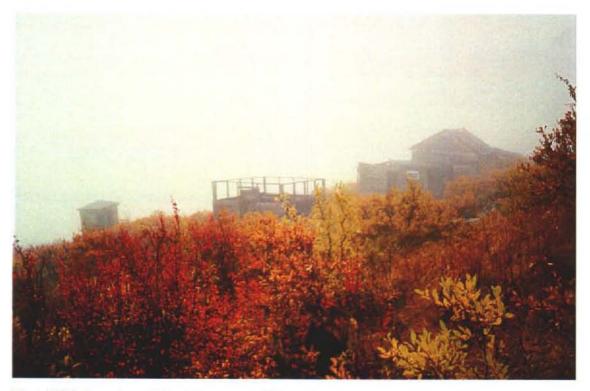
Photo 73-5: Overview of Gambler camp buildings. No changes noted since 1996 inspection. (Azimuth  $130^{\circ}$ )

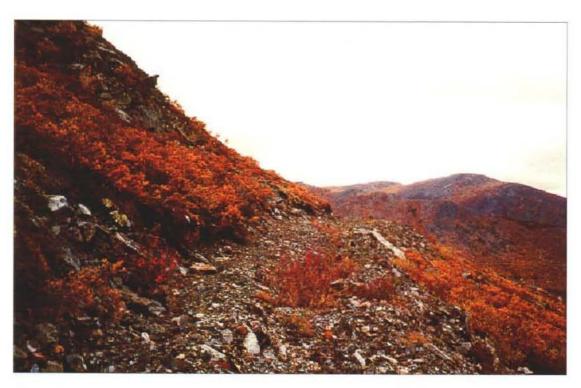
Photo 75-1: View along length of trench cut into side of hill (Trench1) at Bema site.

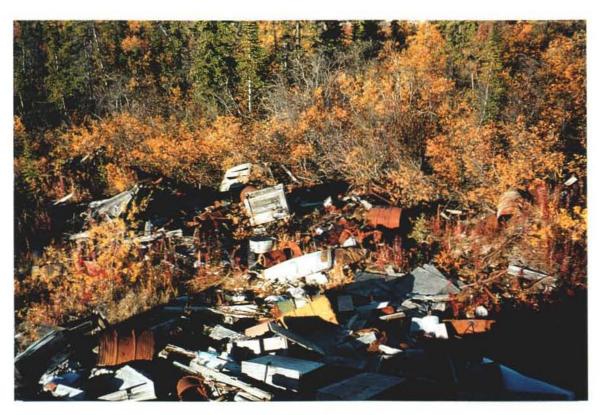
Photo 76-5: Photo taken 150m below the Townsite mine waste dump of the solid waste dump.

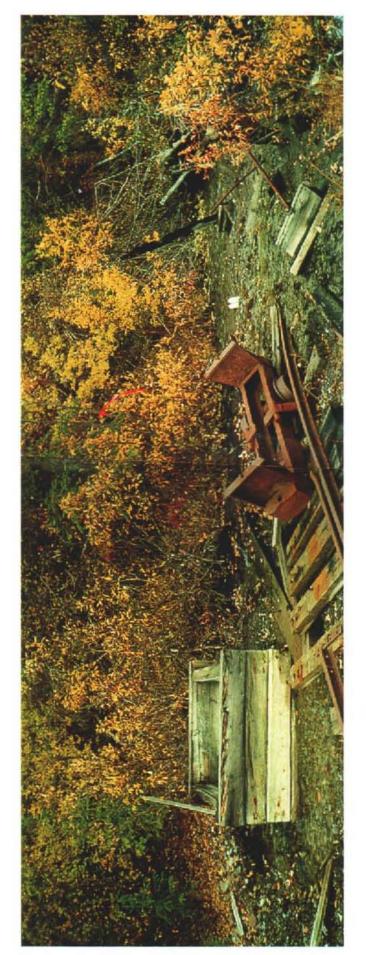
Photo 77-1: Mine water from portal (right) draining down culvert opening (left).

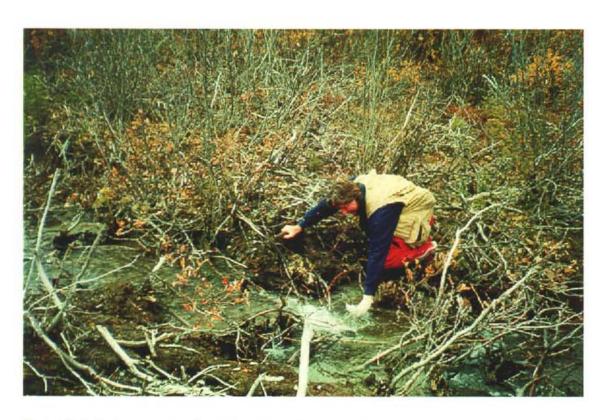
Photo 77-3: Drainage from culvert downslope of waste rock dumps.

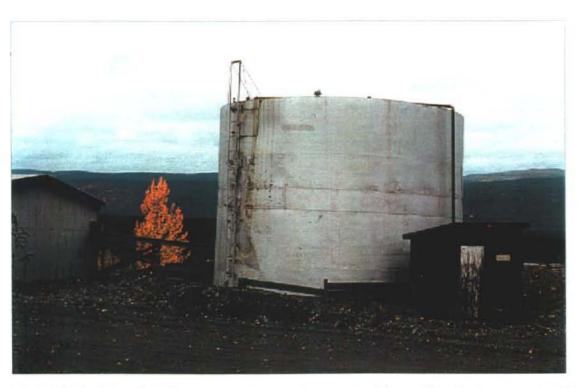
Photo 78-40 : Elsa. Fuel Storage Area #3 - an oil storage tank located beside the rescue building. There are numerous oil stains around the tank. (Azimuth 290 °)

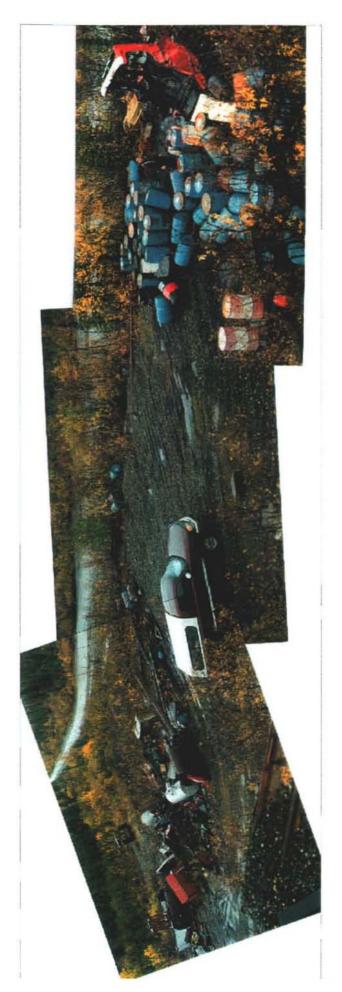
Photo 78-45: Elsa. Waste Fuel Storage Area #1 is on the right and the Solid Waste Dump Area #6 is on the left. The gravel area in front of the truck is saturated with oil. Hwy #2 is in the background. (Azimuth 290°)

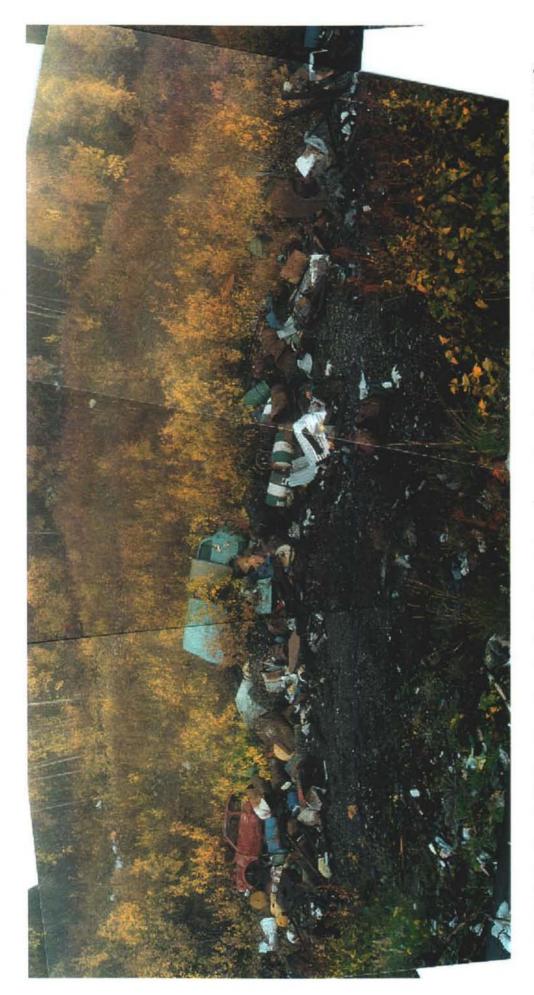
Photo 78-51: Elsa. Solid Waste Dump Area #1 - Municipal waste from Elsa was dumped at a site just east of Elsa, north of Hwy #2. (Azimuth 275°)

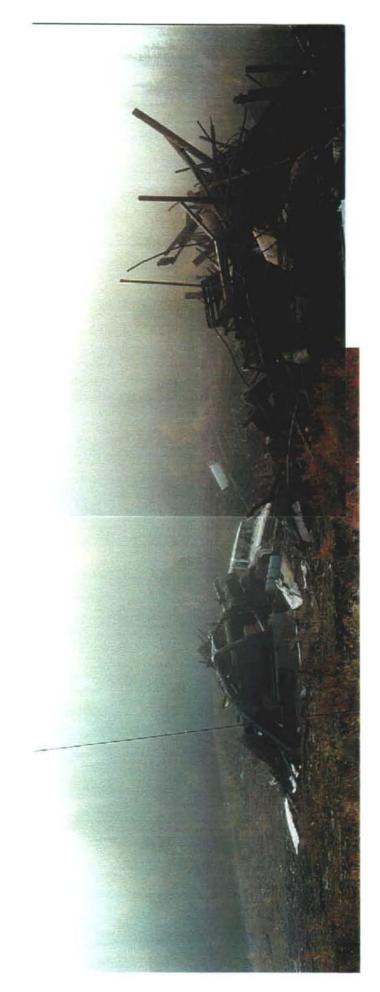
Photo 78-52: Elsa. Solid Waste Dump Area #1, metal debris pile. (Azimuth 130°)

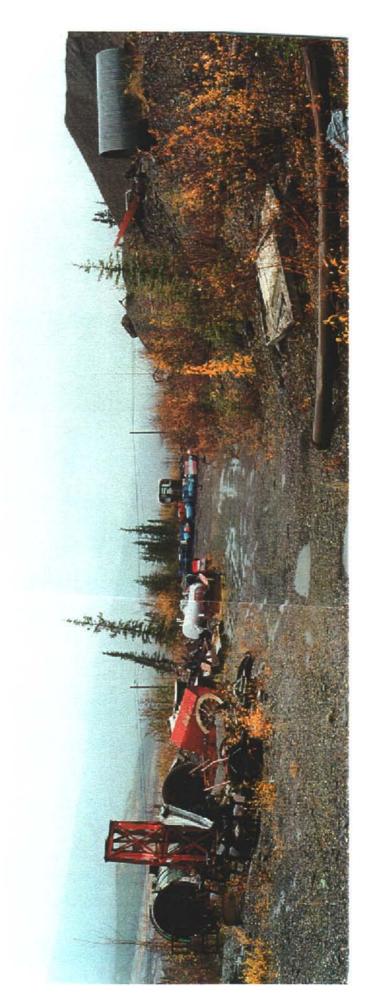
Photo 78-59: Elsa. Solid Waste Dump Area #6. This dump is mostly scrap metal and Is located just downhill of the Mill, beside Hwy #2. (Azimuth 040°)

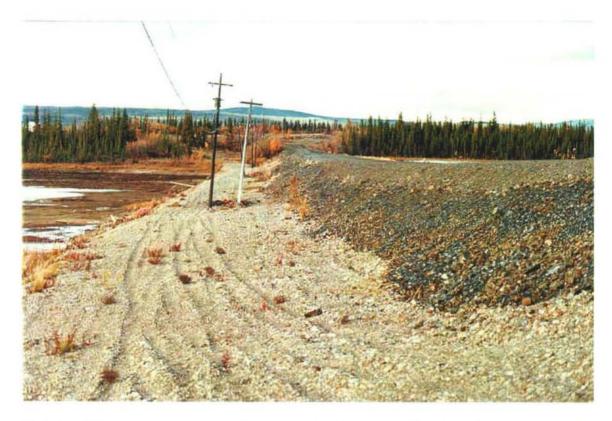
Photo 79-1. Toe berm (light-colored material) at the base of Dam No. 1, looking northwestward.

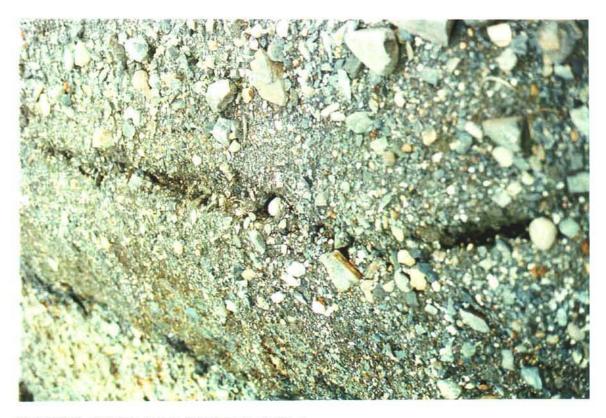
Photo 79-6. Tension cracks in tailings Dam No. 2.

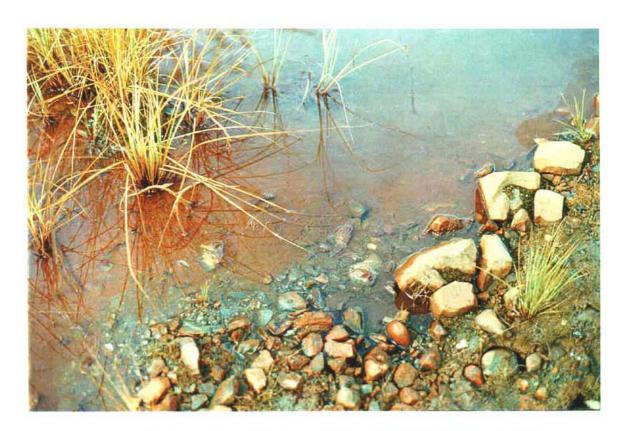
Photo 79-7. Ponded water below Dam No. 2. Note red iron-oxide precipitate in water.

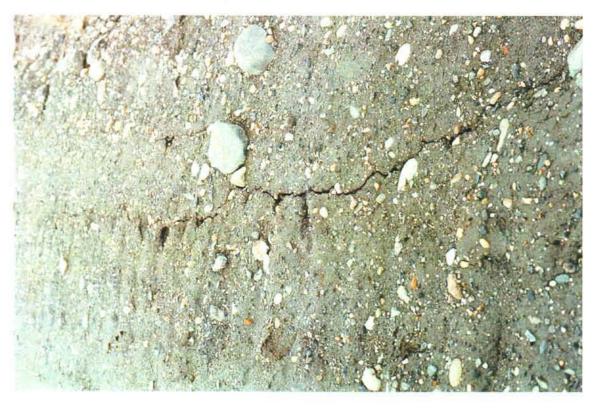
Photo 79-12. Tension cracks in Dam No. 3.

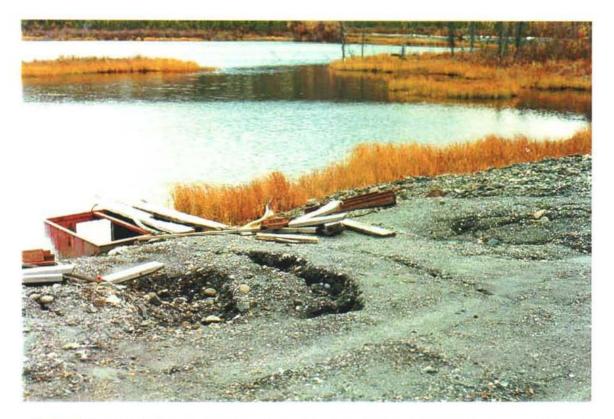
Photo 79-13. Wooden decant and v-notch weir in Dam No. 3. Note subsidence around decant.

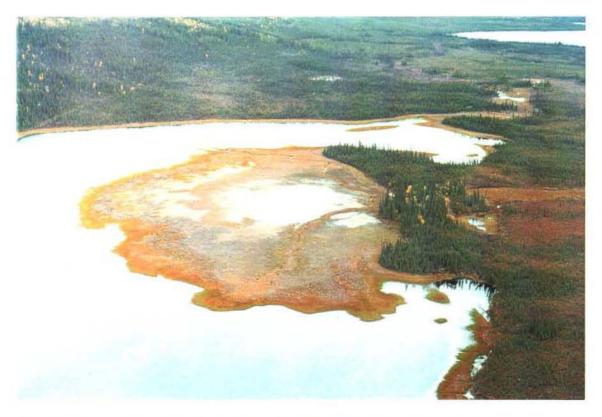
Photo 80-2. Aerial view of tailings, looking eastward. Note that much of the tailings fan is submerged or has naturally revegetated.

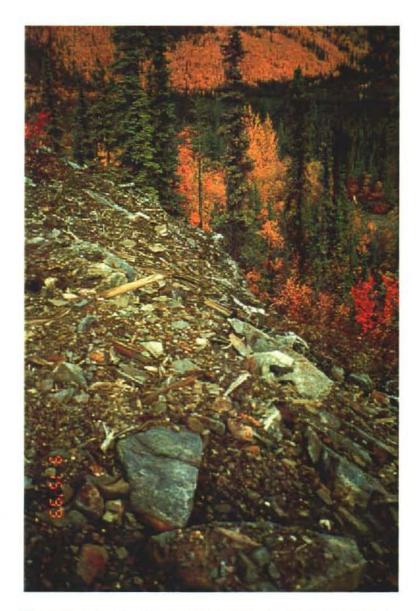
Photo 81-2: North slope south millsite area. Note wood debris.

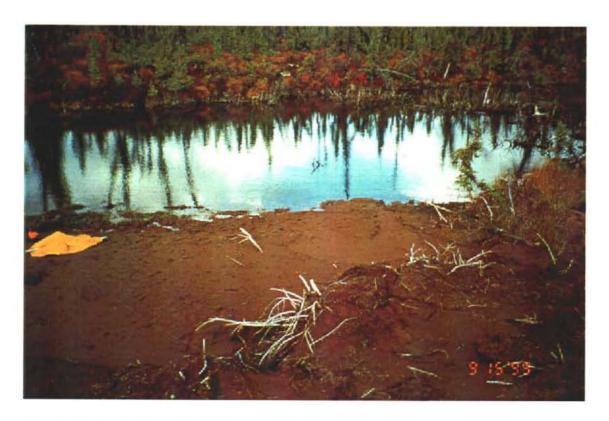
Photo 81-3: Small tailings fan directly on Christal Creek.

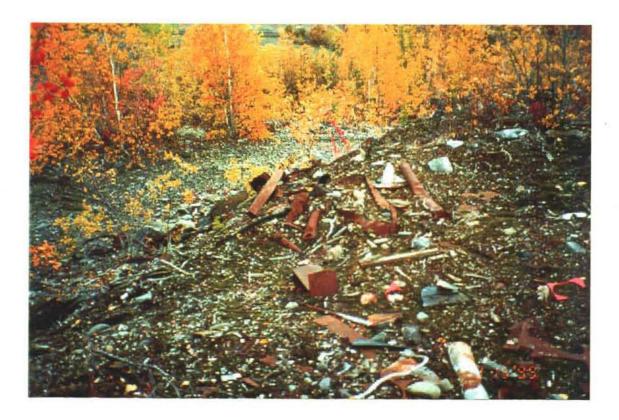
Photo 81-12: Metal and wood debris at west end of upper millsite area.

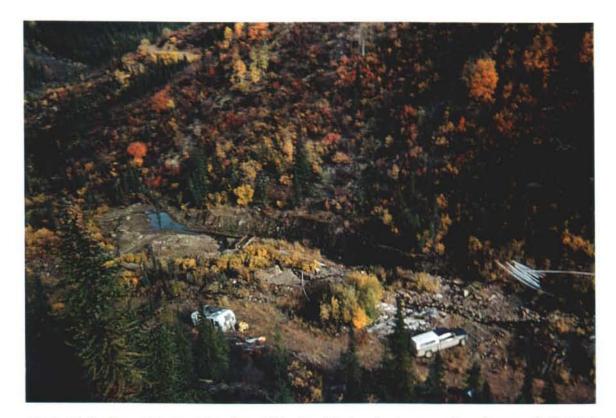
Photo 91-7: Stewart-Catto. View from hill looking N. showing lower portion of camp site & debris.
