AVIATION INVESTIGATION REPORT
A08O0233

UNCONTROLLED DESCENT INTO TERRAIN

CESSNA 172P C-GHSQ
SHELBURNE, ONTARIO, 7 nm W
01 SEPTEMBER 2008

Report Number A08O0233

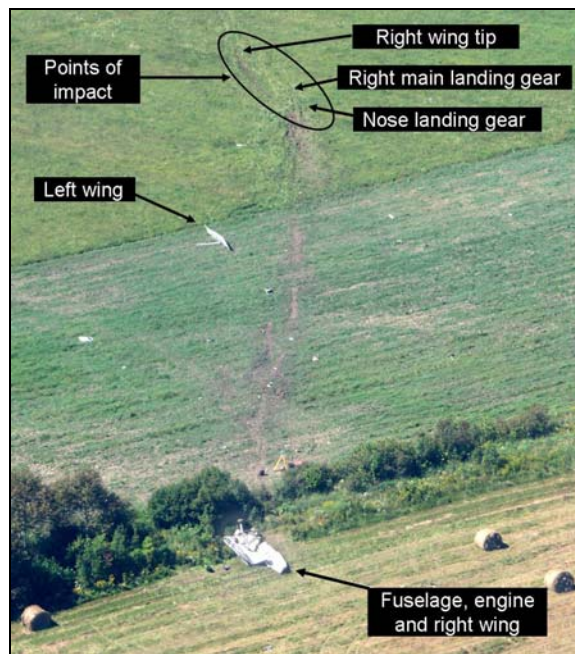
Photo 1. C-GHSQ crash site

The aeroplane struck the ground on an easterly heading, approximately 45° right bank, pitch angle 7° to 8° nose down, airspeed 140 knots. Ground scars indicate that the aircraft's right wing touched the ground first followed by the right main wheel and then the nose wheel. The aeroplane cartwheeled and began to break up. The left wing separated from the fuselage approximately 200 feet from the first point of contact. The main wreckage, consisting of the fuselage and right wing, was found about 430 feet from the initial point of contact. Various items from the cockpit, wing components, doors, and landing gear were found along the impact path. The aeroplane was destroyed (see Photo 1).

The wreckage indicated that flaps were up, and the engine was producing power at time of impact. Control continuity was established except for aileron controls, which were severed as a result of the left wing impact damage. A fuel odour existed at the crash site indicating fuel availability, but the amount of fuel remaining at the time of impact could not be determined due to post-impact leakage. The automatic direction finder was found tuned to 326 kHz. Other radio frequencies could not be determined. A TSB Laboratory examination of the dial faces and the mechanisms of cockpit instruments did not reveal any information as to their indications at the time of impact.
