AVIATION INVESTIGATION REPORT A08C0124

FUEL STARVATION / FORCED LANDING

**MEADOW AIR LIMITED
CESSNA 337D, C-GYHW
BUFFALO NARROWS, SASKATCHEWAN, 14 nm NE
13 JUNE 2008**

Report Number A08C0124

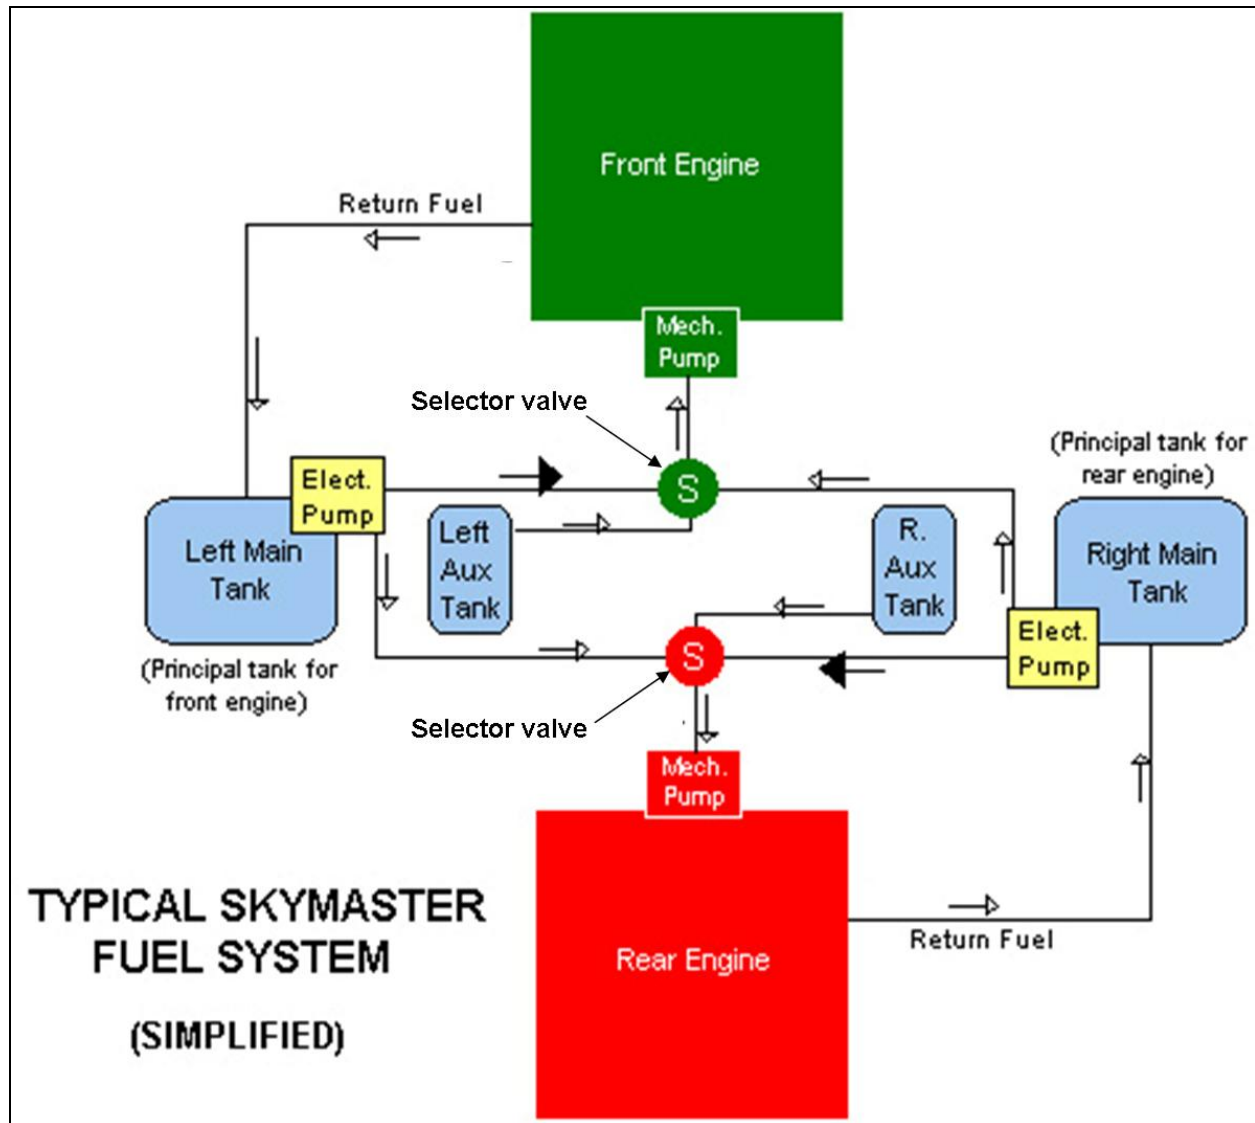
Appendix A – Fuel Schematic (simplified)

The C-337D fuel system is comprised of two outboard main-wing fuel tanks and two inboard auxiliary (aux) fuel tanks. There are two engine-driven fuel pumps which supply fuel to their respective engines during normal operations. There are also two auxiliary fuel pumps which supply fuel to the engine-driven pumps for starting and emergency operations. The design of the system is such that the auxiliary pumps can only pump fuel from the main tanks. In the event that fuel is depleted from the main tanks, operation of the auxiliary pumps will not draw fuel from the auxiliary tanks.

The fuel tank selector controls are mounted overhead in tandem on the cockpit ceiling. The forward mounted selector controls fuel for the front engine and is marked with positions Left Main (normal operation), Fuel Off Front Engine, Right Main (cross feed operation), and Left Aux. The rear-mounted selector controls fuel for the rear engine and is marked with positions Right Main (normal operation), Fuel Off Rear Engine, Left Main (cross feed operation), and Right Aux ³.

1. The design and nomenclature of the C-337D fuel system complicates its operation during periods of high cockpit workload, thus increasing the risk of confusion.
