## **AVIATION INVESTIGATION REPORT**

**A09Q0111**

### **CONTROLLED FLIGHT INTO TERRAIN**

**BELL 206L (HELICOPTER) C-GNLK**

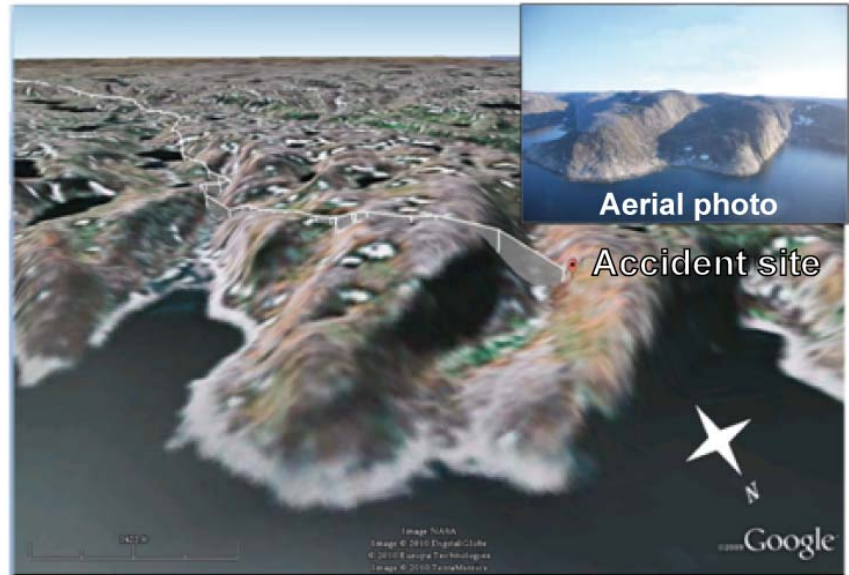
**Figure 1.** Trajectory recorded by the global positioning system (GPS)

The accident occurred a little under 1 nm from the Hudson Strait in a coastal valley lying 36 nm southeast of Kangiqsujaq. The valley is about 2300 feet wide and runs inland toward the west between two rocky escarpments. The elevation of the ridgeline on the south side is 1050 feet asl, and that of the north ridgeline is about 820 feet asl. The aircraft was on a northerly heading when it struck the north wall of the valley at about 700 feet asl.

At the time of impact, the aircraft was in a nose-up attitude of about 30°. The collision trajectory was at an angle of about 45° to the right in relation to the valley. The aircraft was destroyed by impact forces. The main components were projected to the right of the point of impact. Several fires fed by the aircraft's fuel broke out after the collision. The accident was not survivable.

The accident occurred just under 1 nm from the coast while the aircraft was traversing a valley. The GPS data indicate an increase in speed and a loss of altitude after the northbound aircraft flew over the summit of the south wall of the valley. It is possible that the pilot was not aware of his geographical position. If that was the case, he did not know he was about to traverse a valley. The need to maintain visual references therefore led the pilot to follow the downward slope in conditions of reduced visibility. Taking into account his speed, the pilot was unable to avoid the north wall of the valley.

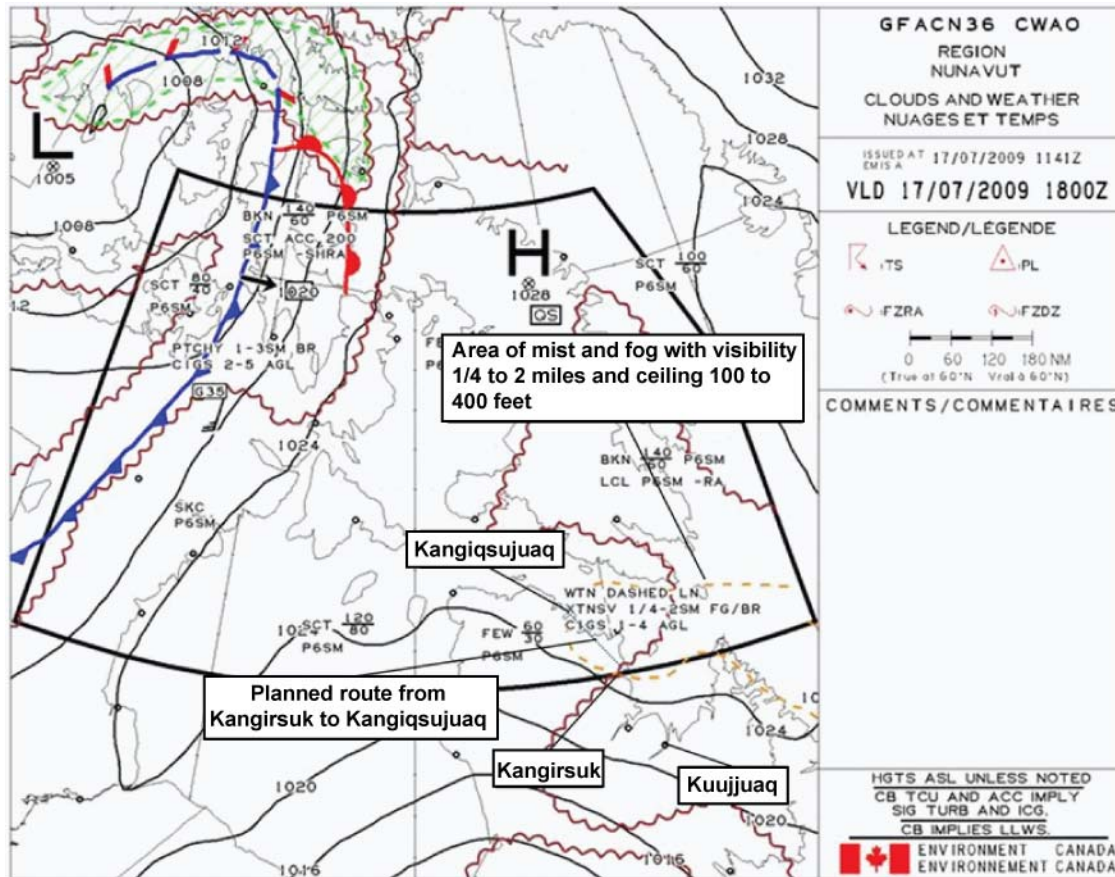
# Appendix A – Graphic Area Forecast (GFA)

The GFAs issued at 0141, 0741, and 1341 (see 0741 GFA at Appendix A) indicate a few clouds based at 3000 asl with tops at 6000 feet asl <sup>11</sup> with visibility over 6 sm. <sup>12</sup> The forecast for the incident area called for a fog bank <sup>13</sup> reducing visibility to between 1/4 and 2 sm in mist and fog with ceiling of 100 to 400 feet agl. <sup>14</sup>

For an undetermined reason, the pilot did not call the FIC at Québec to request a printout of the GFA. Because the pilot could have obtained weather information from the Internet, it cannot be stated without a doubt that he did not check the GFA before going to the airport. However, if he had done so, especially being an airline pilot, he would have easily seen that the GFA for the region called for visibilities of ¼ sm to 2 sm in mist/fog and ceilings of 100 to 200 feet between Kangirsuk and Kangiqsujaq in the coastal area and over the Hudson Strait. Also, by analyzing the GFA he would have seen that the mist was clearing over the land to the west of the shoreline. Given his qualifications, the route he elected to fly and the diversion route he chose, it is unlikely that the pilot checked the GFA on the Internet. Furthermore, it appears that the weather information obtained from the CHL Goose Bay base did not enable the pilot to conceptualize the information provided in the GFA for the region.

This is the GFA available prior to take-off from Kuujjuaq, Quebec:
