**AVIATION INVESTIGATION REPORT
A09Q0131**

LOSS OF CONTROL AND COLLISION WITH CABLES

**ESTROM F-28C HELICOPTER C-GVQQ
MONT-LAURIER, QUEBEC
05 AUGUST 2009**

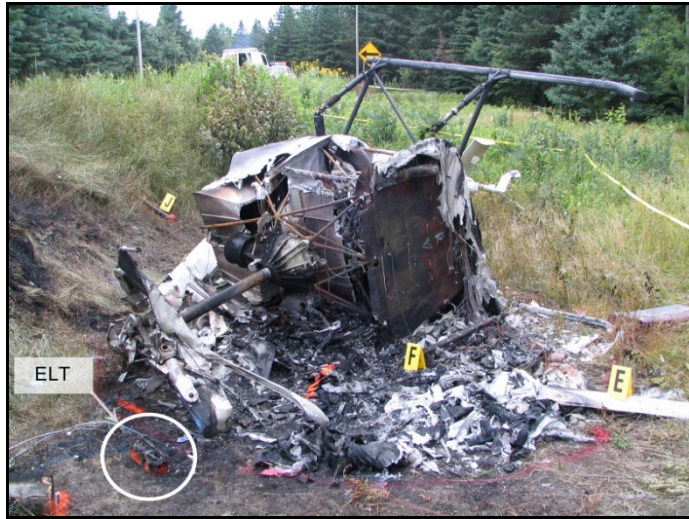
The aircraft was equipped with a Narco 10 emergency locator transmitter (ELT), serial number A17809. The selector was found on ARM; however, the ELT was found separated from its mount and antenna (see Photo 3). The Rescue Coordination Centre was not advised of any ELT signals being received at the time of the accident.

Photo 3. Helicopter wreckage and ELT.
