AVIATION INVESTIGATION REPORT

A09C0114

IN-FLIGHT COLLISION

Glad Air Spray
Pezetel M18B Dromader, C-GEZV and
Air Tractor AT-401, C-GBDF
Gladstone, Manitoba
13 July 2009

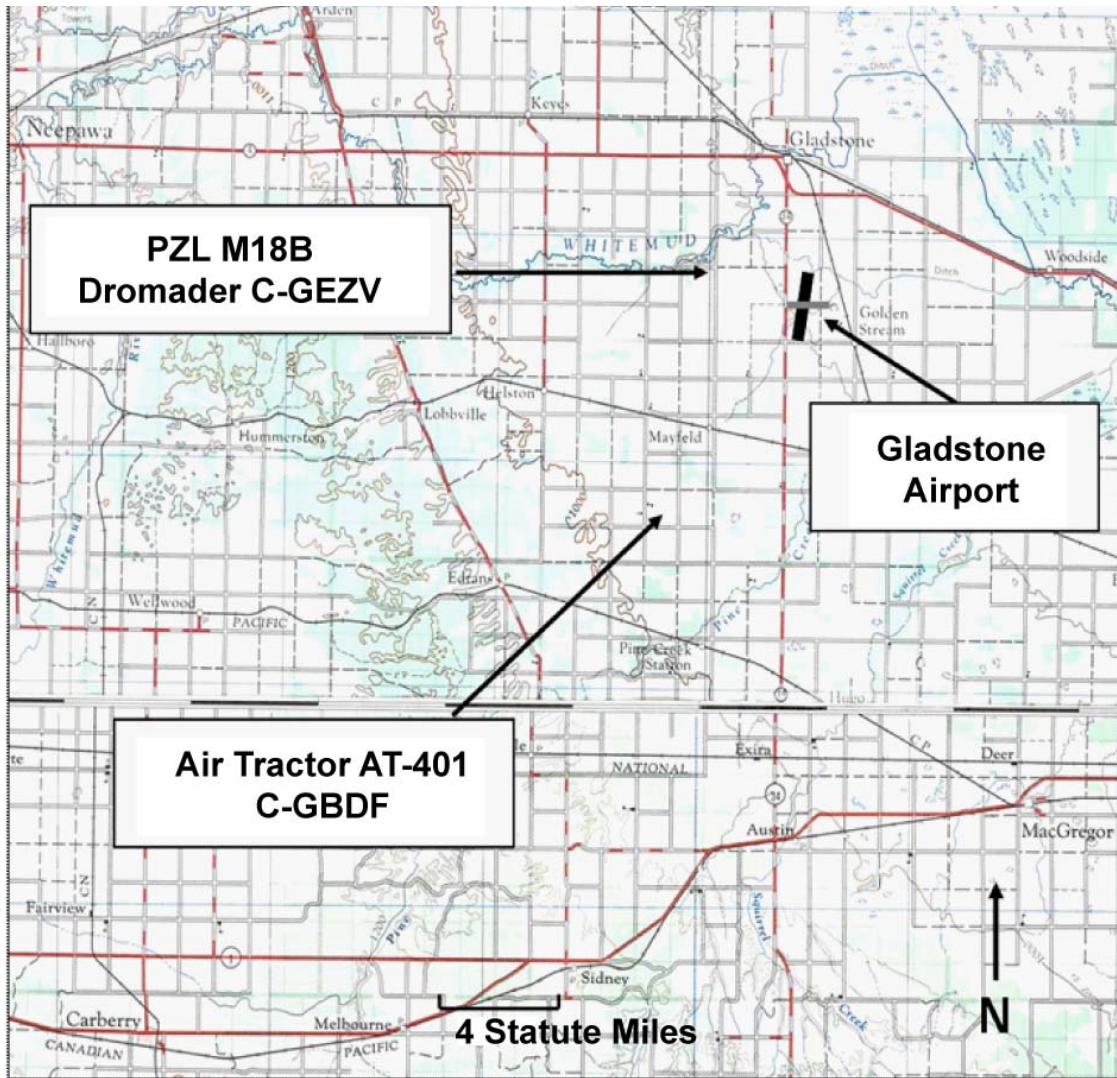
Appendix A - Accident Aircraft Initial Flight Paths

The Air Tractor had been operating near Carberry, Manitoba, earlier in the day. It remained at Carberry mid-day, and then completed a flight as winds subsided in the early evening. Returning to Gladstone, the Air Tractor approached the aerodrome from the southwest, crossed just south of Runway 18/36, and joined the circuit on a left downwind leg for Runway 18, at about 500 feet above ground level (agl).¹ The Dromader approached from the west and joined the circuit directly on a descending right base leg, also for Runway 18, starting at about 1000 feet agl. Both aircraft turned onto final approach for Runway 18 and proceeded towards the runway. The aircraft collided on short final, with the Dromader positioned slightly above the Air Tractor.² Neither pilot saw the other aircraft until the collision.

The Dromader pilot joined the circuit for Runway 18 on a right base leg, contrary to the recommended aerodrome traffic procedure. This compromised his opportunity to observe other traffic in the area and join the circuit without conflict with other traffic.

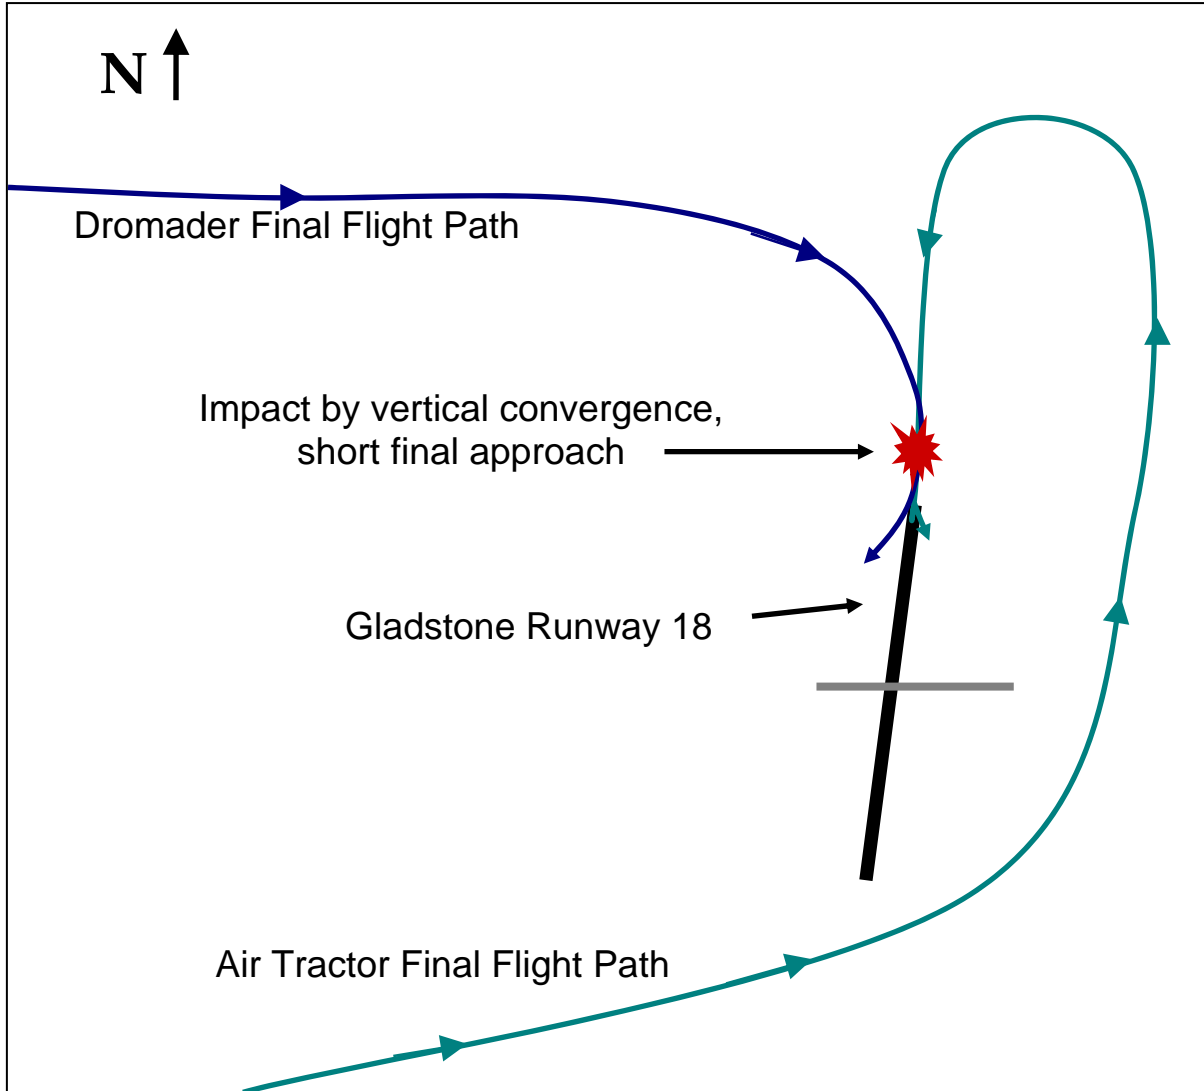
Appendix B – Accident Aircraft Final Flight Paths

The Dromader's nose was large enough to obscure its pilot's view of a significant area ahead of and underneath the Dromader. In the right turn onto final approach, the area which was obscured likely kept pace with the flight path of the Air Tractor while the two aircraft lined up on final approach. Although both aircraft were substantial in size, were painted in conspicuous colours, and the weather was favourable, the relative positions of the aircraft would have made each difficult for the other pilot to detect. The pilot of the Dromader would have had to make clearing turns to observe the area under the aircraft's nose, and because the pilot believed there was no local traffic, no such turns were made. After the Dromader turned onto final approach, its flight path converged with that of the Air Tractor. As it descended, it struck the Air Tractor and both aircraft descended to the ground out of control.

3. The Dromader's nose likely obscured an area which kept pace with the Air Tractor flight path while the two aircraft converged on final approach. The Dromader pilot did not make clearing turns to observe the area under his aircraft's nose and this made it difficult for him to see the Air Tractor's approach and avoid the impending conflict.
4. On final approach, the Dromader's flight path converged horizontally and then vertically with that of the Air Tractor, until the Dromader struck the Air Tractor and both aircraft descended out of control to the ground.
5. The non-use of landing lights and lack of radio communication contributed to the pilots' reduced awareness of traffic in the area.
6. The Air Tractor pilot's arms and hands were not protected, which likely increased the extent of the injuries resulting from the post-crash fire.
