## AVIATION INVESTIGATION REPORT

A09Q0181

### FUEL STARVATION

PIPER PA-34-200T C-FANI

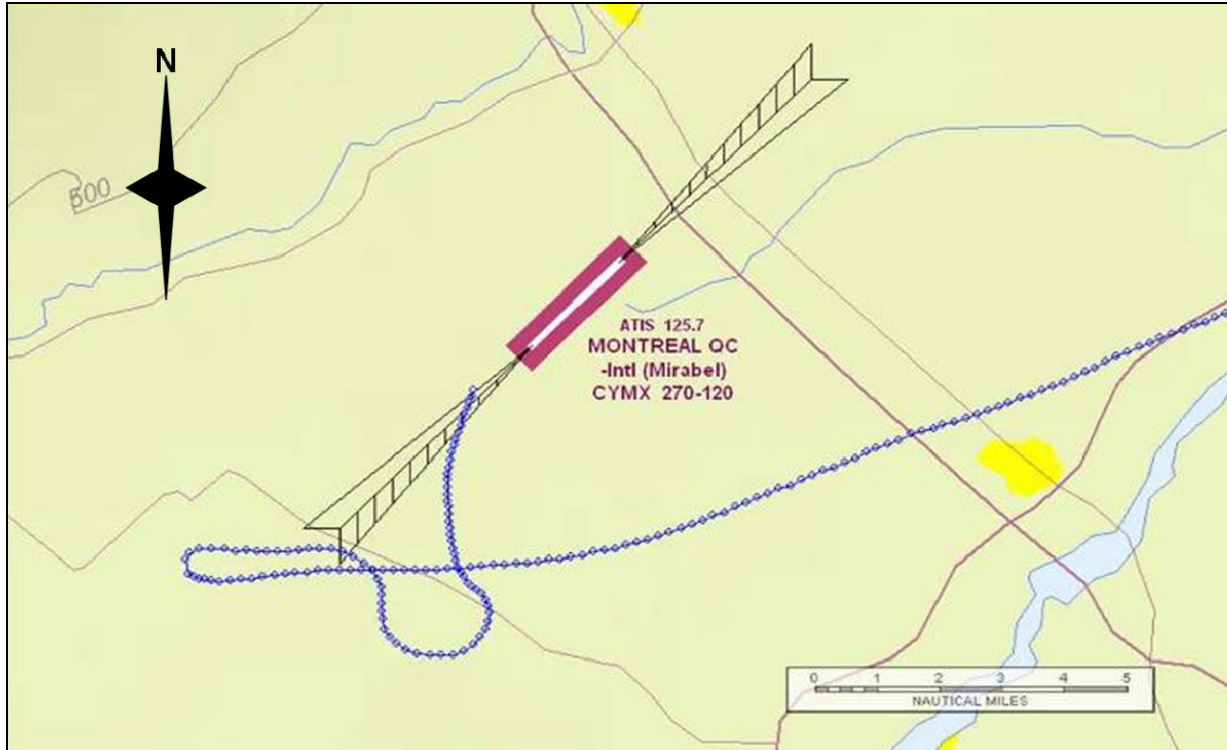
Figure 1. Aircraft trajectory

At 1726, one hour and 14 minutes into the flight, the aircraft was 7.4 nm southwest of Mirabel Airport when both engines lost power. The autopilot disengaged, and the aircraft entered a right turn of approximately 180° (see Figure 1). After the turn, the aircraft was 1000 feet below its assigned altitude, and the pilot informed air traffic control (ATC) that he was having engine problems but did not declare an emergency. He said that the engines seemed frozen. He was assigned a heading of 080° magnetic to direct him toward Mirabel Airport. ATC asked whether he would need emergency equipment at Mirabel or whether he would like to declare an emergency. The pilot declined. Although he read back the heading of 080°, he continued to turn south on a heading of approximately 180° magnetic before being assigned a new heading toward Mirabel. Once the pilot stated that he had visual contact with the runway, ATC cleared him for a visual approach to Runway 24, because the surface wind was 6 knots and favouring this runway. At approximately 4500 feet asl, the pilot reported that the engines were still running, even though the engines were not developing any power. During the descent, the pilot activated the booster pumps, but to no avail. The propellers were not feathered and continued to windmill. At 1600 feet asl, 2.2 nm west of the threshold of Runway 06, the pilot advised Mirabel Radio that he could not make it to Runway 24. The aircraft disappeared from radar at approximately 400 feet asl (150 feet agl) and crashed at 1732, 1.2 nm from the threshold of Runway 06 at Mirabel Airport.

When the engine failure occurred, the aircraft was 6.5 nm from the threshold of Runway 06 at Mirabel and continued to within 4.5 nm of the runway threshold before deviating south. The deviation increased the distance required to reach the threshold. The aircraft glided 10.7 nm before crashing.

When the engines stopped, the aircraft was at 10 000 feet asl and 6.5 nm from the threshold of Runway 06. Considering that the aircraft's deviation to the south increased the distance to be travelled by 4.2 nm and that the aircraft crashed 1.2 nm from the threshold, it is very likely that the aircraft could have glided to the threshold of Runway 06, even though the propellers had not been feathered.

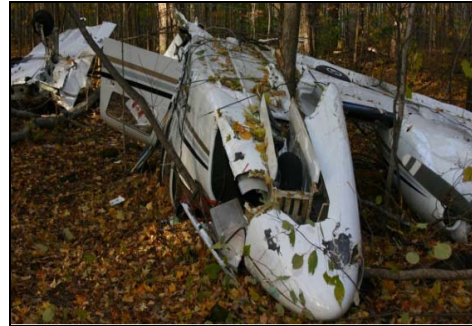
**Figure 2.** Occurrence aircraft

The aircraft crashed in a maple bush among mature trees measuring an average of 24 inches in diameter and over 100 feet tall. The aircraft entered the trees on a heading of 040° magnetic, with a right bank angle of approximately 30°.

The right fuel tank was punctured at impact, and the left fuel tank was torn open. The fuselage came to rest inverted against a tree about 8 inches in diameter that penetrated the cabin on the passenger side (see Figure 2). A strong smell of fuel was noted at the

accident site, indicating that there was fuel on board at the time of impact. The pilot was seriously injured. He was able to exit the cockpit and was found in the rear cabin.

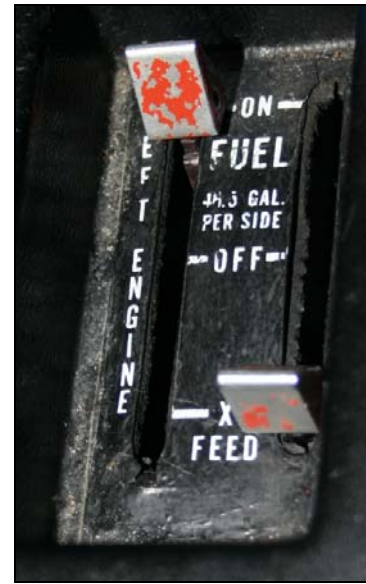
Figure 3. Fuel selector

The fuel system has two fuel selectors (see Figure 3), one for each engine, which are identified as LEFT ENGINE and RIGHT ENGINE. Each selector has three positions. The forward position (ON) allows each tank to feed its respective engine. The central position (OFF) cuts off the fuel supply. The rear position (XFEED) is for crossfeeding, feeding engine from the opposite tank. In other words, if the right fuel selector is on XFEED, the right engine will receive fuel from the left tank.

According to the pilot's checklist, the fuel selector operation is checked while the aircraft is taxiing. In this occurrence, the operation was checked before taxiing. The pilot sets one of the selectors to OFF. Once the corresponding engine starts to sputter, the selector is set to XFEED. The engine resumes operation after which the selector is set to ON. The selector for the other engine is checked in the same manner. The checklist then provides four other opportunities to ensure that both fuel selectors are set to ON: during the engine run up, during the pre-takeoff checks, when the aircraft is lining up on the runway, and once the aircraft is established at cruising altitude. When the aircraft was examined at the occurrence site, the left selector was found on ON, and the right selector was on XFEED.

Using fuel return quantities corresponding to the reduction in engine speed (50 litres while climbing and 45 litres while cruising), an estimated 56.75 litres of fuel would have been returned to the right tank and vented. This situation would not have occurred unless the right selector was set to XFEED for the whole flight (the position in which it was found at the occurrence site).

The most plausible hypothesis is that the right fuel selector was left on XFEED after being checked prior to the aircraft's departure from Saint-Georges.

The propellers were not feathered, and were windmilling. This gave the impression that the engines were still running, albeit slowly. This could explain why the pilot told ATC that the engines were still running as he descended through 4500 feet. Setting the left selector to XFEED and the right selector to ON would have restored fuel supply to both engines.
