**AVIATION INVESTIGATION REPORT
A10Q0132**

**LOSS OF VISUAL REFERENCE WITH THE GROUND, LOSS OF
CONTROL, COLLISION WITH TERRAIN
HÉLI-EXCEL INC.
EUROCOPTER AS350-BA (HELICOPTER) C-GIYR
SEPT-ÎLES, QUEBEC, 22 NM N
17 AUGUST 2010**

Report Number A10Q0132

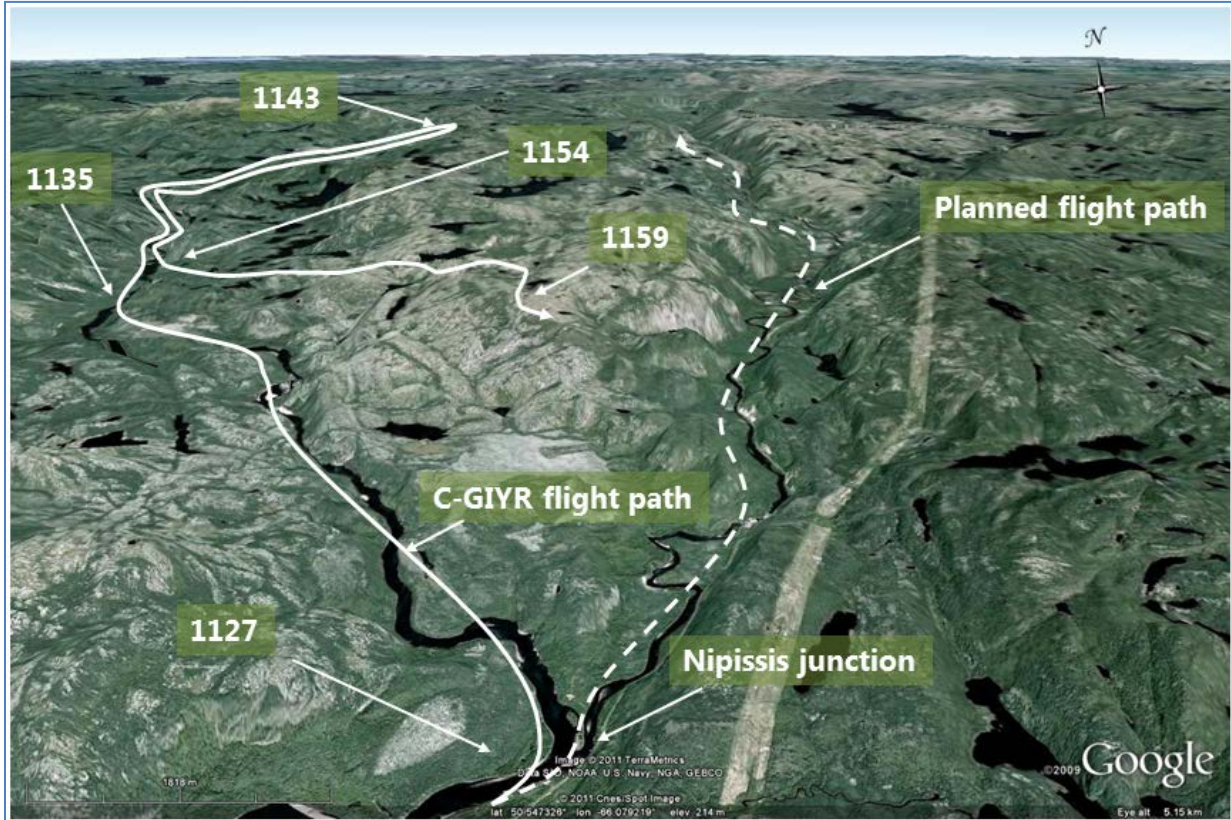
At 1127, at the junction of the Nipissis River, the pilot remained above the Moisie River, which veers northwest, instead of following the railway tracks that run along the Nipissis River valley until Poste Montagnais (Figure 2). The helicopter was flying over the Moisie River at normal cruising speed, at an altitude of about 200 feet agl.

Figure 2. Satellite image of terrain overlaid with C-GIYR flight path from the Nipissis River junction

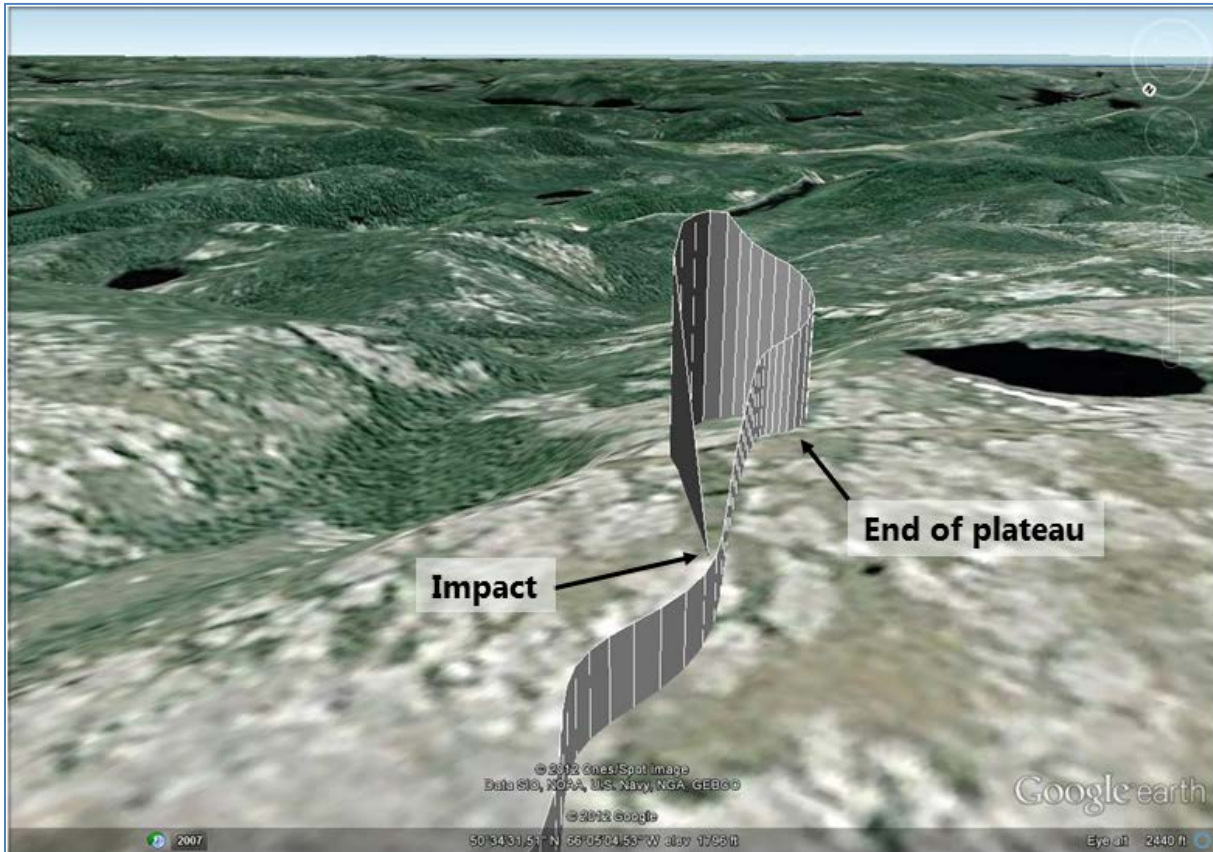
At 1201:5, the helicopter reached the southeast edge of the plateau, where the ground quickly descends towards the Moisie River valley. The helicopter began climbing, levelling off at about 300 feet above the plateau while turning left; less than 4 seconds later it struck the ground at a steep angle, in a northwest direction (Figure 3). The accident occurred at 1201:37.

Figure 3. Satellite image of terrain overlaid with a flight profile showing the helicopter’s position at 1-second intervals preceding impact

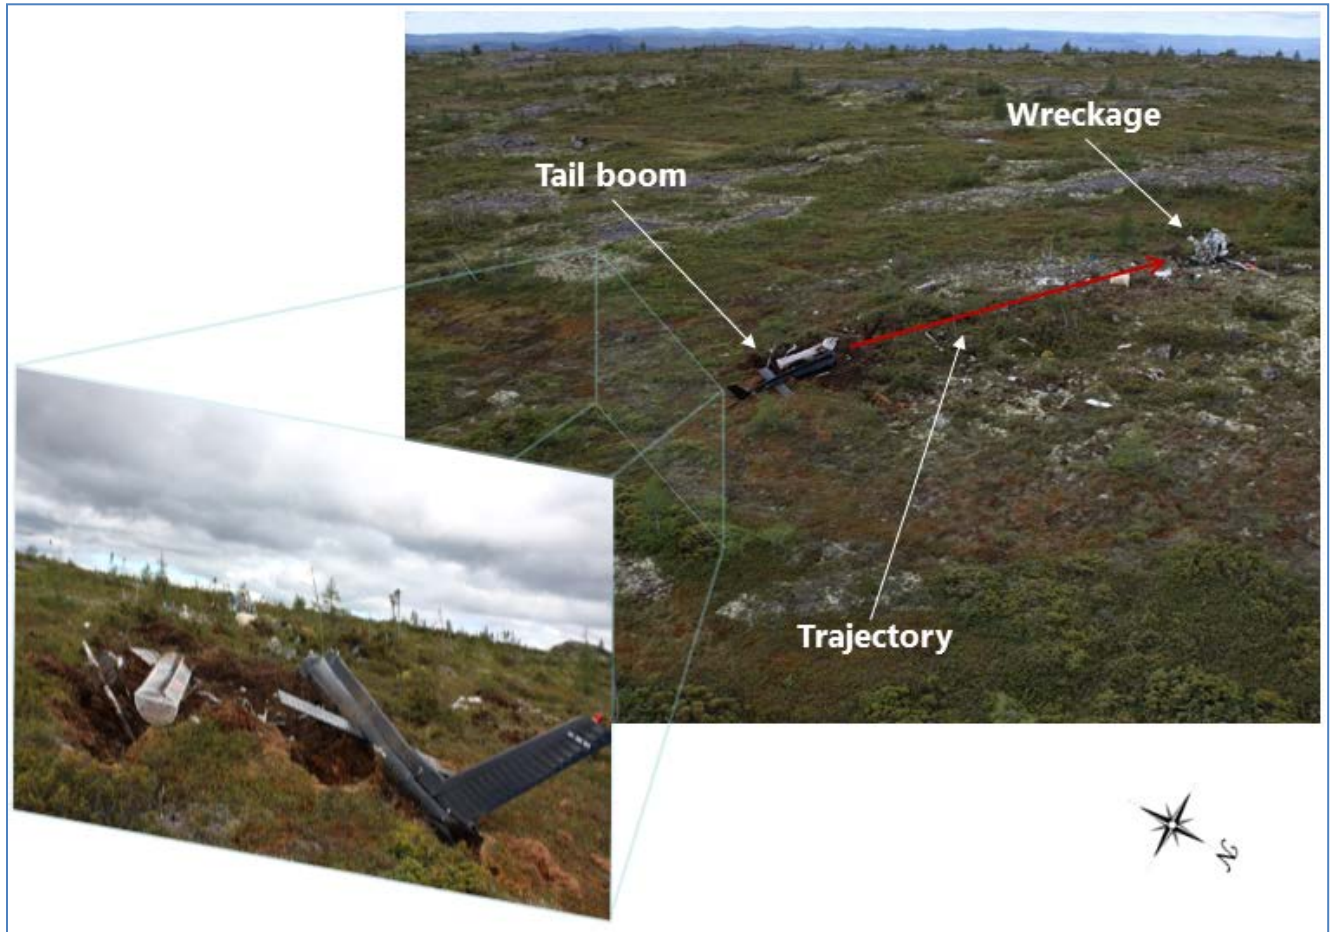
The tailskid left a straight furrow of about 6 feet before the crater caused by the impact of the helicopter. The crater rim had an angle of about 45° and was about 3 feet deep. The tail boom was severed; the 2 skids and the carrying basket remained in the crater (Figure 4). The main rotor crashed through the front of the cabin and severed the instrument panel. The helicopter then bounded and came to rest on its back 90 feet away.

Figure 4. Photographs of accident site showing helicopter wreckage and breakup trajectory

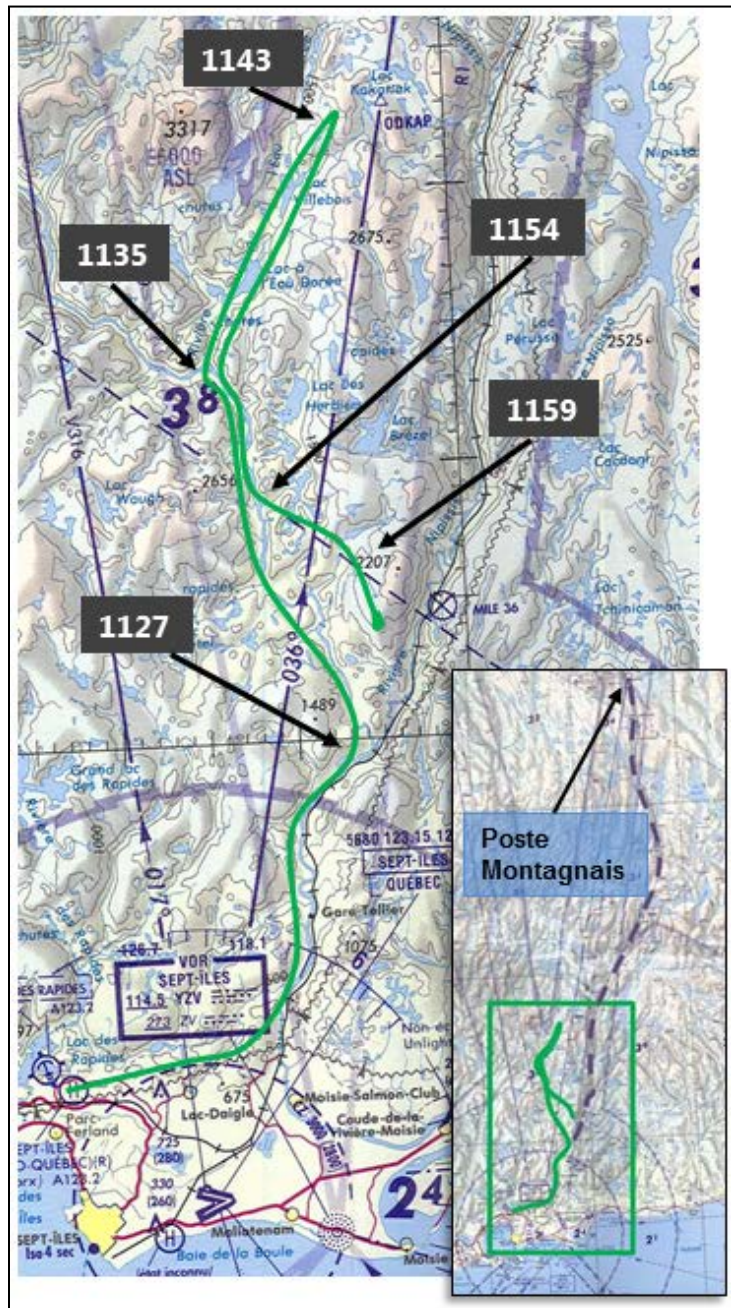
At the junction of the Nipissis River, the pilot continued over the Moisie River instead of maintaining the flight path and following the railway tracks north (Figure 5, 1127). It was not possible to determine why the pilot made this decision.

Eight minutes later, the pilot turned right, leaving the Moisie River and taking a valley towards Poste Montagnais (Figure 5, 1135). However, he made a half-turn at the end of that valley (Figure 5, 1143), going back to the Moisie River. The reduction in speed before the half-turn indicates that visibility was reduced at the end of the valley and that the mountain pass, which was over 2000 feet asl, was in the clouds.

While flying south over the Moisie River, he veered left towards the mountains in the east (Figure 5, 1154). At this point, the helicopter had been in flight 43 minutes and had consumed about 215 pounds of fuel, leaving 385 pounds on board, or fuel endurance of 1 hour 17 minutes.

Figure 5. Map showing flight path with time indications
