**AVIATION INVESTIGATION REPORT
A11O0239**

LOSS OF CONTROL – COLLISION WITH TERRAIN

**CESSNA CARDINAL 177A, C-FEFQ
OTTAWA/MACDONALD-CARTIER INTL, ONTARIO 1.9 NM W
14 DECEMBER 2011**

Report Number A11O0239

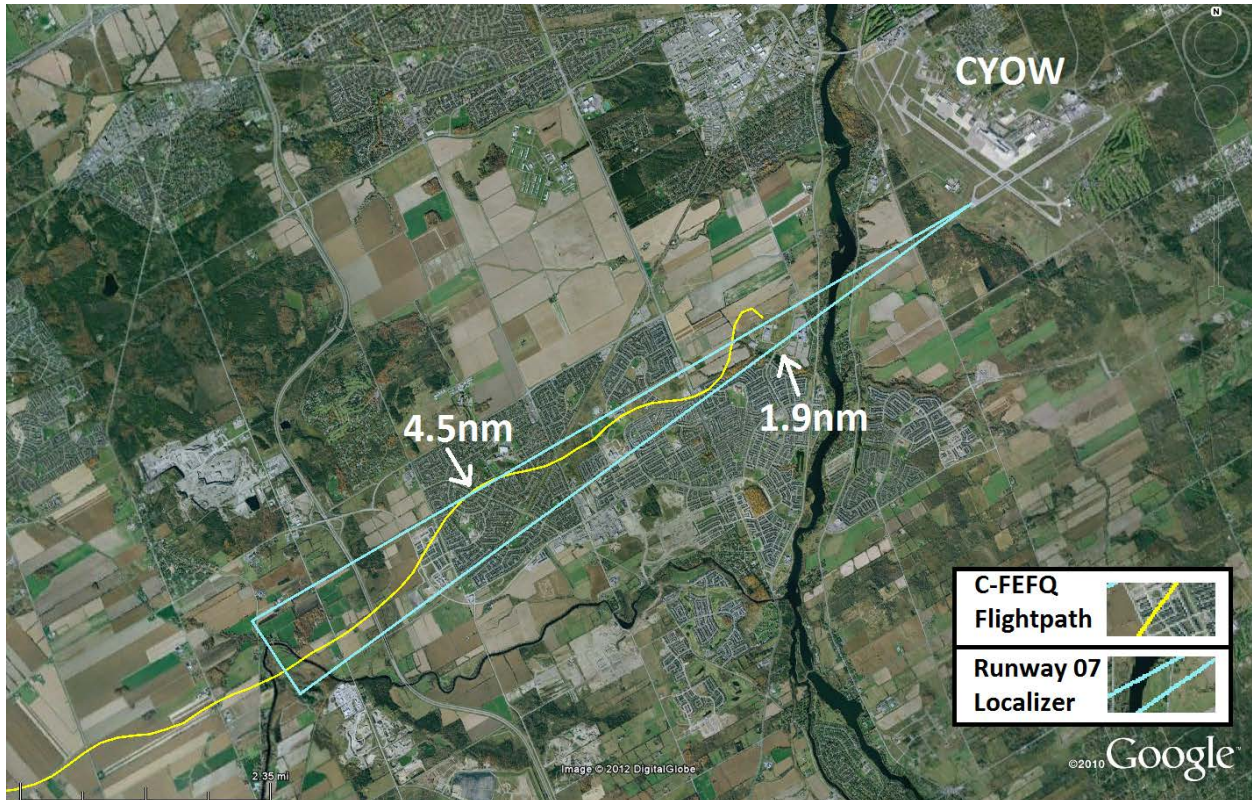
Figure 1. Final aircraft flight path

Radar data shows that, while on the approach, the aircraft twice deviated significantly from the localizer to a point that would have caused the localizer indications on the aircraft instruments to go to full deflection. Airspeed on the approach was maintained above 100 knots until the loss of control (Figure 1).

While on the ILS approach into Ottawa in unfamiliar night IMC conditions, the pilot had significant difficulty maintaining the localizer. During the approach, the tower controller twice advised the pilot that the aircraft was deviating from the approach course. During the second attempt to regain the localizer, the pilot most likely made a steep right turn, which quickly developed into a rapid descent and loss of control.
