**RAILWAY INVESTIGATION REPORT
R07V0109**

NON-MAIN-TRACK TRAIN DERAILMENT

**KOOTENAY VALLEY RAILWAY (KVR)
0700 TRAIL YARD ASSIGNMENT
MILE 19.0, ROSSLAND SUBDIVISION
TRAIL, BRITISH COLUMBIA
23 APRIL 2007**

Report Number R07V0109

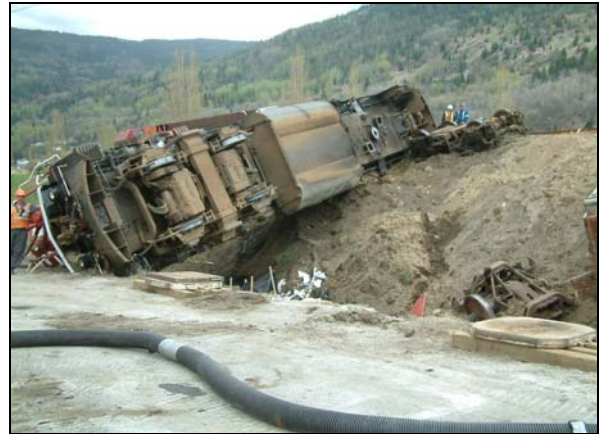
Photo 2. Derailment at Mile 19.038

The two locomotives and the remaining covered hopper car continued across the Highway 22 overpass and derailed to the outside of the 16-degree right-hand curve at Mile 19.038. The lead locomotive was overturned beside the rail, while the trailing locomotive was overturned down the grade. The locomotive engineer was later found beneath the trailing locomotive having suffered fatal injuries.

The two locomotives and the remaining covered hopper car came to rest derailed to the outside of the curve at Mile 19.038 (see Photo 2).

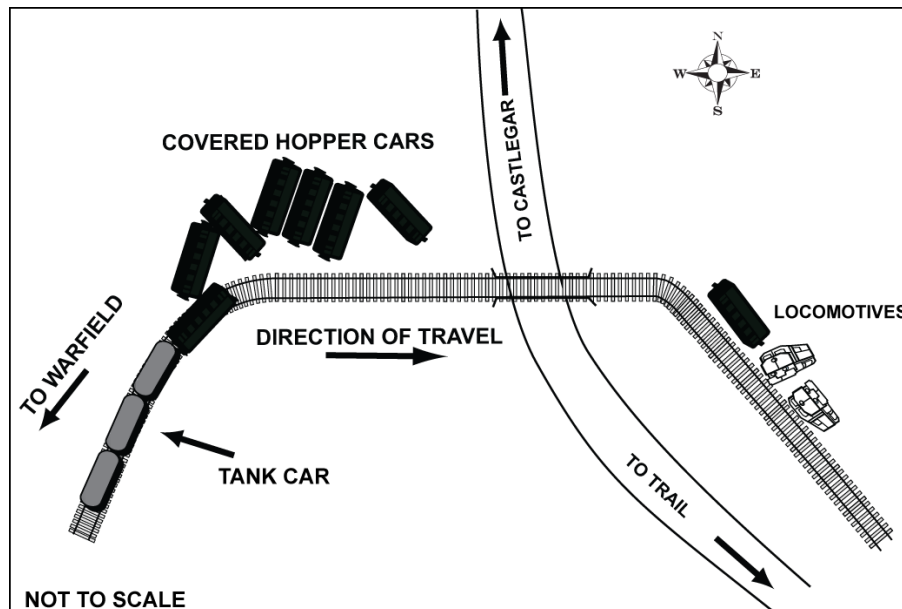
Figure 2. Derailment site

The three residue tank cars did not derail. They came to rest at Mile 19.2 (see Figure 2 and Photo 1).

At both derailment sites, the first marks on the track were wheel flange markings on the heads of the outside rails, indicating the points of derailment. Several feet beyond each point of derailment, in the direction of travel, wheel flange markings were noted on the ties to the field side of the outside rail.
