**RAILWAY INVESTIGATION REPORT  
R08W0058**

**MAIN-TRACK COLLISION AND DERAILMENT**

**CANADIAN PACIFIC RAILWAY  
FREIGHT TRAINS 498, 497, AND 292  
MILE 97.5, WEYBURN SUBDIVISION  
CENTENNIAL STATION, NEAR RALPH, SASKATCHEWAN  
07 APRIL 2008**

Report Number R08W0058

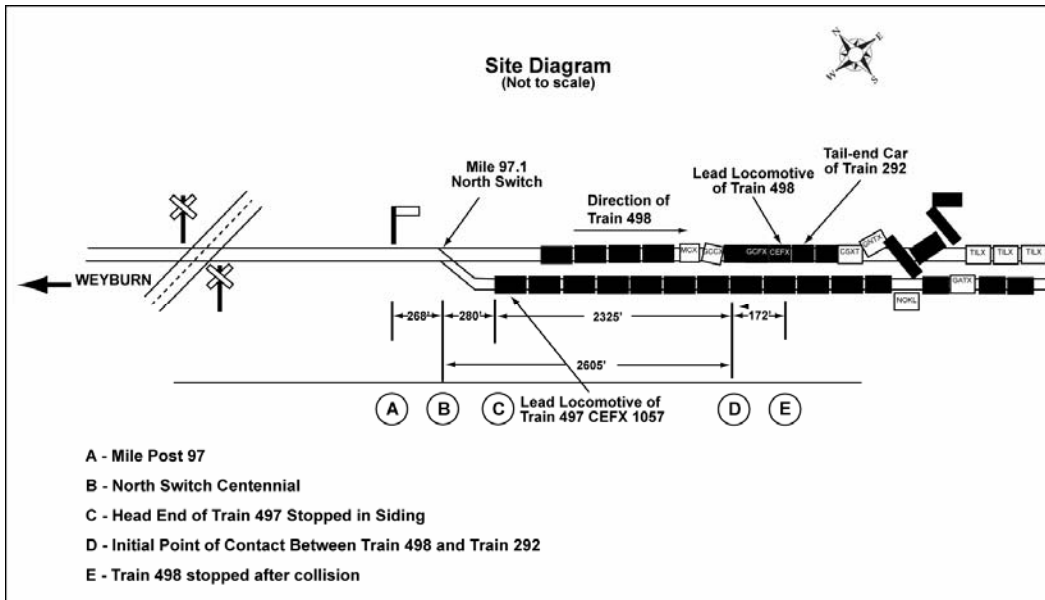
**Figure 2.** Derailment site diagram

At 0806, train 498, travelling at 36 miles per hour (mph), passed the north switch at Centennial. Shortly thereafter, the crew realized that they would collide with train 292 which was stopped ahead on the main track. The crew applied the emergency brakes. Approximately 20 seconds later, train 498's lead locomotive collided with the tail end of train 292. As a result of the impact, seven cars on the tail end of train 292 derailed and two cars on train 498 derailed. In addition, two cars on train 497, which was stationary in Centennial siding, derailed during the resulting side collision with derailed cars from train 292 (see Figure 2).

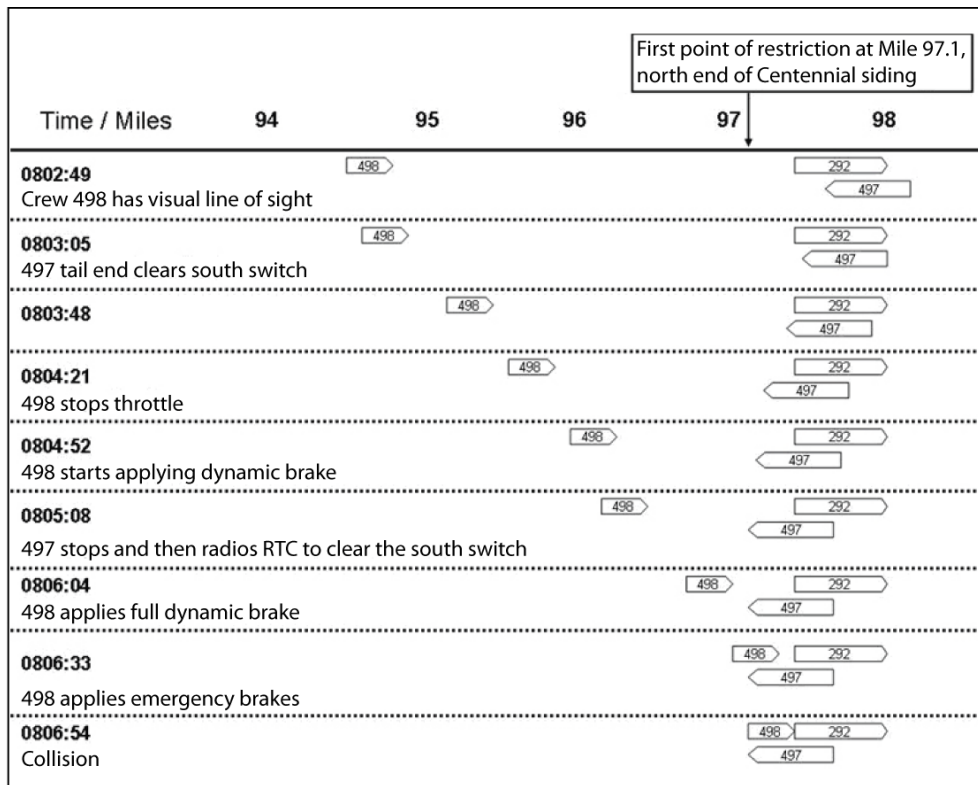
**Figure 3.** Relative positions of the trains

Figure 3 displays the relative positions of the three trains at various times within a four-minute period just prior to the collision.

1. When the crew of train 498 had a visual line of sight of Centennial siding, train 497 was moving northward (towards train 498) in the siding alongside train 292 which was stopped on the main track.

2. Approaching Centennial siding from the north, the crew of train 498 could see the tail end of train 292 and the front end of train 497, but no other portions of these trains. Only after they moved further along the track would the crew have seen other landmarks such as Mile Post 96 and the north end of Centennial siding.

3. When train 497 came to a full stop, the front end of train 497 was approximately 2500 feet past the tail end of train 292.
4. Prior to the accident, the relative positions of train 498 and train 497 in relation to train 292 were not changing at the same rate. Train 498 was moving southward at approximately 40 mph while train 497 was moving northward at approximately 16 mph.

6. The locomotive engineer on train 498 thought that train 292 was moving and that it would soon clear the south switch in spite of 498's restriction at the north switch Centennial and the arrangements made to close-up.
