RAILWAY INVESTIGATION REPORT R12V0008

COLLISION BETWEEN A TRAIN AND A TRACK UNIT

**CANADIAN NATIONAL RAILWAY
TRAIN A41651 13 AND
TRACK UNIT 075765
MILE 14.5, CLEARWATER SUBDIVISION
MESSITER, BRITISH COLUMBIA
14 JANUARY 2012**

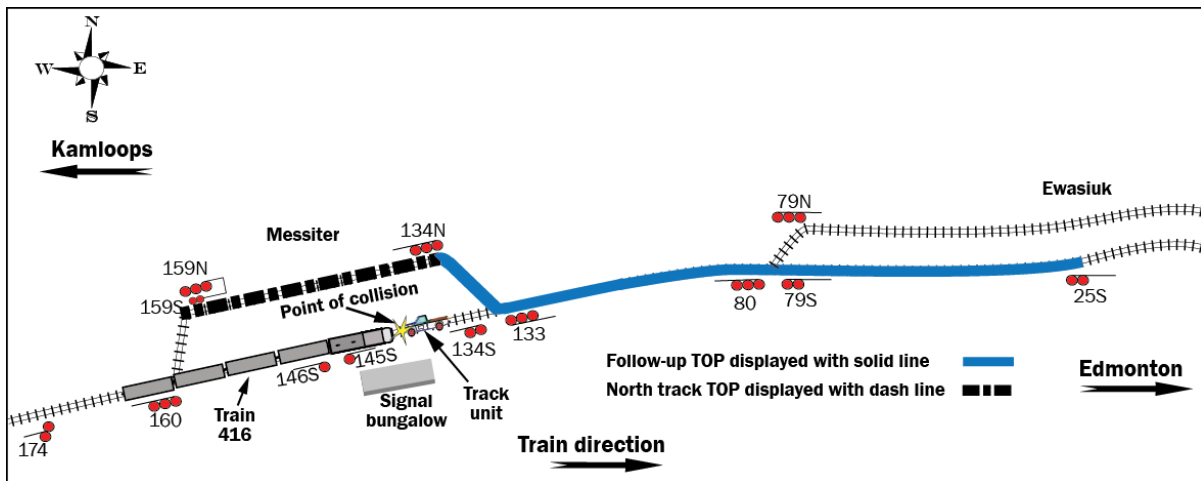
Figure 2. Site diagram

After completing the TOP, the foreman departed for Messiter, following behind train 101. At about 0353, the foreman travelled over the switch at Messiter East, which had been lined to the south track for train 101's movement. The foreman continued to Mile 14.5, where he exited the track unit⁵ to work in the signal bungalow that was located south of the track.
