MARINE INVESTIGATION REPORT

M12W0070

CAPSIZING WITH LOSS OF LIFE

**FAST RESCUE CRAFT *LEWIS-MCPHEE*
SECHELT RAPIDS, BRITISH COLUMBIA
03 JUNE 2012**

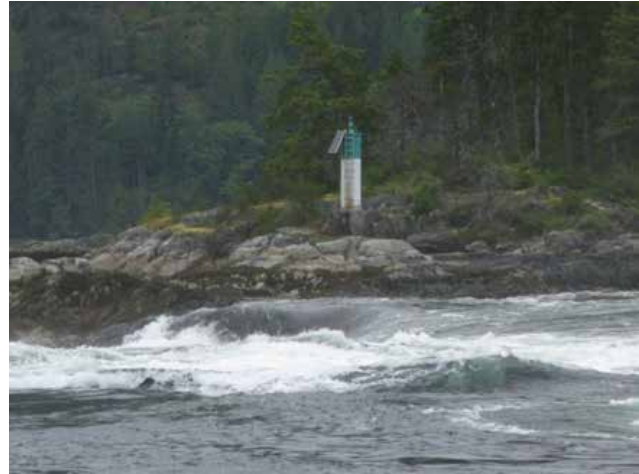
The strongest flood stream occurs to the southeast and west of Sechelt Islets. The strongest ebb stream occurs just west of the green light on Sechelt Islets (Photo 2), with a strong cross-channel set toward the west-northwest. A large back-eddy occurs to the north of the light, and whirlpools form close to the light. On 03 June 2012, the predicted time of maximum ebb current at Sechelt Rapids was 0940, at 13.6 knots. The next predicted time of slack water was 1414.

Photo 2. Green light marking southwest extremity of Sechelt Islets

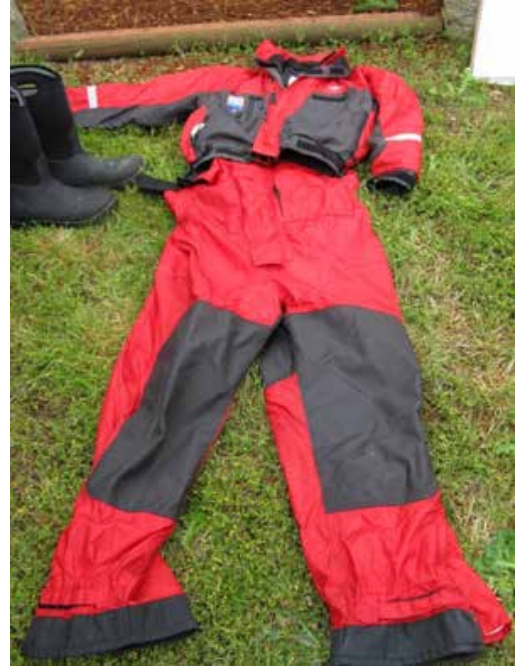
Photo 3. Marine anti-exposure suit

RCM-SAR provides crew members with a list of required PPE. All the PPE worn by the crew of the *Lewis-McPhee* was approved by RCM-SAR for their intended operations. At the time of the occurrence, the crew were wearing marine anti-exposure suits (certified as PFDs) that provided thermal and flotation protection. Three of the crew members were wearing the 2-piece suits

The coxswain and surviving crew member were found to be suffering from mild hypothermia when they were rescued. The marine anti-exposure suits they were wearing did not provide sufficient thermal protection, nor did they provide adequate buoyancy while the crew members were in the cold and turbulent waters of Sechart Rapids.
