PIPELINE INVESTIGATION REPORT P05H0044

CRUDE OIL PIPELINE RUPTURE

**TERASEN PIPELINES (TRANS MOUNTAIN) INC.
508-MILLIMETRE-DIAMETER TRANSFER LINE
NEAR ABBOTSFORD, BRITISH COLUMBIA
15 JULY 2005**

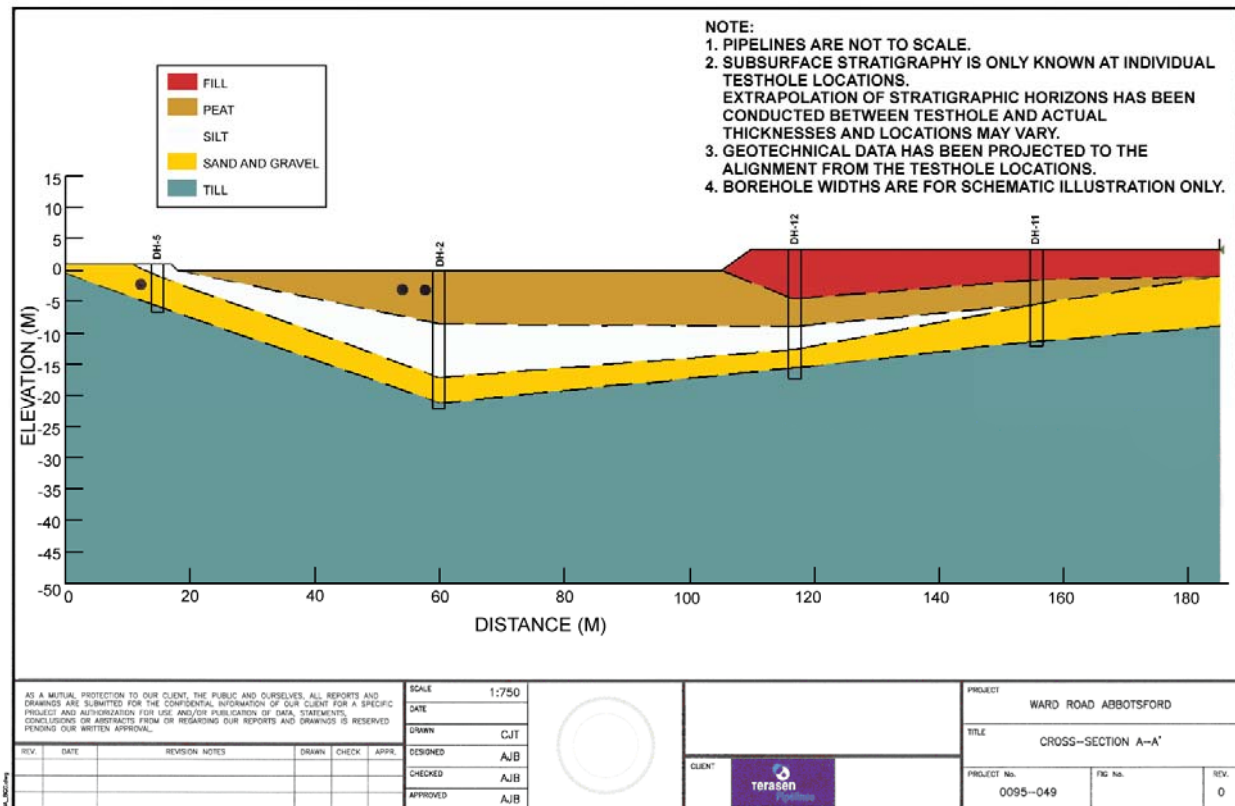
Appendix B – Cross-Section of Ward Road

The first evidence that ground movement played a role in the development of the buckle was the lateral displacements of both the 508 mm and 610 mm lines towards the southwest and north of the pre-existing cold bends. A post-failure survey by Terasen of both transfer lines was conducted 150 m upstream and downstream of the occurrence site. This survey confirmed the presence of lateral deformation, from a straight line, northwest of the two cold bends. Peak deviation from a straight line was found to be 1.5 m and 0.95 m for the 508 mm and 610 mm lines, respectively.

The survey illustrated that both transfer lines showed evidence of being bowed-out, but the 508 mm line was more bowed-out than the 610 mm line. Since the pipe cross-section for the 610 mm line had approximately twice as much bending stiffness as the 508 mm line, the 610 mm line would have resisted movement much better than the 508 mm line. The post-failure survey illustrated that, towards the southeast, and away from the cold bends, both transfer lines were relatively straight.
