PIPELINE INVESTIGATION REPORT

P06H0061

IN-LINE TOOL OCCURRENCE

ENBRIDGE PIPELINES (WESTSPUR) INC.
323.9-MILLIMETRE OUTSIDE DIAMETER PIPELINE
RECEIVING TRAP AT CROMER TERMINAL
NEAR CROMER, MANITOBA
23 NOVEMBER 2006

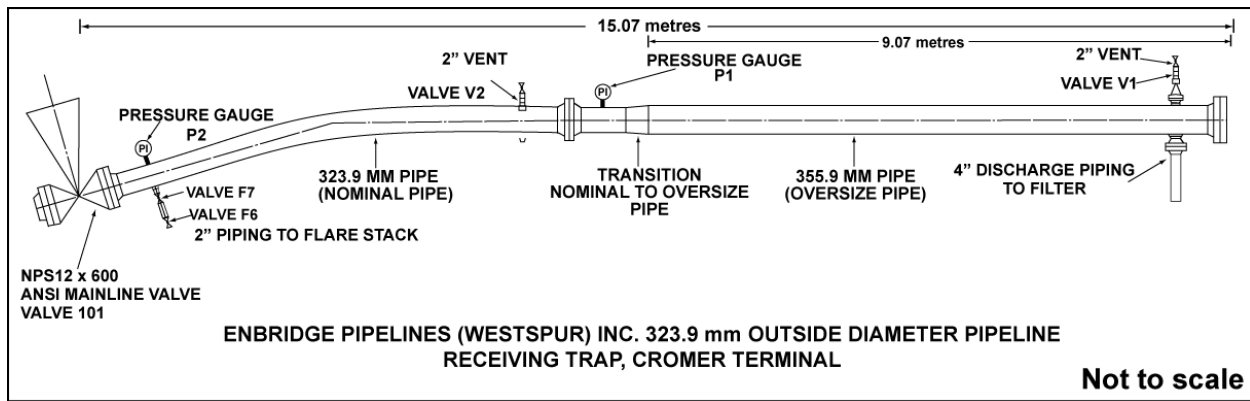
Figure 1. Temporary receiving trap

A temporary receiving trap, as shown in Figure 1, had been constructed for this ILI. The outside diameter of the oversize pipe of the receiving trap was based on EPSI standards for gathering lines and was 355.6mm OD with an inside diameter of 336.55 mm. Each displacement pig had an outside diameter of 323.85 mm. Since the oversize pipe was long enough to accommodate the four displacement pigs simultaneously, a puller that could reach towards the back of the oversize pipe and remove the last displacement pig had been constructed for this project. It was 9.1 metres (m) long and made of square metal tubing with a 12.7 mm hook inserted into the end. There was no detailed written procedure for the use of this puller.

The contamination of the NGL by the natural gas, as evidenced between the arrival of the second and third displacement pigs at Cromer, would have resulted in the accumulation of black powder. Contaminants may have been left in the pipeline following the last cleaning run. The black powder along with other contaminants and the natural flaring of the displacement pig cups from the back pressure in the pipeline combined with the small spacing around the displacement pigs could have created an effective seal around the third and/or fourth displacement pigs so that pressure from the nitrogen purge or any entrapped NGLs could not dissipate around those tools. The resulting pressure differential was sufficient to move the third and fourth displacement pigs backwards in the receiving trap until the third displacement pig became lodged at the transition between the nominal and oversize pipes and the fourth displacement pig was in the nominal pipe of the receiving trap, either just upstream of, or spanning, valve V2.

Following the closure of valves F6 and F7, a small amount of liquid NGLs probably remained in the receiving trap behind the fourth displacement pig. With the pressure in the trap less than 689.5 kPa, the NGLs would have gasified at a ratio of approximately 255:1. Since the fourth displacement pig was either just upstream of, or spanning, valve V2, the pressure could not dissipate through that valve and the valve could not function as designed in ensuring that the receiving trap was depressurized. The third displacement pig became dislodged when the crew pulled on it with the puller. Once the third displacement pig had become dislodged, the pressure behind the fourth displacement pig was sufficient to expel both displacement pigs from the receiving trap.

4. Because the fourth displacement pig had become lodged either upstream of, or spanning vent V2, that vent could not function as designed.
5. Pressure built up behind the fourth displacement pig, possibly due to the gasification of NGLs behind it, until the pressure differential was sufficient to expel the third and fourth displacement pigs from the receiving trap.

Following an internal investigation by Enbridge Pipelines Inc. and Enbridge (Saskatchewan) Operating Services Inc. of the events surrounding the November 2006 occurrence, the 355.6-millimetre (mm) temporary receiving trap was replaced by a 406.4 mm temporary trap to land the four displacement pigs that were used when the 323.9 mm outside diameter mainline was re-filled with natural gas liquids (NGLs). A detailed procedure for loading and removal of those tools was developed. Enbridge Pipelines (Westspur) Inc. (EPWI) has indicated that it is committed to implementing the following recommendations made by the internal investigation team:

- adopt a new gathering system standard that requires 101.6 mm oversizing of traps for all lines of 323.9 mm or greater and ensure that existing traps meet this new standard;
- continue to implement a hazard assessment program;
- develop formal procedures for verifying the isolation and depressurization of receiving traps when NGLs and natural gas have been used;
- review existing manuals to ensure that proper procedures and guidance is provided when considering all aspects of the operation of NGL pipelines;
- initiate training for all operations personnel on the policies and procedures, both new and existing, relating to the operations of NGL pipelines; and
- ensure that policies, procedures and facilities cover the formation of hydrates and how to eliminate or deal with them and that personnel are trained with regard to hydrates.
