## **PIPELINE INVESTIGATION REPORT P07H0014**

### **CRUDE OIL PIPELINE RUPTURE**

**ENBRIDGE PIPELINES INC.  
LINE 3, MILE POST 506.2217  
NEAR GLENAVON, SASKATCHEWAN  
15 APRIL 2007**

Report Number P07H0014

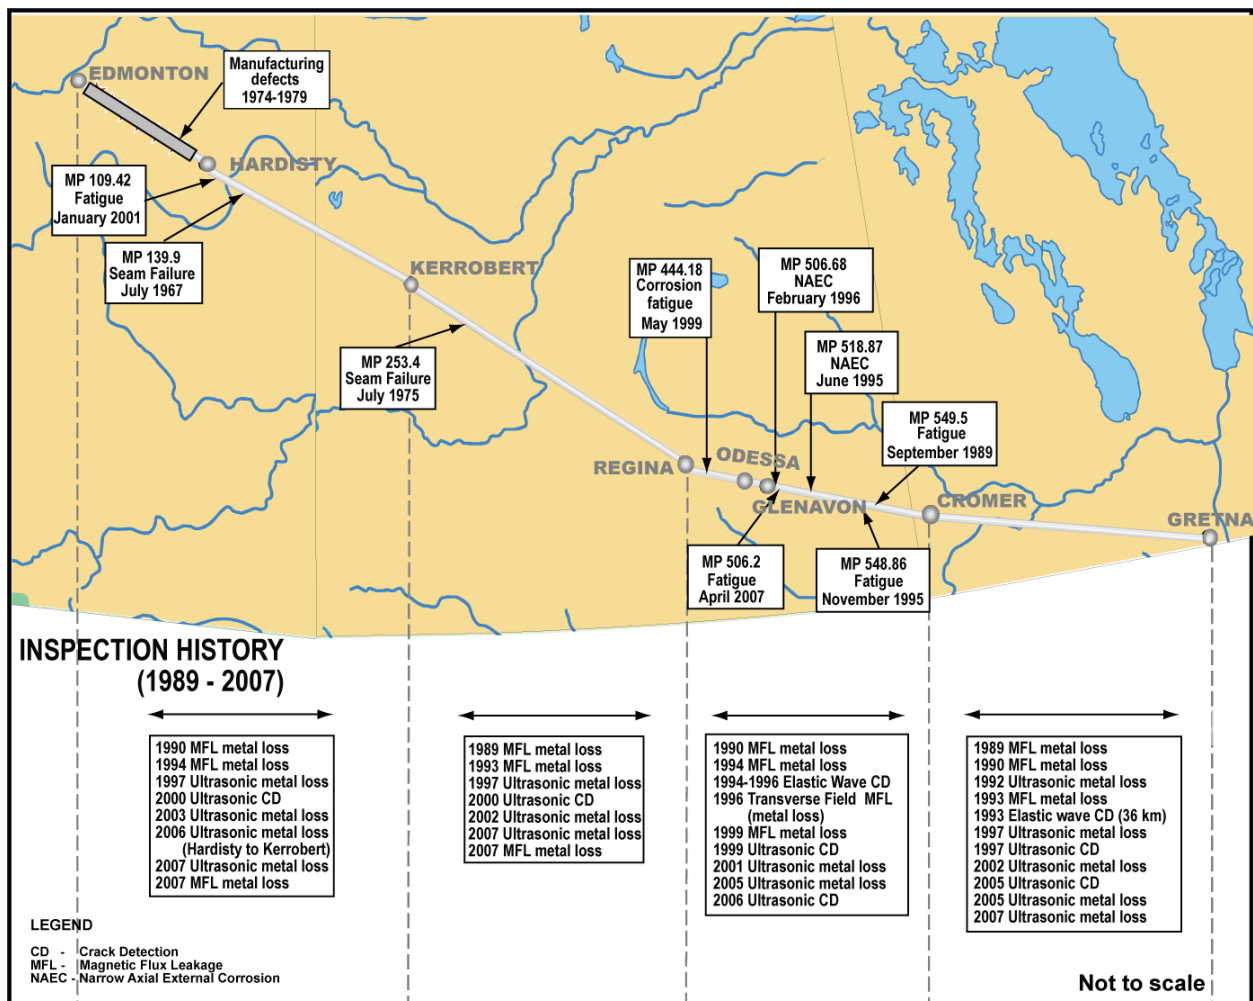
## Appendix A – Long Seam Failures on Line 3

Between 1974 and 1979, five ruptures occurred due to pipe-related manufacturing defects. Two of the ruptures occurred downstream of the Edmonton terminal and three occurred downstream of the Strome pump station. Because these five failures occurred in pipe from the same pipe order (Canadian Phoenix DSAW pipe), Enbridge replaced all Canadian Phoenix DSAW pipe between 1979 and 1985 with IPSCO Inc. DSAW pipe.

In response to a rupture due to corrosion fatigue on Line 3 at Mile Post 549.5 in September 1989, Enbridge committed financial support to the development of an elastic wave tool – an internal inspection device designed to locate and size longitudinal planar defects, such as fatigue cracking, in the vicinity of the longitudinal weld. By 1996, Enbridge had internally inspected most of Line 3 between Regina and Cromer using the elastic wave tool.

Following three ruptures on Line 3 over an eight-month period, the National Energy Board (NEB) issued a directive to Enbridge in March 1996. In response, Enbridge prepared an operational reliability assessment of Line 3 between Edmonton and Gretna and implemented an action plan to address the integrity of the line. The action plan included a hydrostatic test of the line between Odessa and Cromer pump stations, operating pressure reductions, and in-line inspections (ILI) for cracking and narrow axial external corrosion.
