**AVIATION INVESTIGATION REPORT  
A12C0099**

**LOSS OF CONTROL AND COLLISION WITH TERRAIN**

**CESSNA 180G, N4695U  
TROUT LAKE, ONTARIO  
01 AUGUST 2012**

Report Number A12C0099

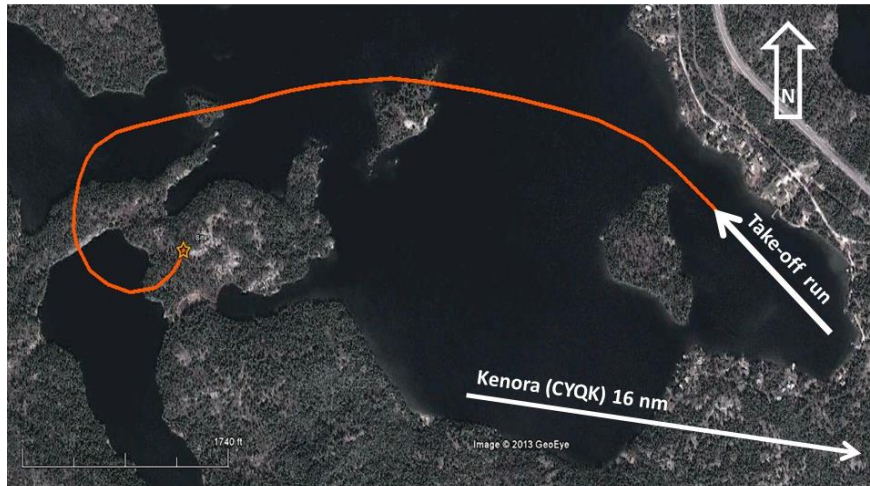
**Figure 1.** Approximate flight path

regain control. The aircraft yawed and rolled left, resulting in an approximately 240° change in heading (Figure 1). The aircraft collided with tree-covered, rising terrain between 2 lakes, on a heading of roughly 025° magnetic. The aircraft came to rest on its left side in front of a 10-foot-high granite wall.

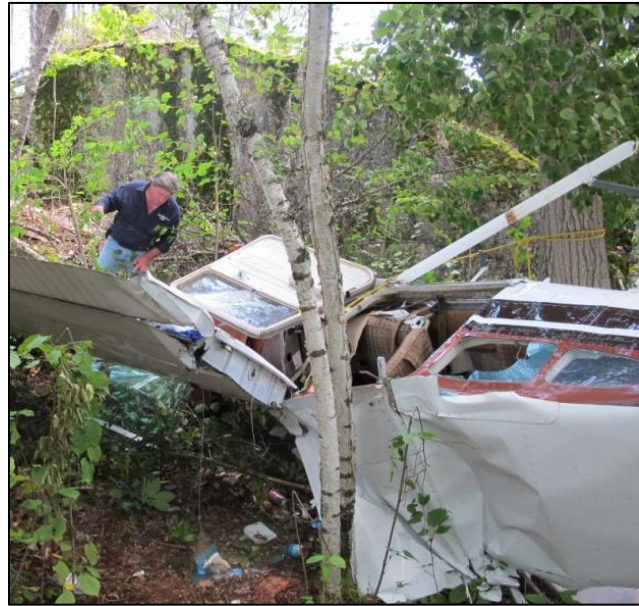
The aircraft wreckage was situated on tree-covered rocky terrain approximately 80 feet above lake level (Photo 1). The aircraft struck the ground at a descent angle of roughly 12° in a left bank. The fuselage was on its left side, with the right wing lying inverted ahead of the aircraft, but still attached at the front spar. The left wing was in 2 pieces. The inboard section was about 40 feet behind the fuselage. The outboard portion was 100 feet down the wreckage trail, in the top of a tree 20 feet above the level of the crash site. The right wing still contained fuel, and the severed fuel lines had been plugged by local residents during the rescue. The left-wing fuel tank had burst on impact with the trees. Fuel system continuity was verified from the right-hand wing root to the firewall fuel filter, and fuel was present in the lines. The emergency locator transmitter (ELT) was attached to a removable floor panel under the pilot's seat. The ELT had remained in place, and the antenna was still connected. The switch on the ELT was in the ARM position; however, the ELT had not activated.

**Photo 1.** Aircraft on its left side and right wing

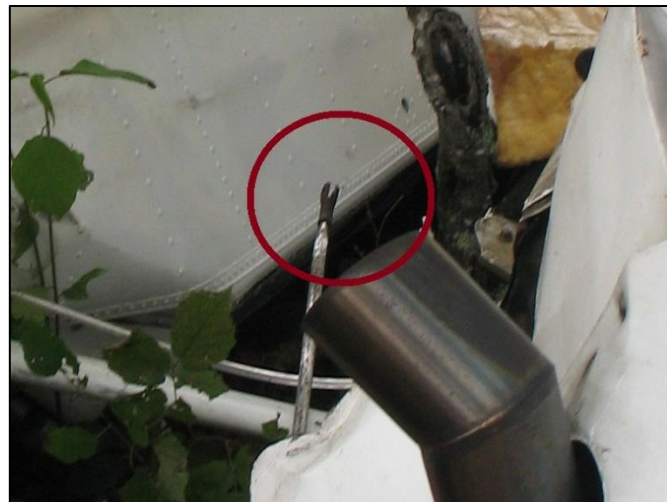
The bows of both floats were heavily damaged by impact with large trees. The front bracing wire that ran between the right float and the left fuselage attachment was lying loose in the wreckage. A clevis pin was missing from the clevis fork on the upper end of the bracing wire (Photo 2). The clevis pin in the opposite end was still in place in the clevis fork, and had been torn out of the wire-pull fitting at the front fitting of the right float. The 2 front seats were still latched on their respective seat tracks, and the seat-track safety clips were in place. The battery and master contactor had been wrenched from their mounting points, and the associated electrical cables were no longer connected. Continuity of the rudder, elevator, and stabilizer trim controls was established from the cockpit to the empennage. The flap and aileron cables had all failed close to the wing attachment points. Continuity of the flap and aileron cables was established from the cockpit to the failure points, and hence out to the wings. The flap selector was latched in the up position. The engine exhibited no sign of rotation at impact with the ground; however, at least 1 tree had been scarred with multiple slashes resembling propeller strikes.

**Photo 2.** Bracing wire with clevis pin missing

The float bracing wire was found loose in the wreckage. The clevis pin was missing from the clevis fork at the upper end of the bracing wire. It is likely that the clevis pin fell out after take-off before the loss of control. The absence of the clevis pin could not be explained, and because the clevis pin was not recovered, it was not possible to determine whether the correct parts had been installed. The possibility exists that the clevis pin failed in shear and allowed the bracing wire to become disconnected. The cotter key may have corroded or worn through; however, no other cotter keys displayed any signs of abnormal wear or corrosion. It is also possible that the cotter key may have been removed when the bracing wires were adjusted in May 2010. However, it could not be determined whether that was the case, as it is not usually necessary to remove the cotter key or clevis pin to accomplish this task.

It is most likely that the bracing wire became disconnected shortly after take-off, when the unsecured clevis pin fell out. The looseness that existed at the float attachment points allowed the now-unbraced floats to twist out of alignment. The subsequent increase in parasitic and induced drag initiated a loss of airspeed. Although the exact airspeed trend was not observed or recorded, it progressed to the onset of an aerodynamic stall. Subsequent to the unfamiliar sound, this progression was indicated by the activation of the stall warning horn, the uncommanded left bank, and the ineffective flight controls. The stall occurred at an altitude of approximately 200 feet above the level of the tree tops on the surrounding terrain, and a successful recovery was not possible.

1. For undetermined reasons, a clevis pin that attached a front bracing wire to the left landing-gear adapter was not secured by a cotter key. As a result, shortly after take-off, the clevis pin likely fell out of the clevis fork, and the front bracing wire became disconnected.
2. Looseness between the struts and the float attachment fittings that had developed due to long-term wear allowed the floats to twist out of alignment.
3. The misaligned floats increased drag, causing a loss of airspeed, which led to the onset of an aerodynamic stall and subsequent loss of control at an altitude from which recovery was not possible.

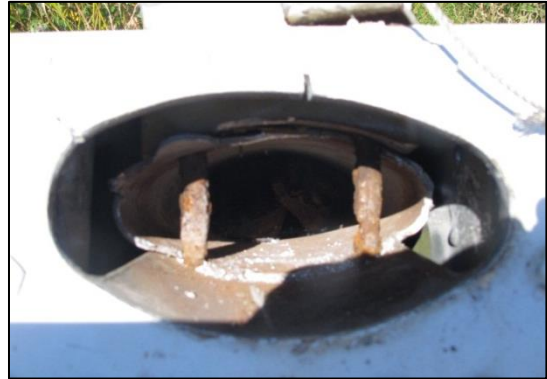
The spreader bars were found to be severely corroded within the float-socket attachment point. The corrosion had developed around wood filler plugs<sup>2</sup> in the spreader bars, and was concentrated around the holes for the steel through-bolts. The through-bolts were severely corroded and were impossible to remove. Bolts in the right-rear spreader bar had corroded to the point that the bolt diameters were reduced by approximately 50% (Photo 5). The front spreader bar was broken and pulled out of the left float socket. The rear spreader bar was broken at the right float, but was still captive within the socket.

**Photo 5.** Corroded through-bolts

The spreader bars were sent to the TSB Laboratory for examination of the fracture surfaces. Although internal corrosion of the forward and rear spreader bars and the through-bolts was deemed extensive, the corrosion was not a factor in the initiation of the fractures.

The corrosion noted on the spreader bars was not visible externally, since it occurred within the spreader-bar mounting sockets. The extent of the corrosion damage suggests that periodic float removal, disassembly and thorough component inspection would be beneficial. If corrosion on the spreader bars is allowed to progress unchecked, it will eventually reach the point at which the affected components will be reduced in cross-section, such that they can no longer withstand the applied loads and may fail in service. Detection of the spreader bar corrosion and any associated repairs would require that the spreader bars be removed from the floats. Currently, there is no requirement to periodically disassemble floats for inspection. As a result, pilots and passengers travelling on float planes may be at increased risk due to undetected corrosion damage to float-attaching hardware.
