**AVIATION INVESTIGATION REPORT  
A12C0141**

**COLLISION WITH TERRAIN**

**AEROFAB INC. LAKE 250, C-GZLC  
PICKLE-LAKE, ONTARIO  
16 OCTOBER 2012**

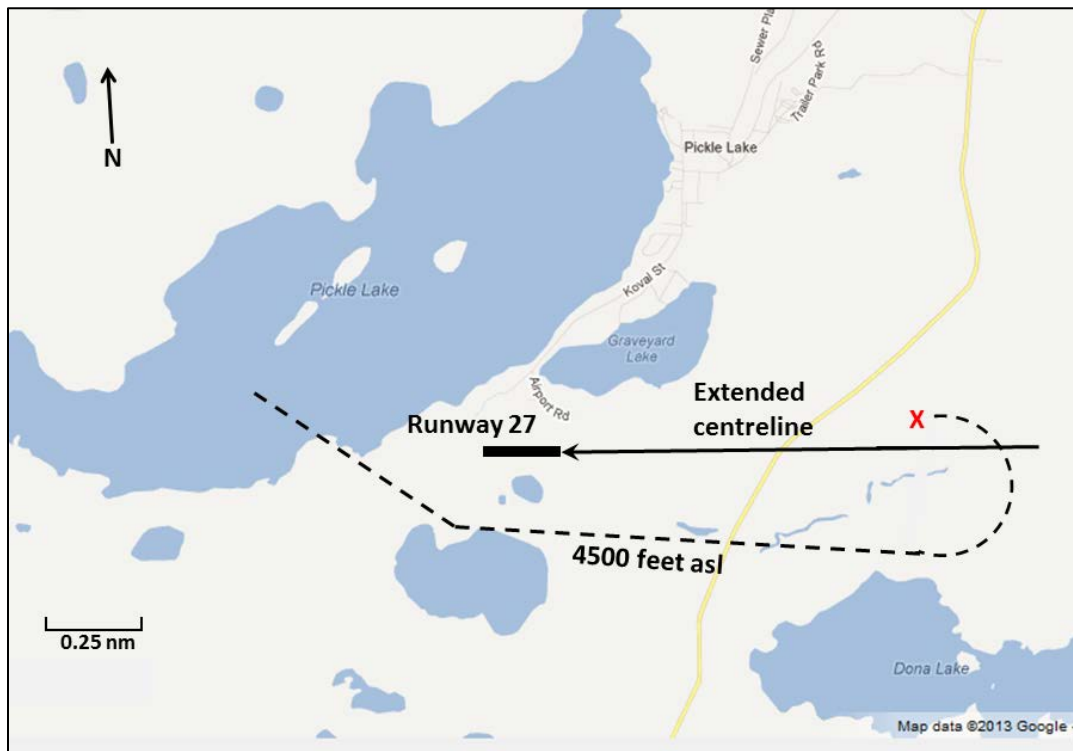
**Figure 1.** Pickle Lake Airport and estimated flight path (shown by the dashed line); X marks the approximate point of impact

On final approach, the landing gear was extended and the associated landing gear lights illuminated, actions that the PIC had instructed the left-seat pilot to perform. The pilots did not appear to be having any difficulty controlling the aircraft; however on final approach, C-GZLC entered a steep descent and struck trees approximately 1 nm short of Runway 27.

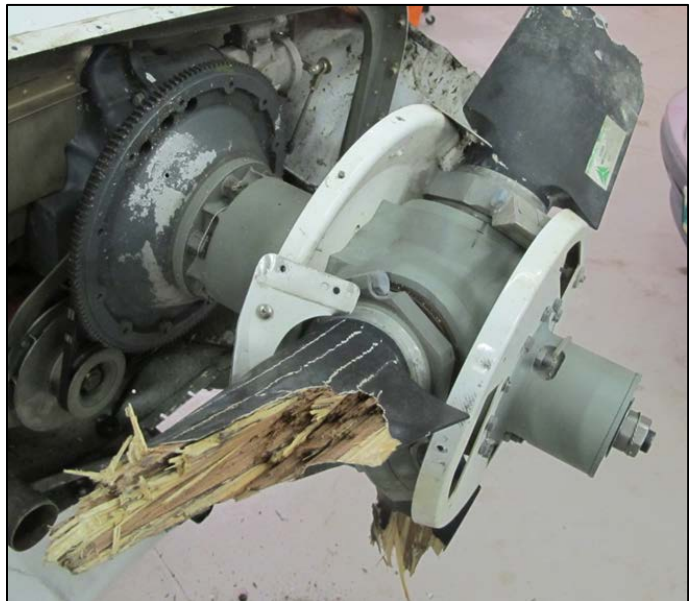
**Photo 1.** Propeller hub after occurrence; propeller in governing range.

Initial inspection of the propeller indicated that the blades were in the flight (coarse blade angle) governing range at the time of impact.

The propeller had sustained substantial damage during impact. All 3 blades had been shorn off approximately 8 inches from the propeller hub. Disassembly of the propeller hub revealed strike marks corresponding to varying blade angles. These marks would have resulted from rotational forces derived from the propeller blades striking surrounding terrain at the time of impact. No damage or conditions of the propeller hub assembly that could have caused an uncommanded propeller-reversing operation or blade angle were observed.

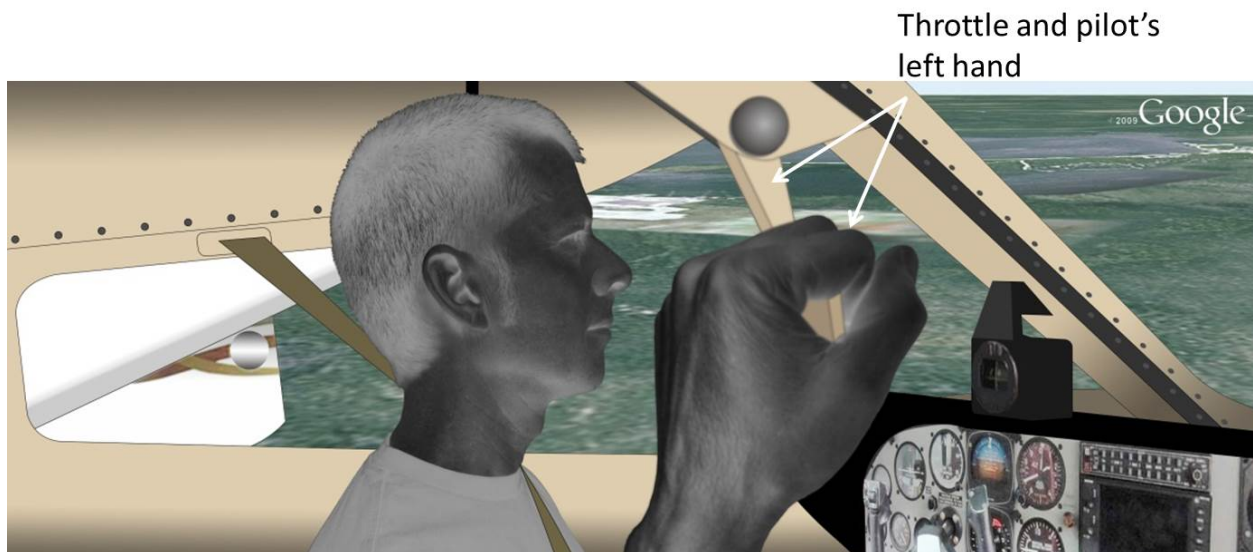
A light associated with the landing gear extension had illuminated in the cockpit, and was shaded on the PIC's command. The momentary flash of the light could have impaired the pilots' night vision to a certain degree. The PIC was flying in the right seat while carrying out a left-hand circuit. Looking across the cockpit past the pilot in the left seat would have made visual acquisition of the runway more difficult (Figure 2).

**Figure 2.** Right seat pilot's view obstructed by left seat pilot.
