**AVIATION INVESTIGATION REPORT
A13O0045**

RUNWAY INCURSION AND RISK OF COLLISION

**SUNWING AIRLINES VEHICLE AND
AIR CANADA EMB190 C-FLWH
TORONTO LESTER B. PEARSON INTERNATIONAL AIRPORT
11 MARCH 2013**

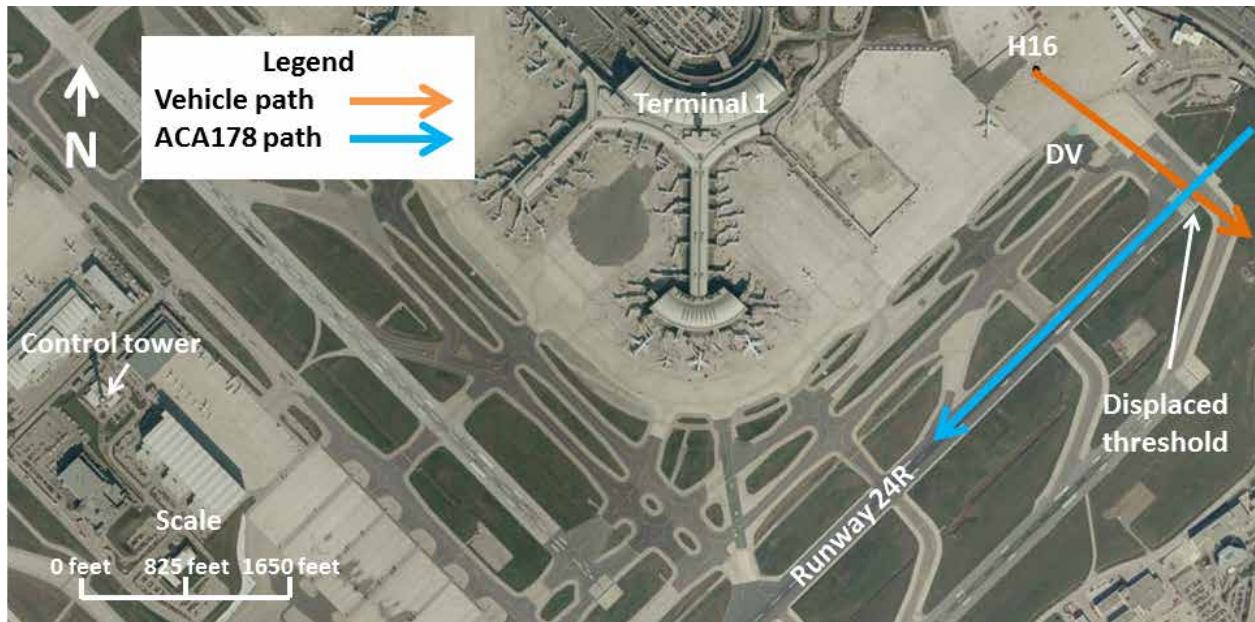
Figure 1. Occurrence map

Sunwing Airlines Inc. (Sunwing) is a charter operator based at Toronto–Lester B. Pearson International Airport (CYYZ), Ontario. A large portion of the company's fleet undergoes maintenance and grooming during the evenings. Generally, these routine tasks are performed while the aircraft are parked at gates set aside for this type of operation on the east side of Terminal 1 (Figure 1).

While the technician was inside the aircraft, the unattended vehicle, at idle and in drive gear, had begun to roll. The vehicle grazed the outer cowling of C-FTLK's left engine and continued under the wing in the direction of the threshold of Runway 24R, the active arrival runway. As the vehicle proceeded across the apron and maneuvering area, the speed varied between 1 and 5 mph, likely due to the gradual slopes in the pavement. The vehicle crossed Runway 24R perpendicularly, almost directly over the displaced threshold, continued straight across taxiway D7 and into the grass where it struck a taxiway reflector sign and became stuck. The vehicle was located 14 minutes later, with the engine running, headlights, taillights, and beacon on, and the automatic transmission in drive.

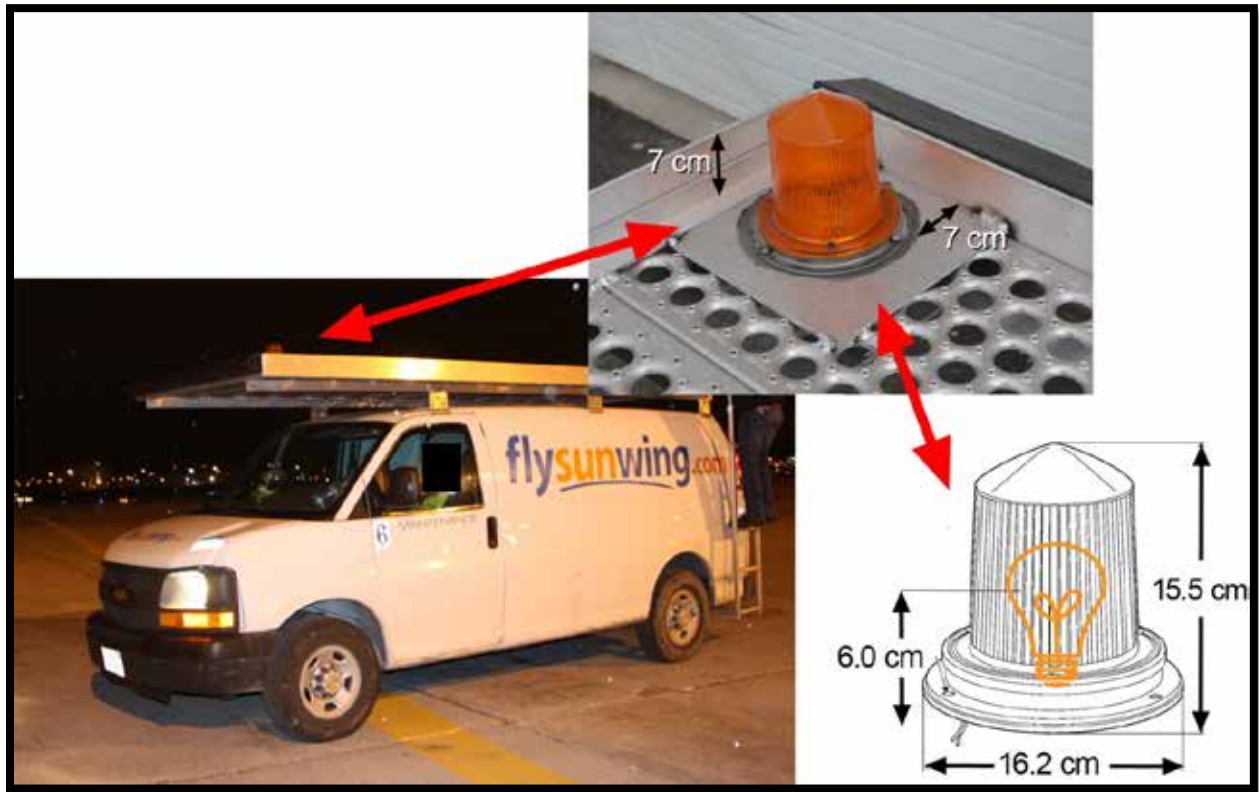
Figure 2. Grote beacon light installation on the maintenance van

Affixed to the roof of the van was a large aluminum work platform with a ladder running down the left side. Attached to the front left corner of the platform was an orange beacon light. The beacon was approximately 15.5 cm tall and was mounted 7 cm from a 7 cm tall skirt, which surrounds the platform. From a position 3 degrees above horizontal, similar to an approaching

aircraft's perspective, the bottom 6.6 cm of the beacon would not be visible. The filament of the bulb was located 6 cm from the base (Figure 2).

The beacon is designed to use a #1295 bulb, which is 37.5 W, to provide the 40 candelas specified by Transport Canada.⁶ After the incident, it was determined that the bulb inside the occurrence beacon was only 7 W. It could not be determined why or when the incorrect bulb was installed.

The vehicle was not noticed as it moved slowly across the apron. The ground controller first saw a very slow-moving unidentified airport surface detection equipment (ASDE) target shortly after its appearance on intersection DV but was unaware of the target's identity or intentions. The controller planned to monitor the target, and returned to other tasks. When attention was returned to the target 2 minutes later, the target was on the runway. The 3 controllers attempted to determine the target's identity but could not visually see the vehicle, possibly due in part to the inadequate vehicle beacon.

- Airside vehicle beacon safety blitz: GTAA aviation safety officers undertook spot checks and airside traffic stops of any vehicle that appeared to have a weak or inoperative roof beacon, and directed drivers to have vehicle beacons repaired or replaced.

Sunwing Airlines reported to Transport Canada Civil Aviation that it had inspected all of its airside vehicles' rotating beacon bulbs, and that bulbs found not to meet the specifications of TP312 were replaced to meet it.
