RAILWAY INVESTIGATION REPORT R12W0182

CROSSING ACCIDENT

**CANADIAN PACIFIC RAILWAY
FREIGHT TRAIN 205-09
MILE 128.90, BROADVIEW SUBDIVISION
BROADVIEW, SASKATCHEWAN
9 AUGUST 2012**

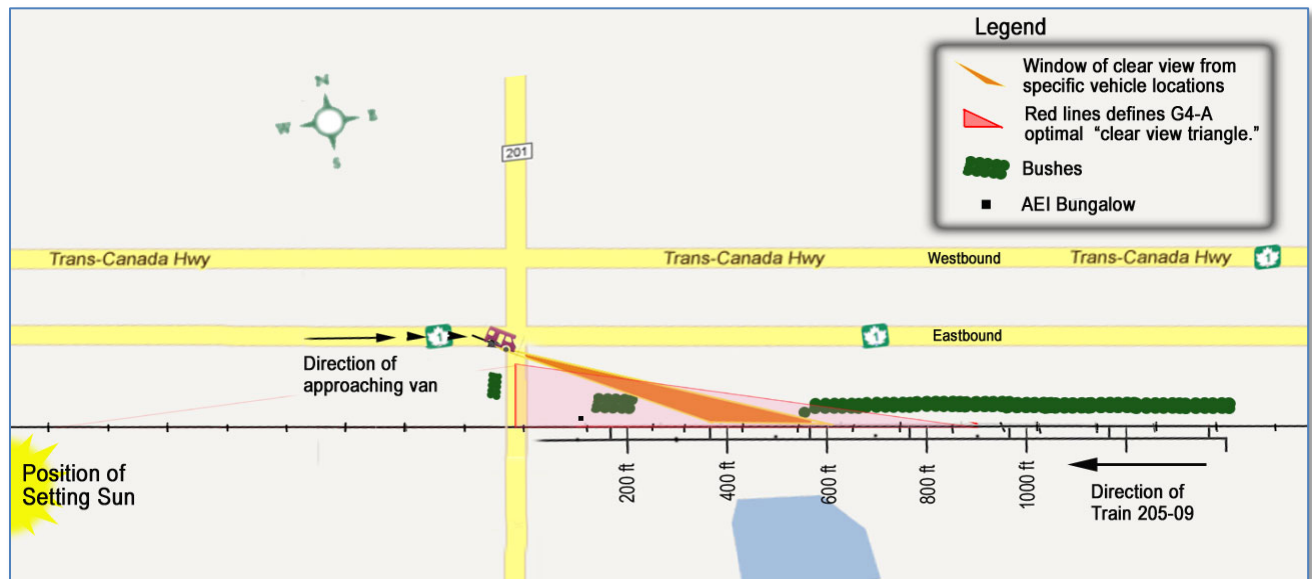
Figure 2. Site diagram

Approaching Airport Road (Provincial Road 201), the van moved right onto the paved turning lane and slowed almost to a stop before turning south (right) onto Airport Road (Figure 2).

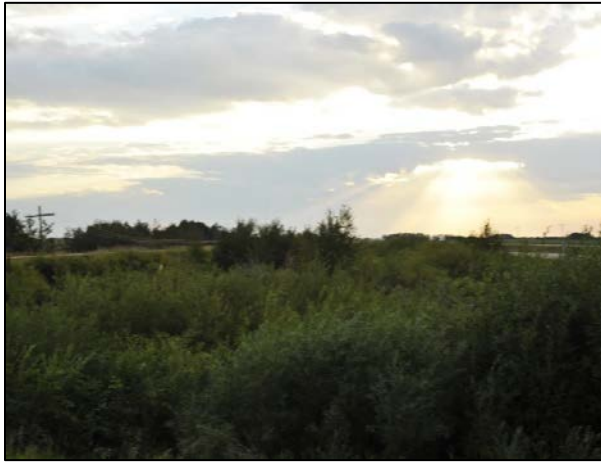
Photo 3. Westward view from 30 m north of the crossing (12 August 2012)

After turning, the driver briefly accelerated up to nearly 28 km/h and then slowed to about 18 km/h near the crossing. Just before reaching the crossing, the driver shoulder-checked again to the left (east) and for the first time saw the approaching train framed between the signal

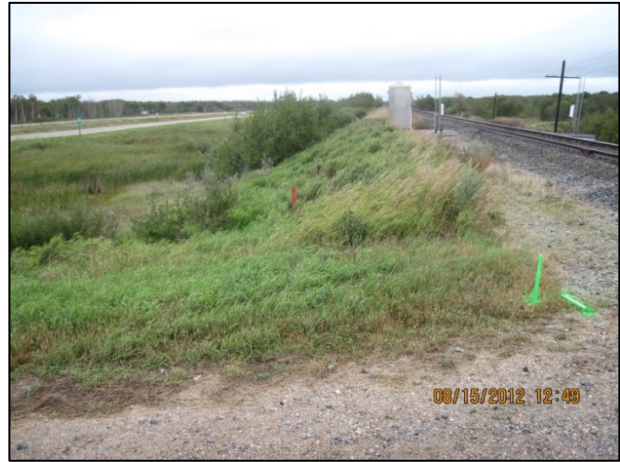
Photo 4. Eastward view from 5 m-10 m north of the crossing (12 August 2012)

bungalow and the crossing (Photo 4). The driver accelerated at the last moment, but it was too late to avoid the collision. The airbags deployed as a result of the accident.

Two groups of trees and other bushes were situated on the north side of the railway right-of-way (ROW), east of the crossing. For eastbound vehicles on Highway 1 and for vehicles turning south onto Airport Road, the vegetation obscured drivers' view of approaching westbound trains. The sightlines to the east were limited to less than 700 feet. For the westbound train, the train crew first observed a flash of light reflected from the windshield of the van approaching the crossing from the north, about 575 feet east of the crossing, as the train cleared trees along the ROW.

TSB examination following the accident revealed clusters of trees and bushes on the north side of the railway right-of-way, east of the crossing. For eastbound vehicles on Highway 1 and for vehicles turning south onto Airport Road, the vegetation obscured the driver's view of an approaching westbound train and limited the driver sightline towards the east to less than 700 feet. For the conditions at that location, the G4-A Guideline for minimum sightlines at passive crossings suggests that a clear view of the track for a distance of 273 m (900 feet) in both directions is required. The RSI suggested that since vegetation control near passive crossings protected solely by standard railway crossing signs (SRCS) is essential to safe railway and vehicle operations, inspection and maintenance programs should be sufficiently robust to ensure that crossing sightlines are proactively monitored and maintained.

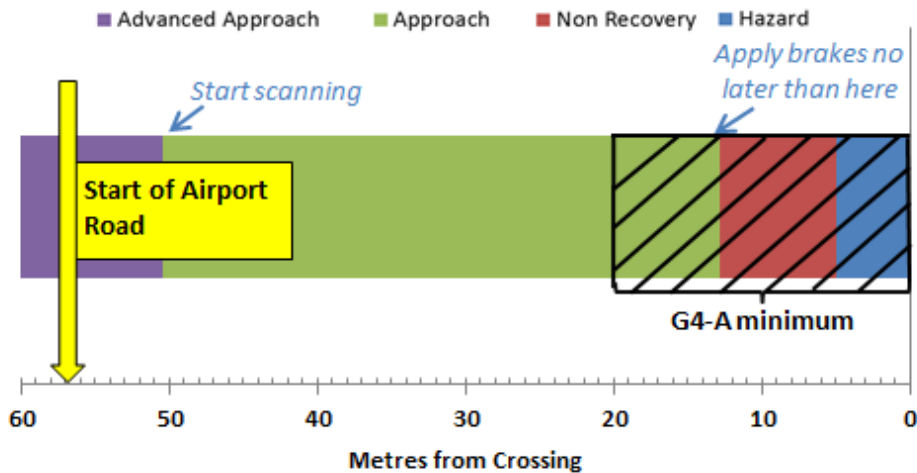
Considering the 4 zones drivers encounter when approaching a passive crossing equipped only with SRCS, when a 4.5 s PRT is used to calculate the optimal required sightline distance at this crossing (Figure 4) and is compared to minimum G4-A sightlines (Figure 4, hatched area), a significant proportion of vehicle/driver approaches (i.e., up to 83%) could potentially result in inadequate sightlines.

Figure 4. Passive level crossing approach zones for the Broadview crossing, assuming a driver PRT of 4.5 s and average vehicle speed of 30 km/h, overlaid with minimum G4-A sightlines based on PRT of 2.5 s (hatched area)
