## **RAILWAY INVESTIGATION REPORT R13D0001**

### **CROSSING COLLISION**

**VIA RAIL CANADA INC.  
TRAIN NUMBER 601  
MILE 98.79, JOLIETTE SUBDIVISION  
JOLIETTE, QUEBEC  
09 JANUARY 2013**

Report Number R13D0001

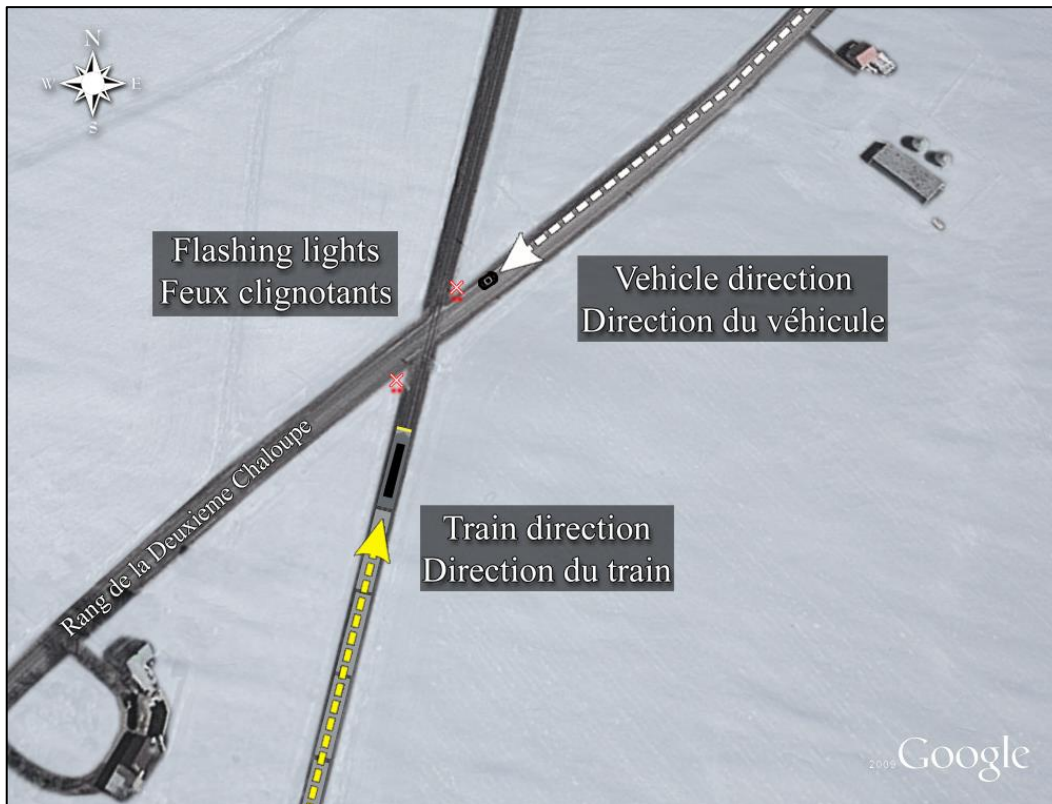
Figure 2. Rang de la Deuxième-Chaloupe crossing

Rang de la Deuxième-Chaloupe is a paved, 2-lane, undivided rural road that intersects the track at a 35°/145° angle (see Figure 2). Under normal visibility conditions, sightlines along the railway right-of-way were clear. The crossing is protected by flashing light signals (incandescent) and a bell. In good weather conditions, the light signals are visible to approaching motorists for at least 600 feet. Advanced warning signs are installed about 600 feet from the crossing along the roadway approach in both directions and are visible to approaching motorists for at least another 600 feet. The road has a maximum speed limit of 80 km/h.

Prior to the accident, the crossing was last inspected by the railway in May 2008. During this inspection, it was noted that the advanced warning sign, which is maintained by the road authority, was showing the crossing angle to be 90°. This advanced warning sign depicting the crossing at 90° was still present at the time of the accident.

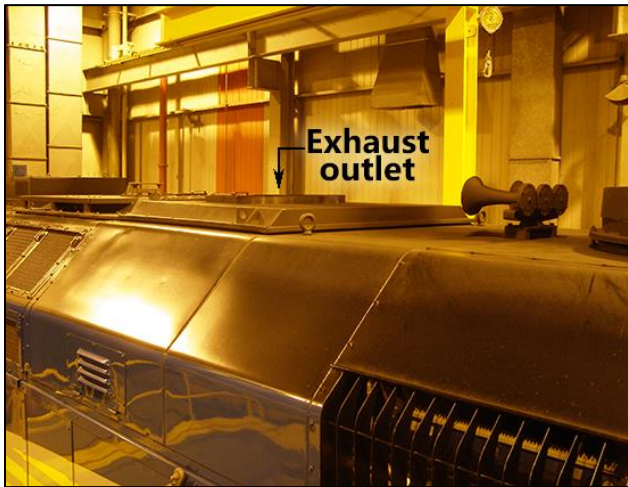
Locomotive VIA 6404 is a F40PH2D model locomotive built by General Motors in 1987. The original horn on this type of locomotive was a forward-facing 3-flute horn positioned mid-locomotive along its centreline and directly behind the exhaust outlet (see Photo 1). To comply with the *Railway Locomotive Inspection and Safety Rules*, VIA 6404 was recently retrofitted with a second, louder 5-flute emergency horn positioned over the cab (see Photo 2). The 3-flute horn is used during normal service operations, including whistling at crossings. The 5-flute horn is limited to emergency situations in order to reduce the train crew's exposure to high level sounds. *Canada Occupational Health and Safety Regulations* restrict the maximum sound level in the locomotive cab to 96.7 dB(A). No specific instructions are issued to operating crews outlining conditions where the use of the emergency horn is required.

**Photo 1.** 3-flute horn on locomotive VIA 6404

In this occurrence, the train horn (that is, the 3-flute horn situated mid-locomotive) was sounded from the whistle post (that is, about 1450 feet from the crossing) to close to the crossing. However, it was not effective in alerting the drivers of both the first vehicle and the following vehicle to the presence of the train. The driver of the first vehicle and the driver of the vehicle that was stopped on the west side of the crossing did not hear the horn until the train was very close to the crossing.

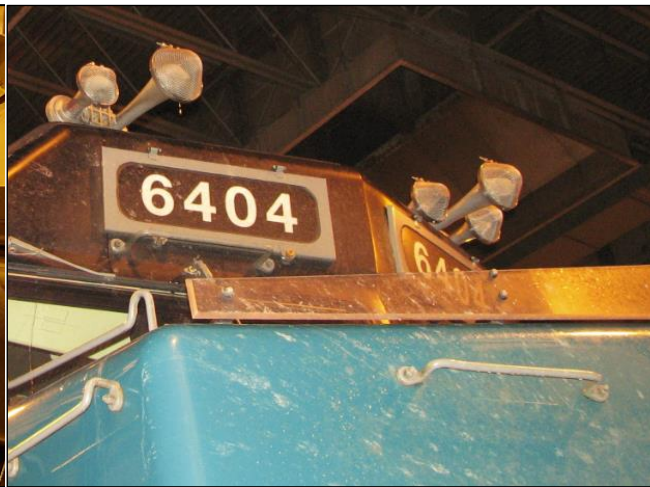
**Photo 2.** Emergency horn on locomotive VIA 6404

The emergency horn is generally used only for high risk or emergency situations (for example, when trespassers are walking along the track facing away from oncoming trains). However, during severe weather conditions such as dense fog or blowing snow, when visibility in the vicinity of the crossing is hindered, proactive use of the train's emergency horn could provide an effective warning to oncoming vehicles, reducing the risk of crossing collisions.
