**RAILWAY INVESTIGATION REPORT
R13E0015**

CROSSING COLLISION

**CANADIAN NATIONAL TRAIN L51141-23
MILE 33.70, BLACKFOOT SUBDIVISION
PAYNTON, SASKATCHEWAN
24 JANUARY 2013**

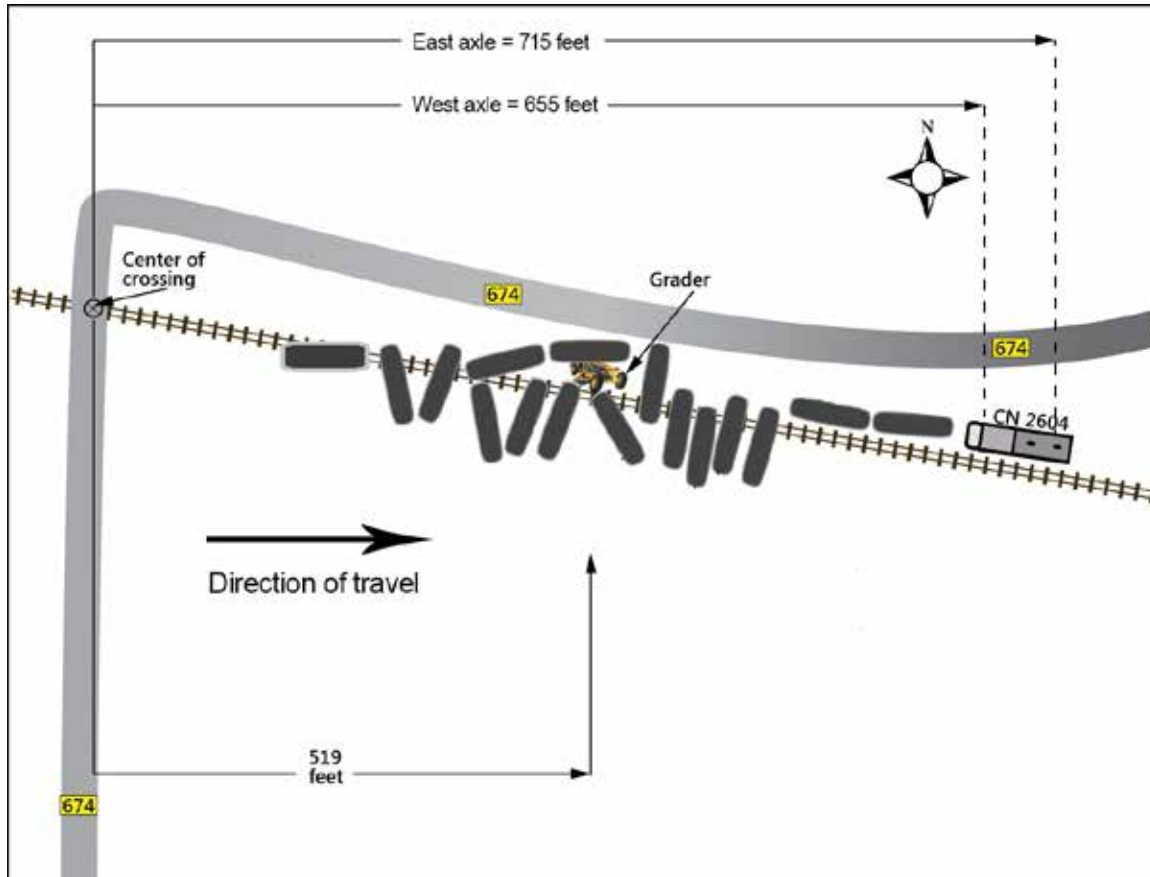
Figure 2. Accident site sketch

Unable to stop in time, the train collided with the stationary road grader. The force of the collision propelled the road grader eastward for approximately 519 feet where it came to rest on the north side of the track. The grader operator sustained fatal injuries. The lead locomotive (CN 2604) continued east and derailed approximately 715 feet past the crossing. In addition, 16 loaded dangerous goods tank cars carrying petroleum crude oil (UN 1993) derailed (Figure 2). Four DOT Class 111 cars were breached and released 106 000 L of crude oil. The locomotive sustained damage to the long hood and running gear due to the collision and derailment. The crew was uninjured.
