**RAILWAY INVESTIGATION REPORT  
R13D0054**

**RUNAWAY AND MAIN-TRACK DERAILMENT**

**MONTREAL, MAINE & ATLANTIC RAILWAY  
FREIGHT TRAIN MMA-002  
MILE 0.23, SHERBROOKE SUBDIVISION  
LAC-MÉGANTIC, QUEBEC  
06 JULY 2013**

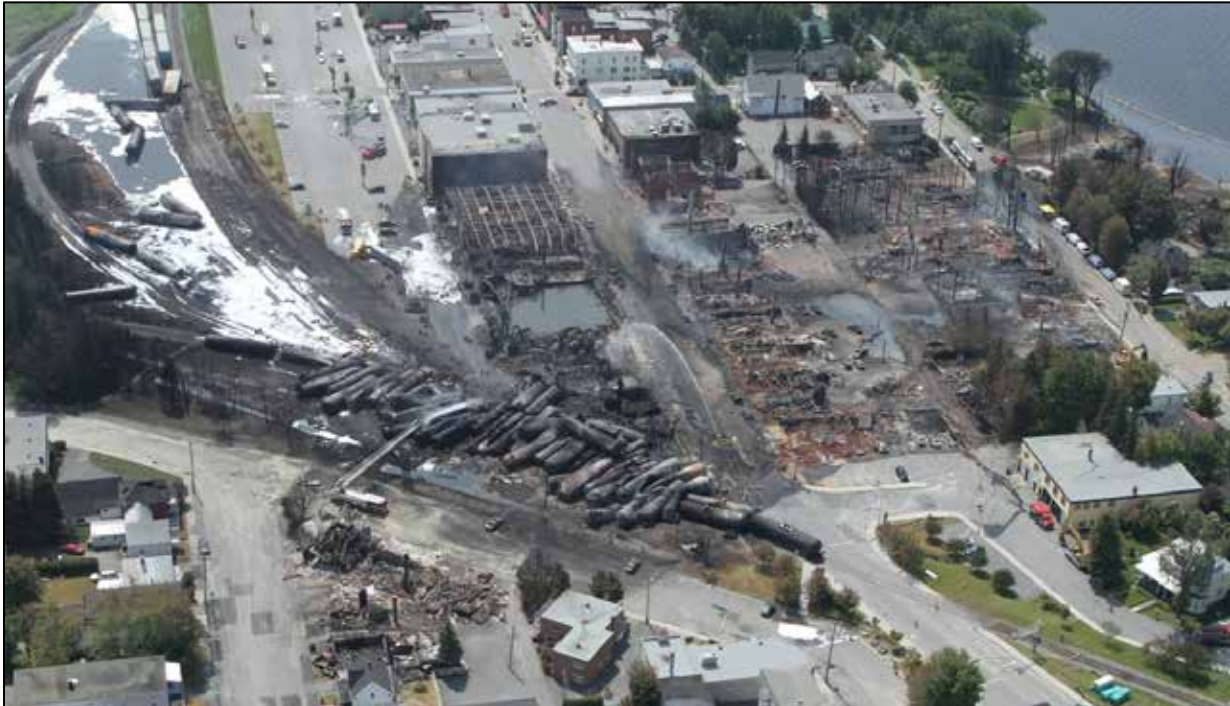
Photo 1. The Lac-Mégantic derailment site following the accident

As a result of the derailment and the ensuing fires and explosions, 47 people died, and about 2000 people were evacuated. Forty buildings and 53 vehicles were destroyed (Photo 1).

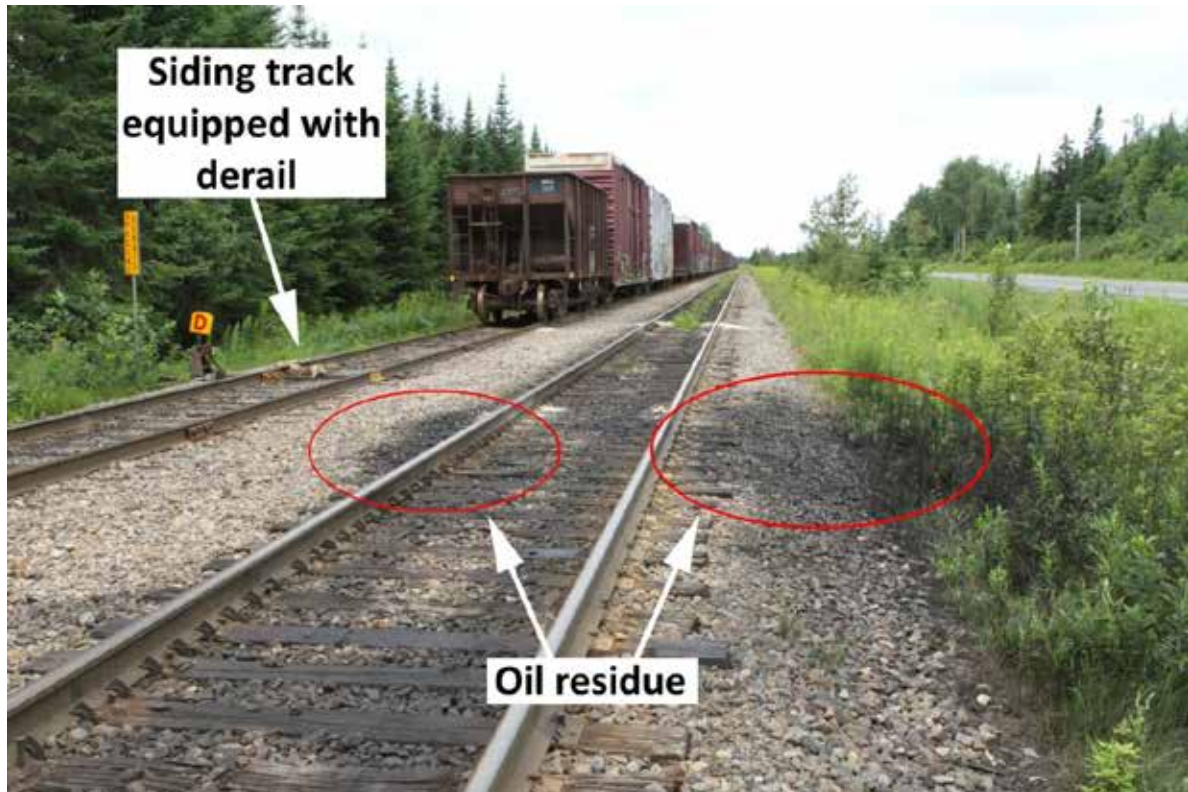
Photo 3. Oil residue on the ground and vegetation at Nantes. Note derail on adjacent siding track on left (view westward from the location where the lead locomotive was parked on the main track).

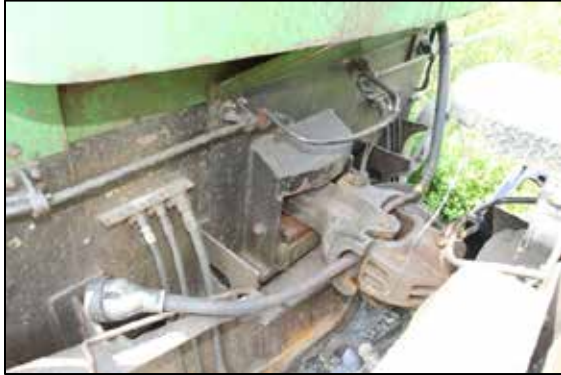
- One of the knuckles connecting the second locomotive (MMA 5026) and the third locomotive (CITX 3053) was broken, and a locomotive connector cable had been pinched between the knuckles (Photo 7), indicating that a separation had occurred and the consist had rejoined.

Photo 7. Pinched connector cable between couplers of second and third locomotives (occurring after the accident)

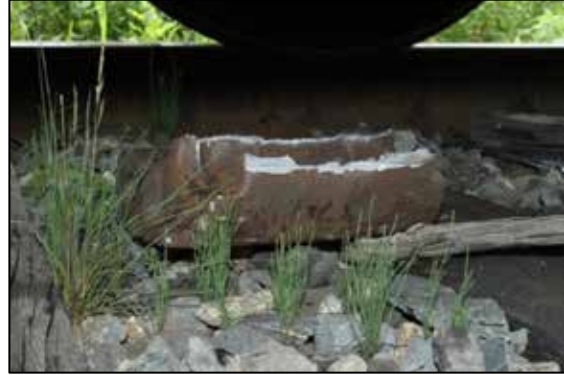
- A broken piece of the knuckle was found under the second locomotive, approximately 15 feet from the coupling (Photo 8). The locomotive knuckle and pin failed in tensile overstress mode, initiating at pre-existing fatigue cracks (Engineering Laboratory Report LP184/2013).

Photo 8. Broken locomotive knuckle segment found under the second locomotive

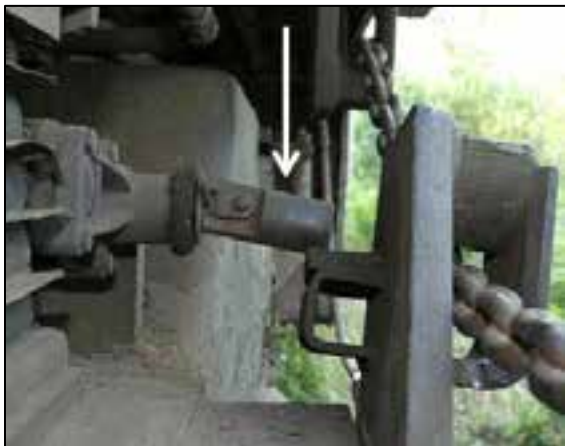
Photo 10. QRB valve used to exhaust brake cylinder air during hand brake application

The QRB valve on the second locomotive (MMA 5026) did not trip to exhaust brake cylinder air when tested. An examination of the valve showed wear and damage to the QRB valve's lifter and inside surface of the retaining disc. In addition, the examination showed that non-standard repairs had been applied to the valve's release mechanism in an attempt to keep the valve working.

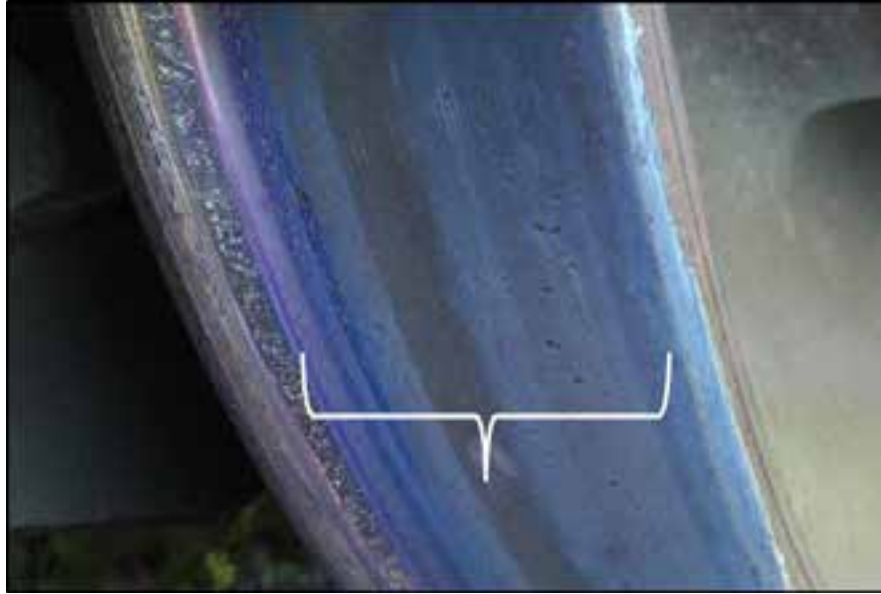
Photo 12. Blueing of locomotive wheel due to heat

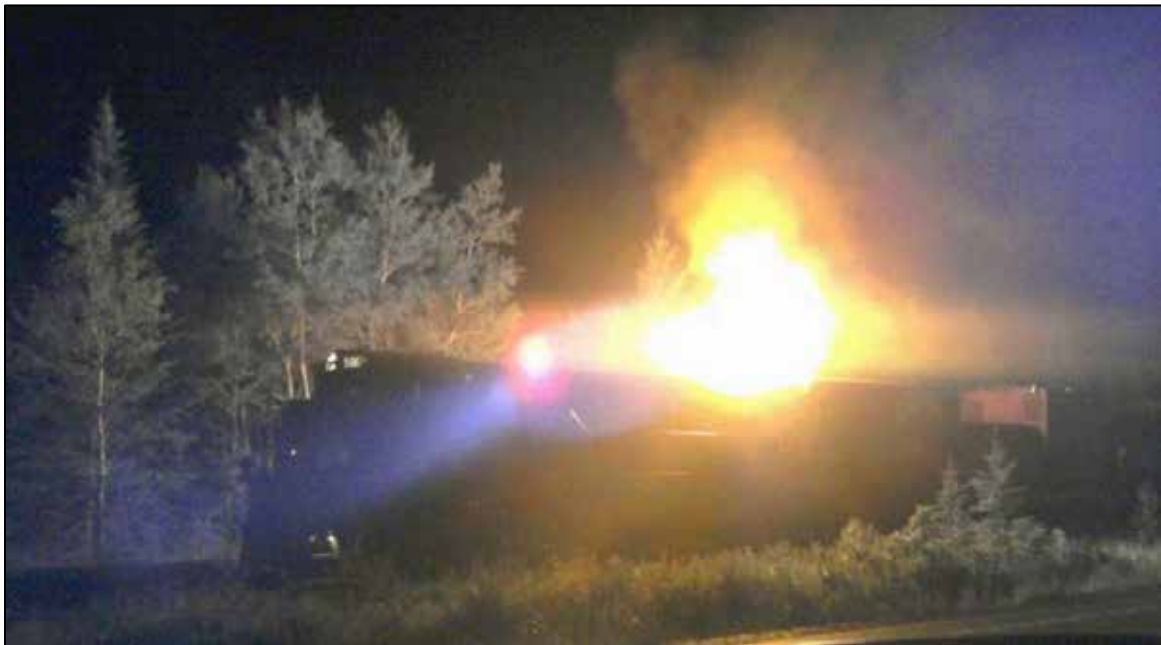
Photo 13. Locomotive fire at Nantes (photo: Nancy Cameron)

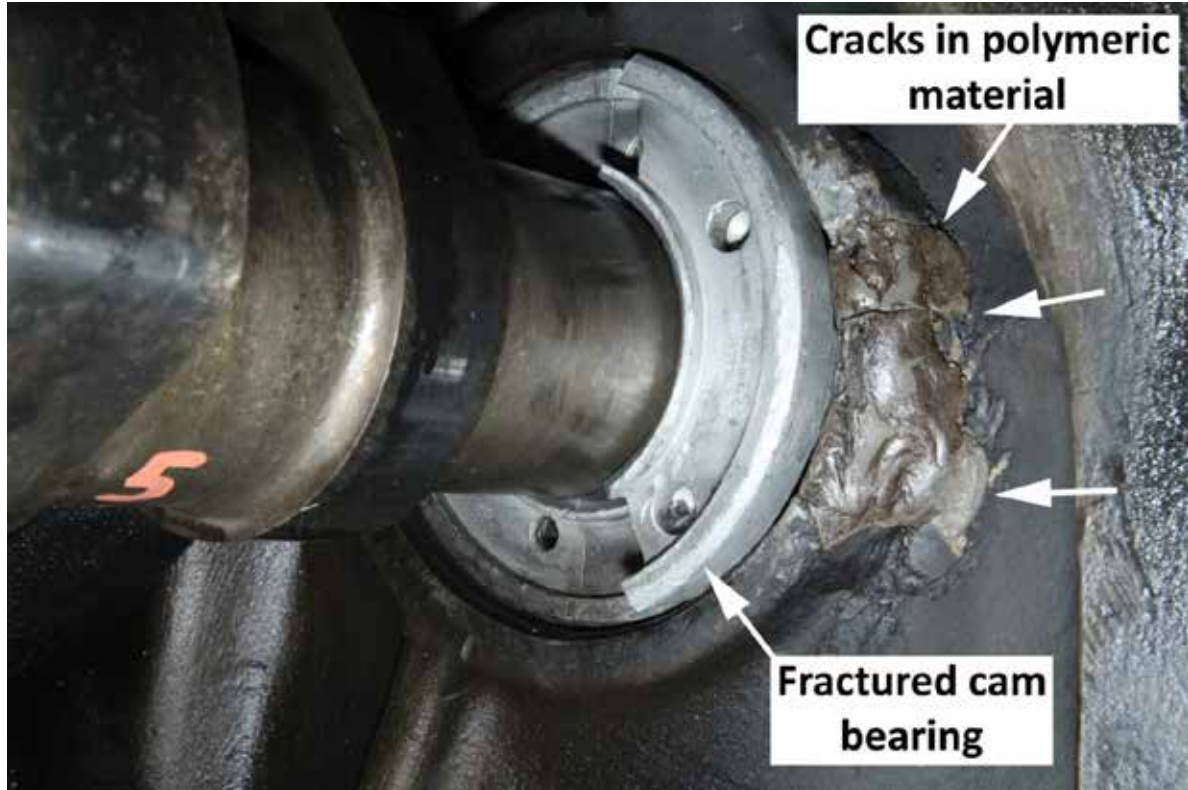
Following the accident, the locomotive consist was moved from Lac-Mégantic to a maintenance facility in Saint John for examination. A partial engine teardown of MMA 5017 was conducted (see Engineering Laboratory Report LP181/2013 for complete details). It was determined that the cam bearing had fractured when the mounting bolt was over-tightened after the cam bearing had been installed as part of a non-standard repair to the engine block. This temporary repair had been performed using a polymeric material, which did not have the strength and durability required for this use (Photo 14). Failure of the cam bearing reduced the engine oil supply to the valve train at the top of the associated power assembly. The decreased lubrication led to valve damage and eventually to a punctured piston crown. The damaged valves and piston crown allowed engine oil to flow into the cylinder and the intake and exhaust manifolds. Some of the engine oil collected in the body of the turbocharger. The engine fire later occurred in the exhaust stack due to the build-up and ignition of engine oil in the body of the turbocharger.

Photo 14. Polymeric material applied to cam bearing bore and fractured cam bearing

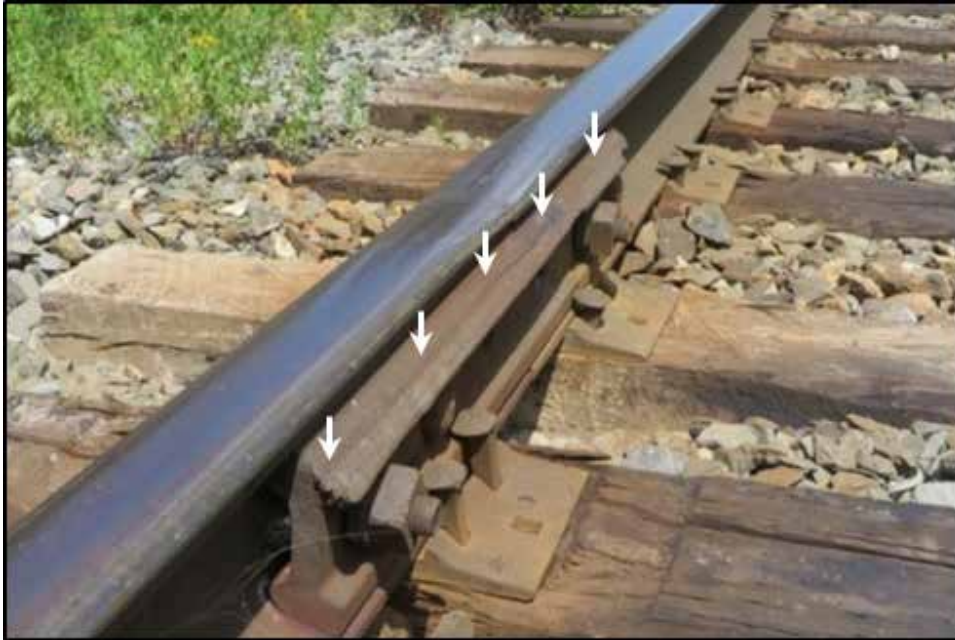
Photo 15. Damaged rail joint bar due to contact with wheel flanges

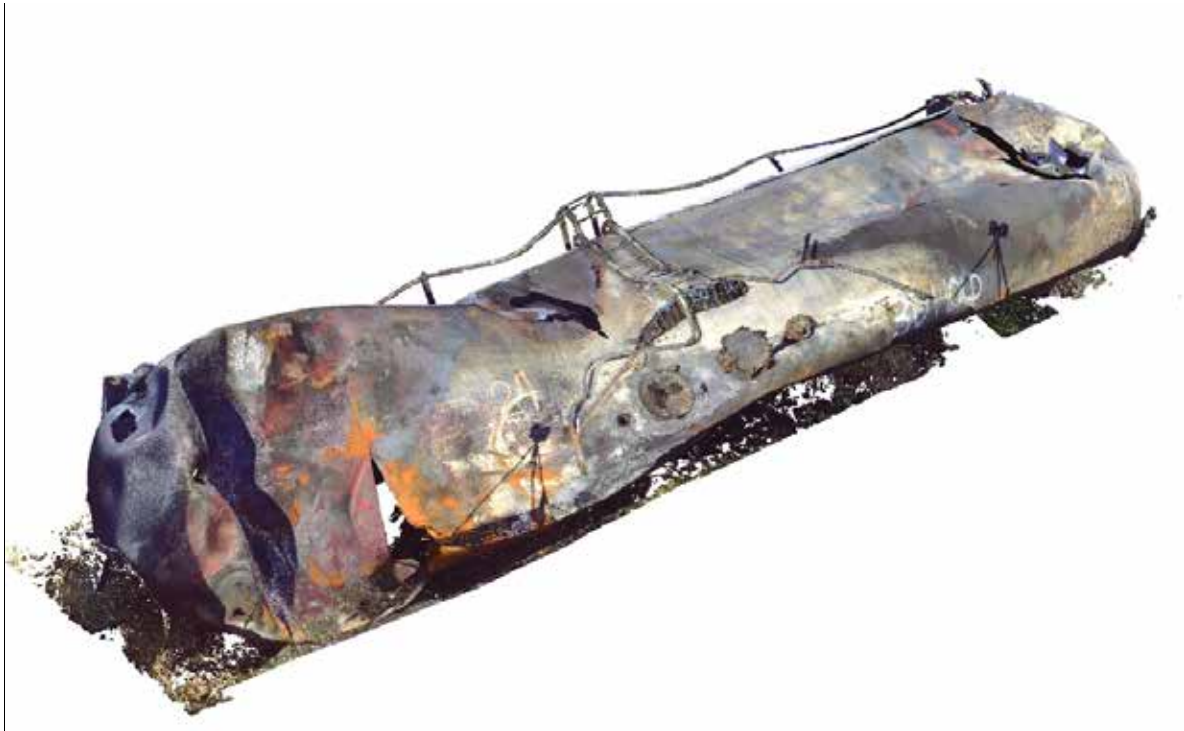
Photo 16. 3D laser scan of badly deformed tank

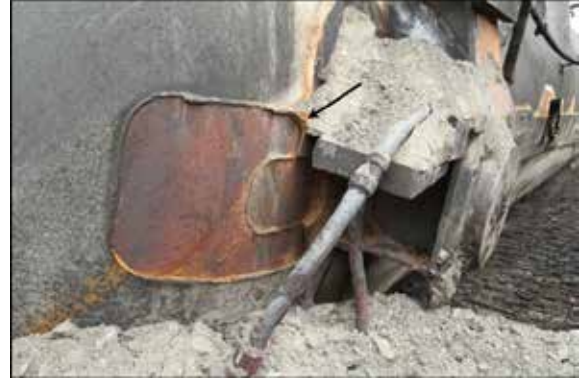
Photo 18. Damaged stub sill

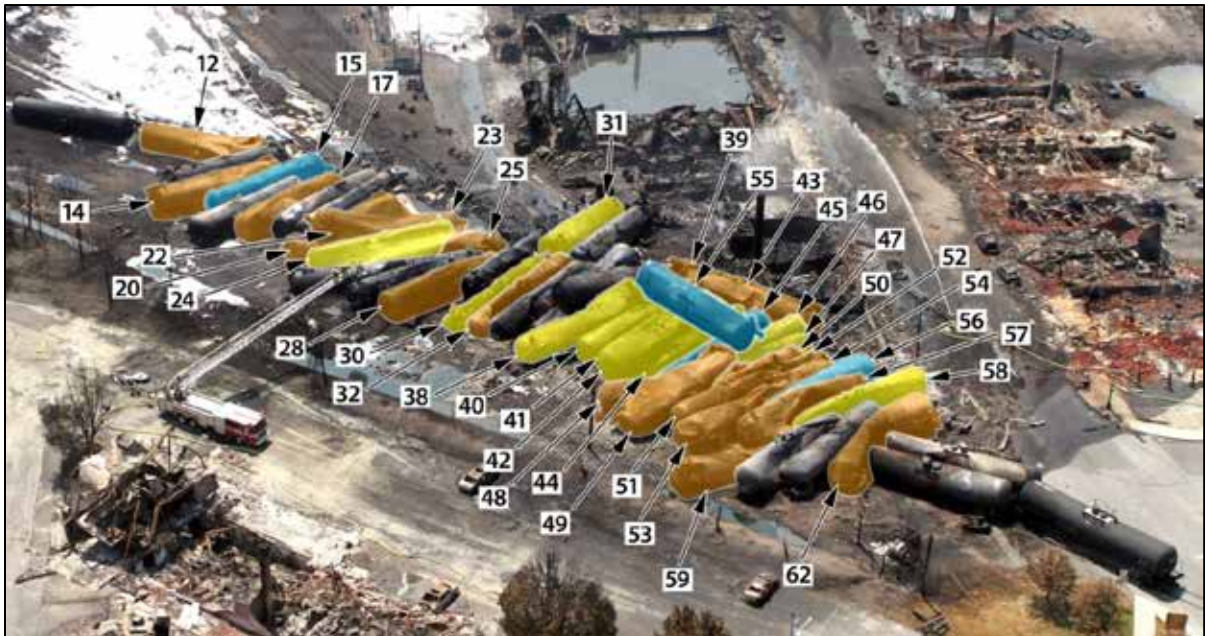
More than half of the tank cars (37 cars) released product due to impact damage to their shells (Photo 19). Other tank car shell damage included deformed/dented shells with no breach, as well as breaches due to thermal tears.

Photo 19. Tank cars with breaches to their shells (colour indicates relative size of breach: orange = large, yellow = medium, blue = small). The relative size of the breaches is also identified in Appendix B.

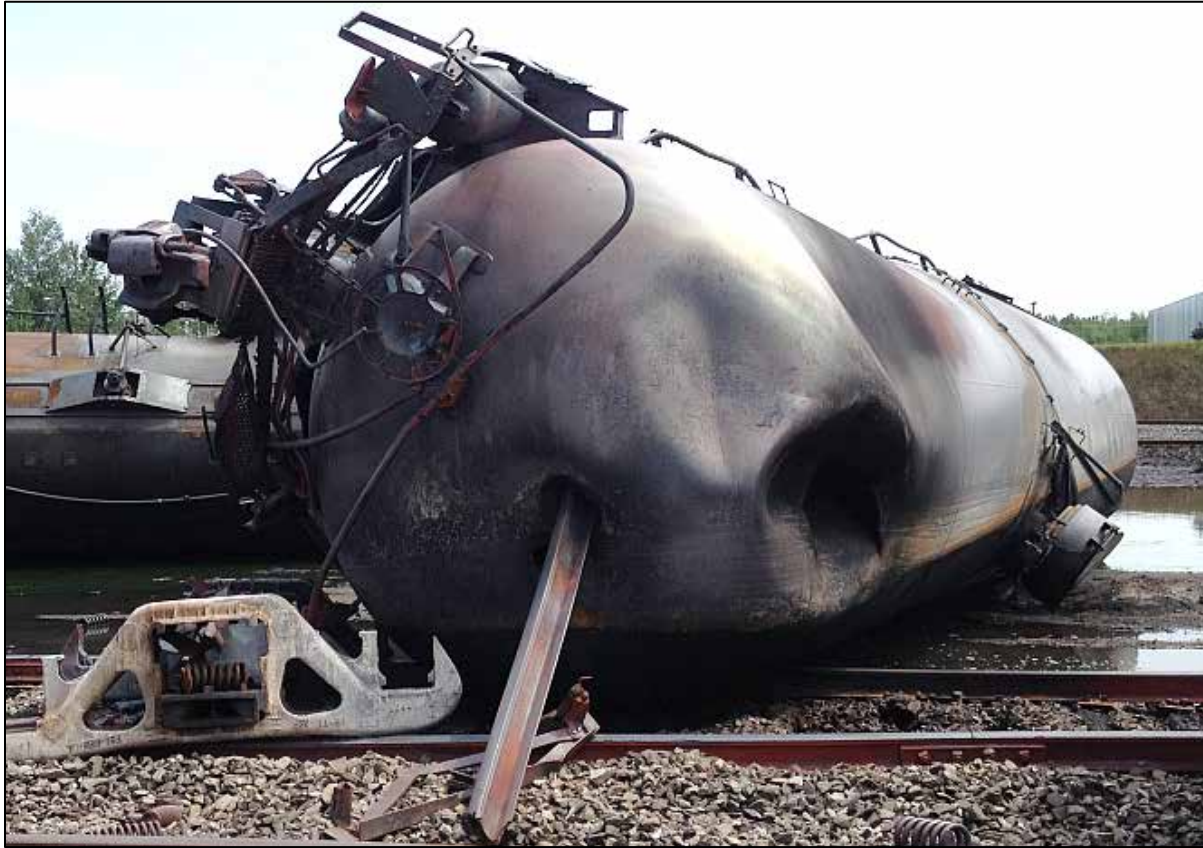
All but 4 of the 63 derailed cars exhibited some form of impact damage (for example, denting or breach) in the top portion of at least one head (Photo 20). About half of the tank cars (31) released product due to damage to the tank car head.

Photo 20. Head puncture due to rail impact

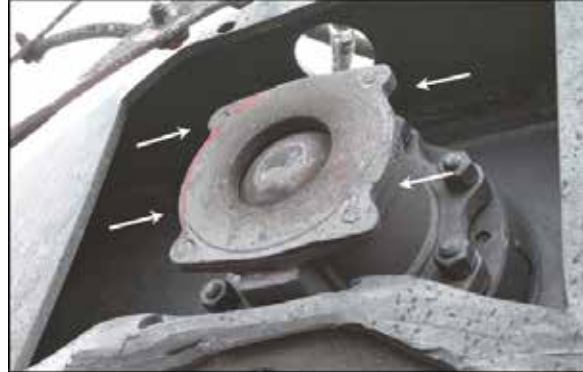
Photo 26. Bottom outlet valve with sheared-off nozzle

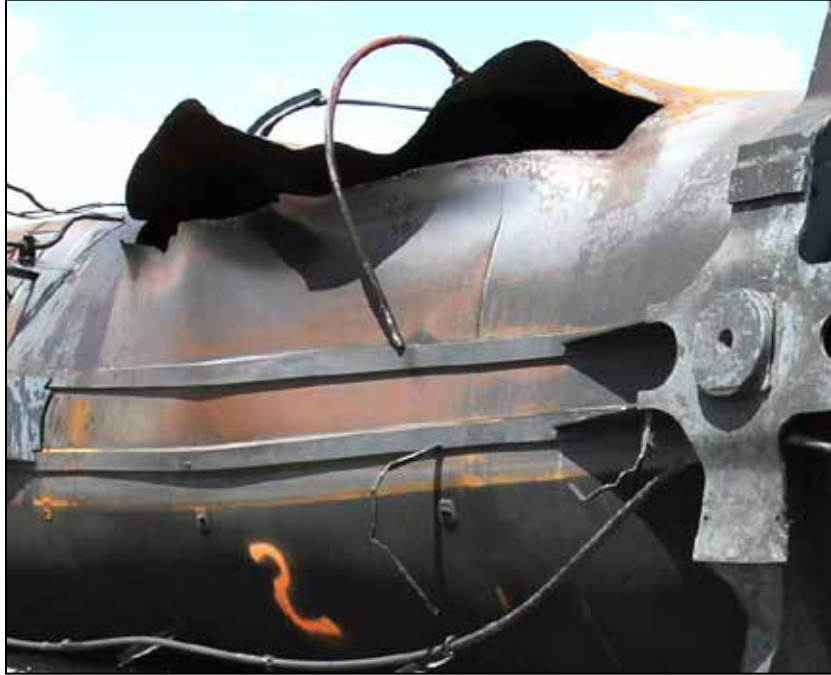
Photo 27. Thermal tear

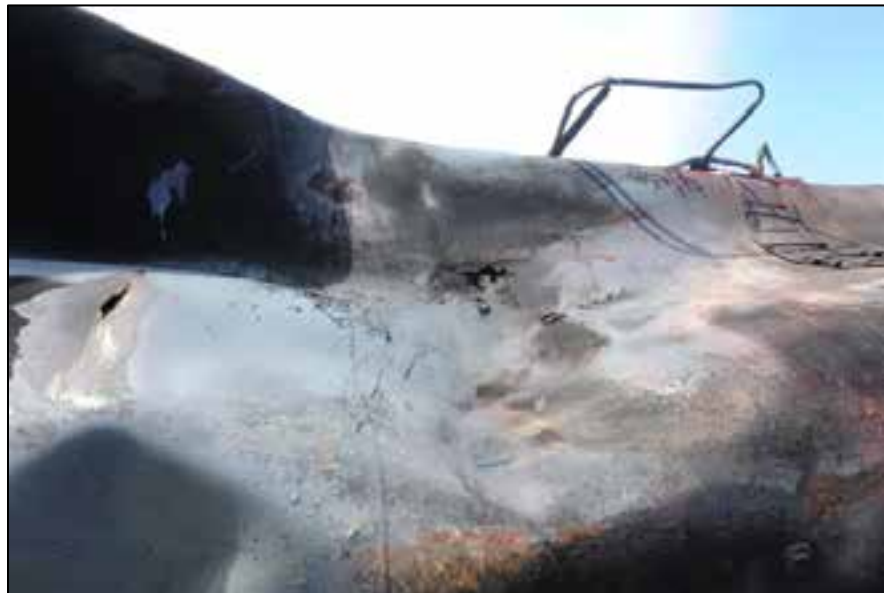
Photo 28. Burn-through

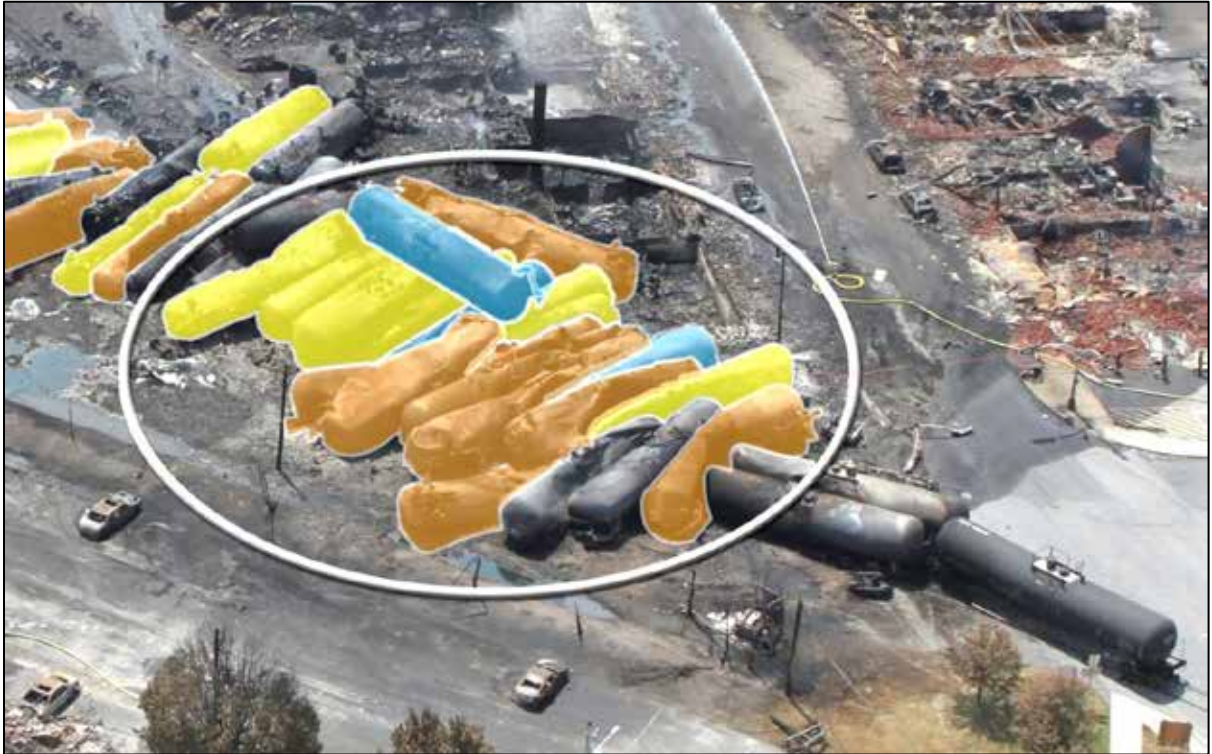
Photo 30. Concentration of large (orange) and medium (yellow) breaches toward the end of the derailment

About half of the cars with large breaches were clustered toward the end of the derailment. These cars would have encountered more severe derailment conditions than the conditions experienced by the cars located toward the front of the train, due to the large pileup ahead of them. This pileup likely acted as a wall for the cars derailing toward the end of the train. These highly constrained derailment conditions caused large-scale buckling and extreme tank deformations (that is, plastic collapse), which resulted in large shell ruptures. These cars derailed at a slower speed, and came to rest perpendicular to the track. Their thin wall construction (7/16 inch), as well as the absence of jackets, did not provide sufficient protection from the derailment forces. Consequently, large tank shell breaches occurred in a short period of time on about 1/3 of the derailed tank cars, which resulted in the rapid release of large quantities of petroleum crude oil.
