Transportation Safety Board  
of Canada

**MARINE INVESTIGATION REPORT  
M13N0014**

**CAPSIZING OF TOW AND ACCIDENTAL DEATH  
TUG *WESTERN TUGGER* AND BARGE *ARCTIC LIFT I*  
33 NAUTICAL MILES SOUTHWEST OF BURGEO,  
NEWFOUNDLAND AND LABRADOR  
10 MAY 2013**

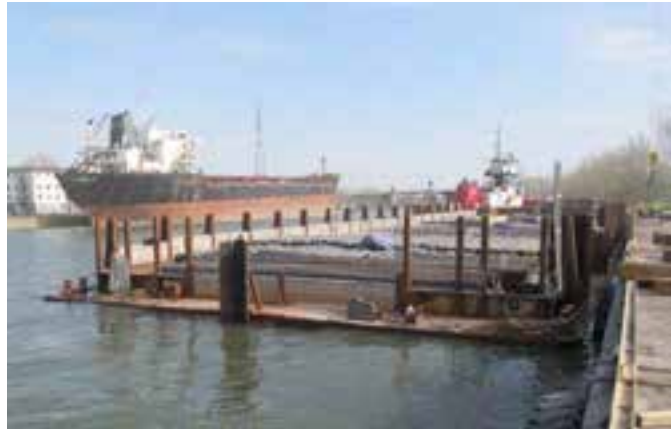
Photo 1. The *Arctic Lift I*, before departure from Sorel, Quebec

The barge *Arctic Lift I*, constructed of welded steel, was built in 1972 in the US (Photo 1). At the time, as per US regulations, it was assigned a load line<sup>2</sup> by the American Bureau of Shipping. The vessel was sold to a Canadian owner and began operating in Canada in 1998. The current owner purchased and salvaged the barge after a previous occurrence had left it a constructive total loss in 2006.

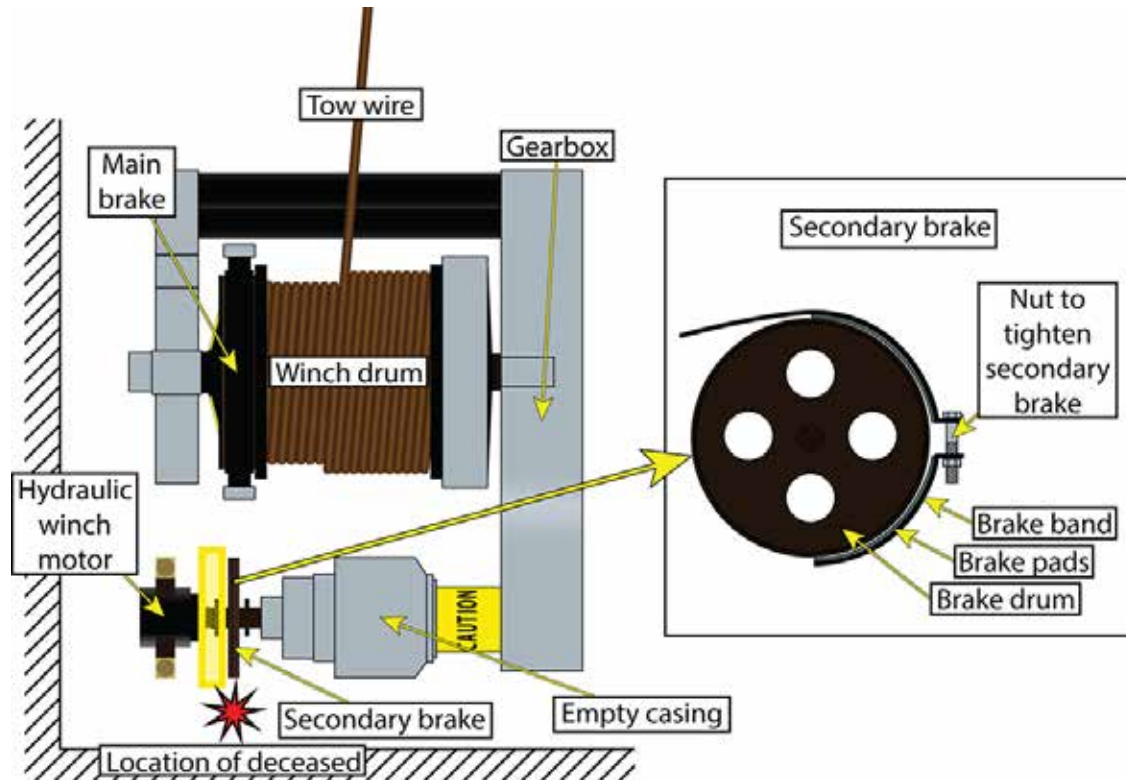
Figure 1. Simplified diagram of the towing winch, showing the locations of the 2 brakes and the nut used to tighten the secondary brake.

The tug had an emergency tow release that was intended to allow an operator located in the wheelhouse to immediately release both air brakes; however, this function was overridden by the nut-and-bolt assembly on the secondary brake.

On the *Western Tugger*, the main brake was unable to keep the winch drum from slipping while towing, even with the on-board practice of keeping the drum clutched in to the motor. For this reason, a secondary brake, which consisted of a brake drum on the drive shaft, had been

installed.<sup>5</sup> However, these 2 brakes combined were still unable to keep the winch drum from slipping, so the on-board practice was to manually tighten the nut-and-bolt assembly on the brake band of the secondary brake in order to stop the winch drum from slipping.

Although the vessel had an emergency tow release, it could not be activated from the wheelhouse due to the nut-and-bolt assembly on the secondary brake. As such, the master requested that the deckhand go to the winch room and stand by to loosen the nut. Moments later, the forward end of the barge rose out of the water and the barge capsized. The resulting strain on the secondary brake drum caused it to shatter, and parts of it hit and fatally injured the deckhand.

The remote release on the *Western Tugger* was unable to function as intended because of the nut-and-bolt assembly on the secondary brake drum. The installation of a nut-and-bolt assembly required a crew member to enter the winch room and manually loosen the nut before the winch drum would pay out the tow wire, rendering the emergency tow release ineffective. This practice introduced a hazard to operations, which was not identified or mitigated.

The vessel operator is repairing the vessel's towing winch, which will not incorporate a second brake.

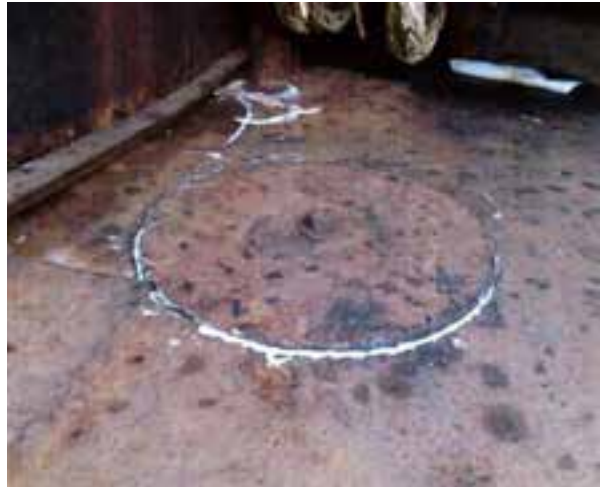
Photo 3. Silicon sealant on 1 of the 26 hatch covers

Prior to loading the cargo for this voyage, the barge owner visually inspected the seals on the hatches. A bead of silicon was applied around selected hatch covers where the previously applied sealant had deteriorated (Photo 3).

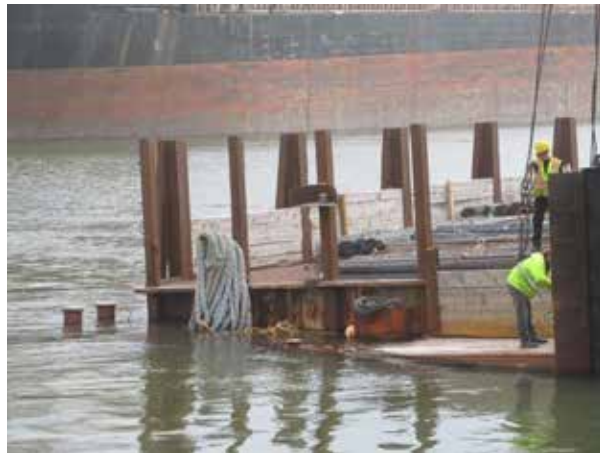
Photo 4. After end of barge during loading

Upon completion of cargo loading, the surveyor determined that the barge was trimmed 106 cm by the stern, with measured freeboards of 122 cm forward and 15 cm aft. These numbers were agreed upon and signed off by the master, and a copy of the survey was sent to the vessel’s owner.

In this occurrence, the *Arctic Lift I* had measured freeboards of approximately 122 cm forward and 15 cm aft in fresh water. Calculations by the Transportation Safety Board (TSB) determined that, given these freeboard measurements, the aft deck edge would be submerged at a 1° roll, or in a 0.15 m sea. When the barge entered salt water, the freeboard would have increased to 132 cm forward and 25 cm aft. Aft deck edge immersion would have occurred at 1.3° roll, or in a 0.25 m sea.

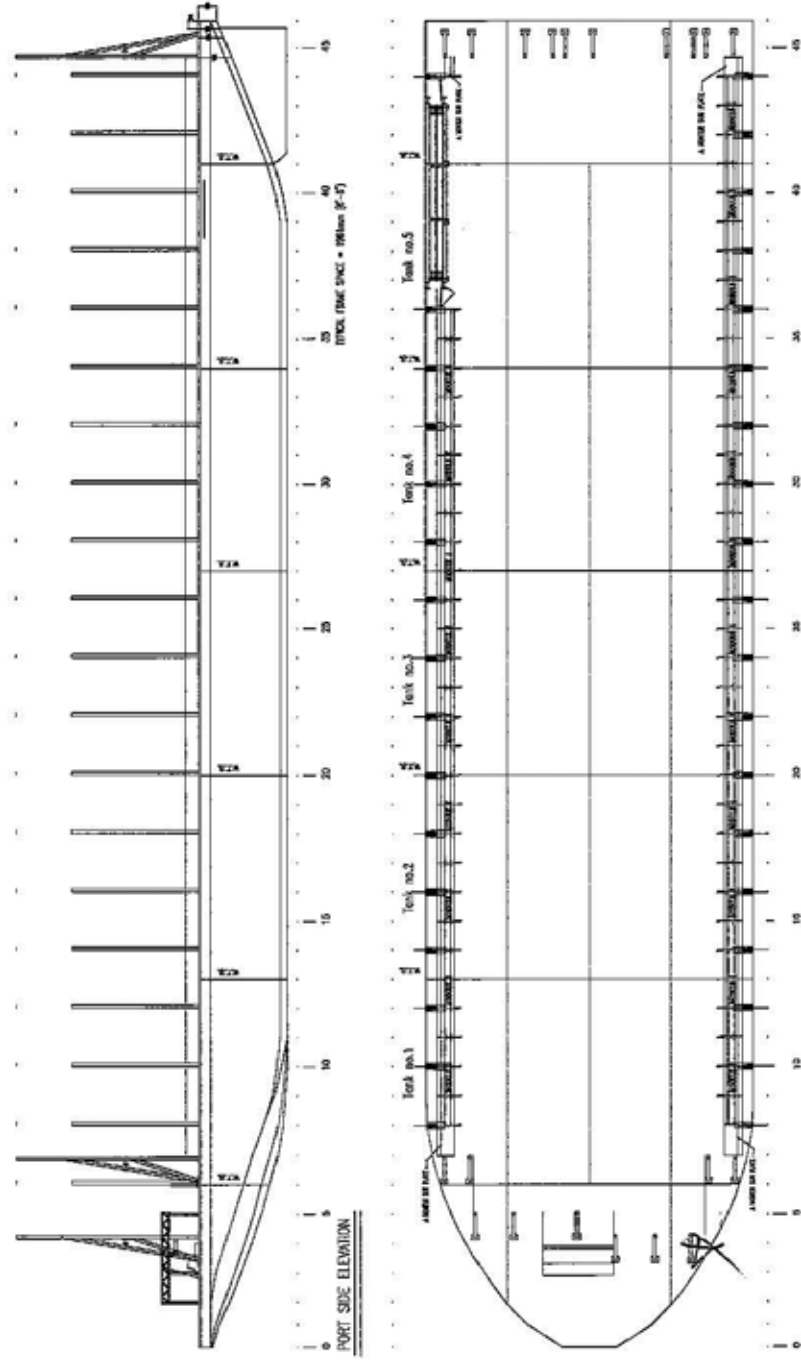
## Appendix A – Arctic Lift I general arrangement

The hull is subdivided by 3 longitudinal bulkheads and 6 transverse bulkheads into 26 compartments (Appendix A). A steel bin-wall, 1 m in height, partially surrounds the barge. Each compartment has a hatch and an accompanying hatch cover. The hatch covers on the *Arctic Lift I* had been fabricated by the current owner to replace the original ones. The new covers were designed to be secured by a nut on the top of the hatch cover and by a dog underneath that could be tightened against the underside of the deck. The on-board practice for sealing the hatches was to apply a bead of household silicon around the perimeter of the hatch opening before securing the hatch down. Another bead of silicon was then applied around the exposed edge of the hatch cover.

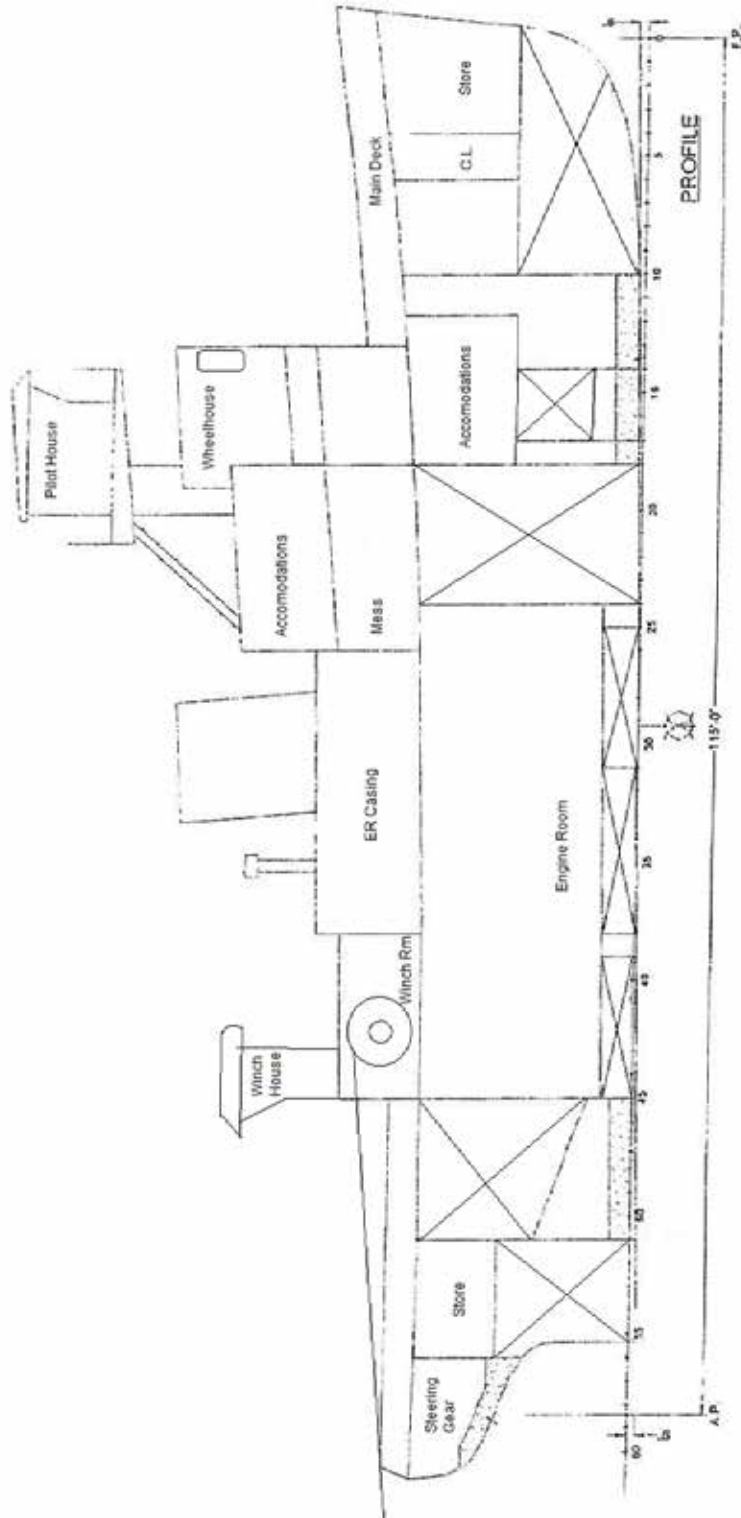
Appendix B – Profile of the Western Tugger

The towing winch is located in a winch room that is aft of the deckhouse on the main deck (Appendix B). The winch is operated from a winch house located directly above the winch room.<sup>3</sup> The towing wire on the winch at the time of the occurrence was 460 m long and 5.08 cm in diameter. The towing winch itself was equipped with a main air brake on the steel winch drum and a secondary air brake on the drive shaft (Figure 1). Because the winch drum had a tendency to slip while towing, even with both brakes applied, a nut-and-bolt assembly on the secondary brake was used to tighten the brake band and hold the winch drum in place. When

When the secondary brake drum on the *Western Tugger* shattered, shards from the drum holed the deckhead and damaged the remote shut-off for the vessel's carbon dioxide extinguishing system. The shards also made dents and punctures in the winch room forward bulkhead and deckhead.
