Pipeline Incident Report

Investigation Pursuant to Section 12 of
the *National Energy Board Act* into the
20 July 2009 Rupture of the NOVA Gas
Transmission Limited Peace River
Mainline at KP 379, South of High Level,
Alberta, Canada

November 2013

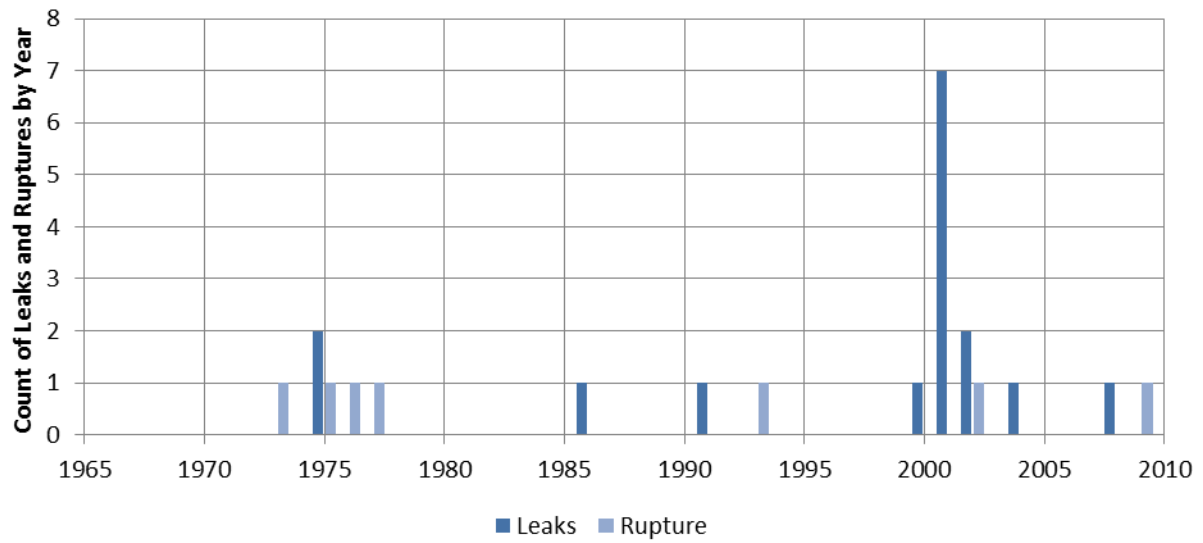
Figure 2: Peace River Mainline Leaks and Ruptures by Year

In 1973, the PRML experienced its first rupture due to geotechnical forces⁴. Since then, external corrosion has become the predominant failure mechanism, causing 16 leaks and 6 ruptures. Figure 2 provides a graphical representation of the number of pipe body leaks and ruptures over the lifecycle of the PRML.

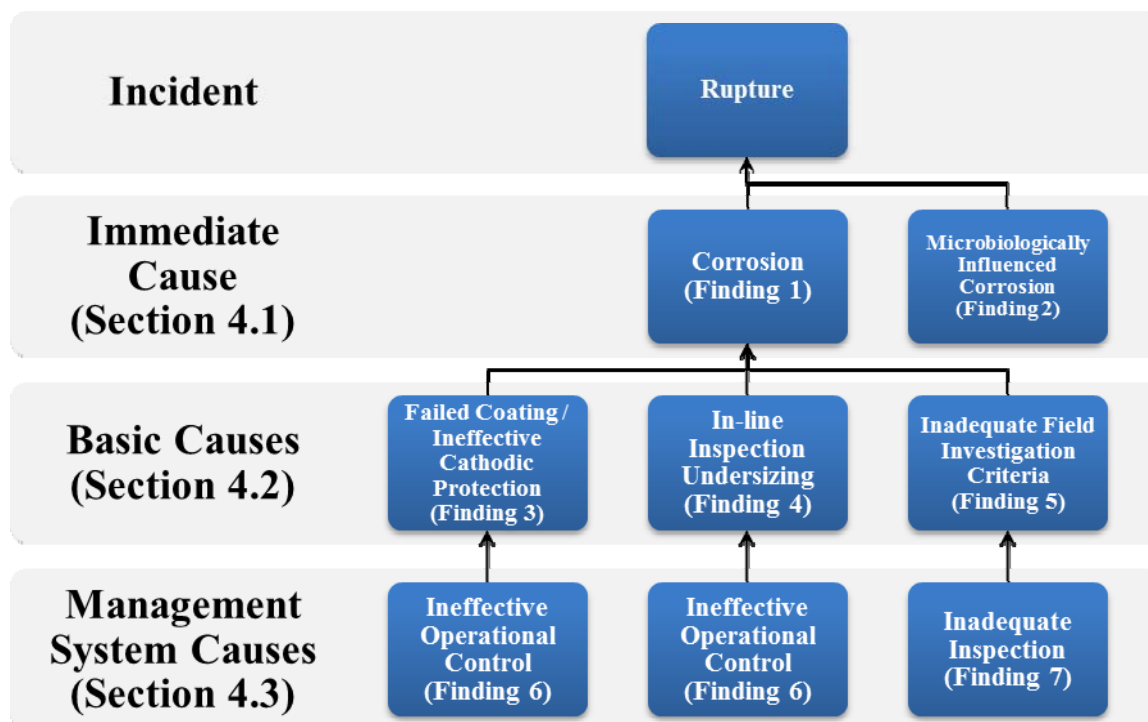
Figure 3: Causal Flow Chart for 2009 Rupture of the PRML

Finding 1. External corrosion was the immediate cause of the 20 July 2009 rupture of the PRML.

Finding 2. Microbiologically influenced corrosion was a contributing factor to the 20 July 2009 rupture of the PRML.

Finding 3. Failed Polyvinyl Chloride (PVC) coating that resulted in localized shielding of cathodic protection was a basic cause of the 20 July 2009 rupture of the PRML.

Finding 4. The MFL ILI tool's inability to accurately characterize complex geometries of corrosion was a basic cause of the 20 July 2009 rupture of the PRML.

Finding 5. Inadequate field investigation criteria was a basic cause of the 20 July 2009 rupture of the PRML.

Finding 6. Ineffective operational control was a management system cause of the 20 July 2009 rupture of the PRML.

Finding 7. Inadequate inspection was a management system cause of the 20 July 2009 rupture of the PRML.
