The Renovation of an Apartment Building with Solid Masonry Walls

Research Highlight

Research Report: *The Renovation of an Apartment Building with Solid Masonry Walls*

Research Consultants: Dr. Robert Dumont, Larry Snodgrass and Jerry Makohon, Building Performance Section, Saskatchewan Research Council

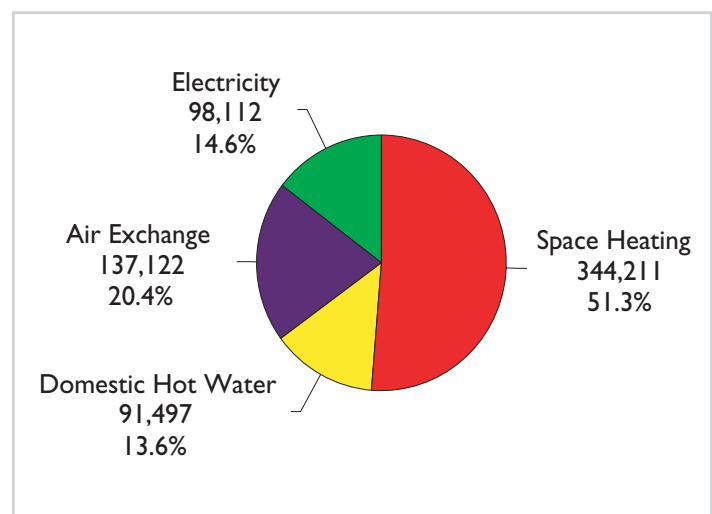
Figure 1 Annual Post-Retrofit Energy Consumption

The energy consumption of the renovated building was compared to pre-renovation use. Despite the installation of upgraded thermal insulation, air barrier system, radiant floor heating, and new windows, the building consumed 670,942 kWh (399 kWh/m² or 0.061 kWh/m²/degree-day). Approximately 20 per cent more natural gas was consumed in the first year after the renovation than was used in the previous year. The installation of a high capacity, continuously operating ventilation system, increased occupancy, and occupants' preference for relatively high indoor temperatures are likely the primary causes of the increased energy consumption. However, when the energy consumption of the building is normalized to building area and degree day location, it is found to be comparable to other, recently constructed, mid-rise residential buildings in Canada.
