Performance of a Brick Veneer/Steel Stud Wall System

The subject of the research summarized here is an exterior wall section on the top floor of a seven-storey residential building in Ottawa. It was built in 1990. Instrumentation was incorporated in the wall to allow temperatures, air pressures, and moisture in key locations inside and outside the wall to be monitored and recorded. Moisture was sensed as humidity in air, as water on surfaces and as water absorbed in materials. The sample wall was on the lee side of the building with respect to prevailing winter winds. Thus, combined stack, wind, and fan pressures would maximize air leakage in cold weather. This orientation placed the wall on the windward side during prevailing rains, maximizing exposure to moisture from rain as well as from winter air leakage and resulting condensation. The project was selected because the designers, contractors and owner were all willing to participate.

Research Highlight

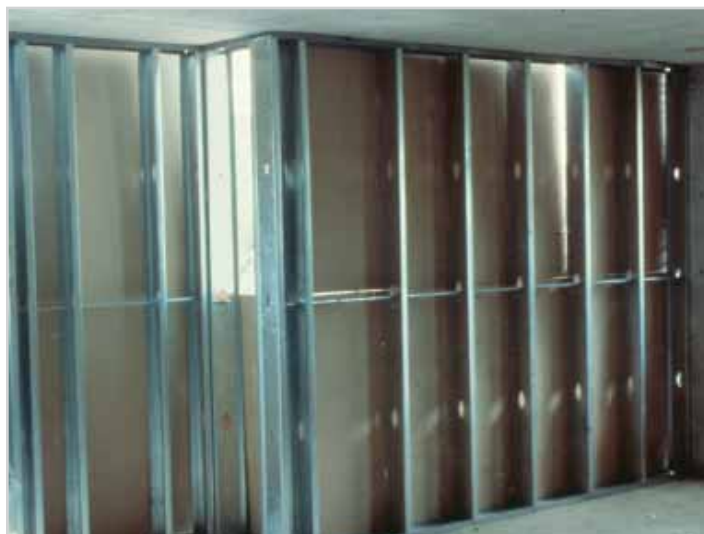
Photograph 1 Framing and Exterior Sheathing

The sheathing is not fastened against the framing yet, but when it is, gaps will remain at the joints that make the sheathing the least air-tight layer in the wall.

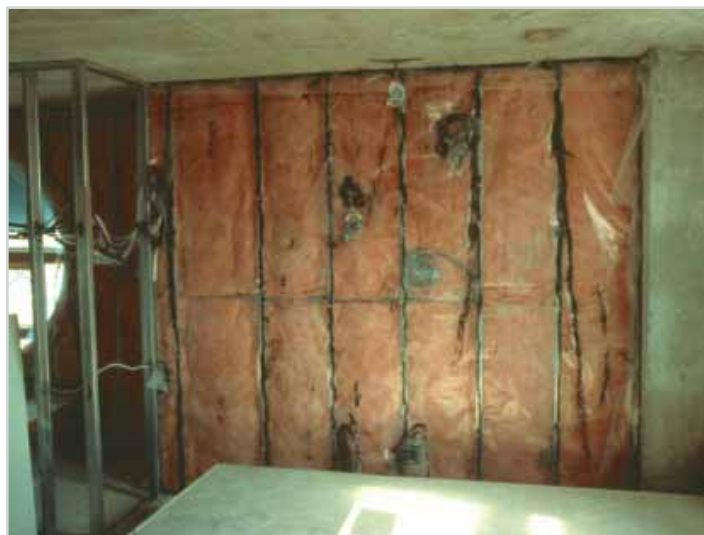
Photograph 3 Insulation and Vapour Barrier

The researchers observed the wall during construction and found that it generally conformed to the design. The workmanship was of above-average quality. Thermocouples, relative humidity sensors, moisture sensors and pressure taps, along with a computer system to collect and record data, were installed. **Photograph 3** shows the wall during construction, with studs, insulation and vapour barrier in place.

The polyethylene vapour barrier is sealed at laps and to adjoining concrete. Electrical outlets have polyethylene back pans, and other penetrations are sealed. For a wall that depends on the vapour barrier to be an air barrier as well, it is reasonably tight.

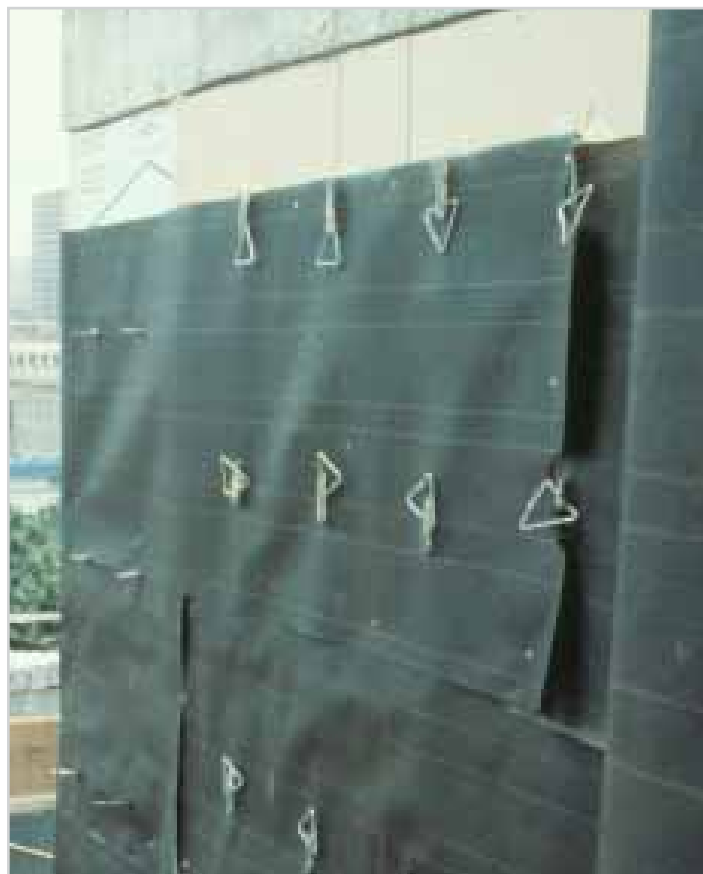
Photograph 2 Sheathing Paper and Masonry Ties

The sheathing paper is lapped to drain, but will not be a barrier to exfiltration. The corner column is insulated on the exterior with rigid extruded polystyrene insulation. At the bottom of the cavity, rigid insulation on the slab edge (covered with paper in this view) extends outward from the plane of the wall, narrowing the cavity at the bottom.

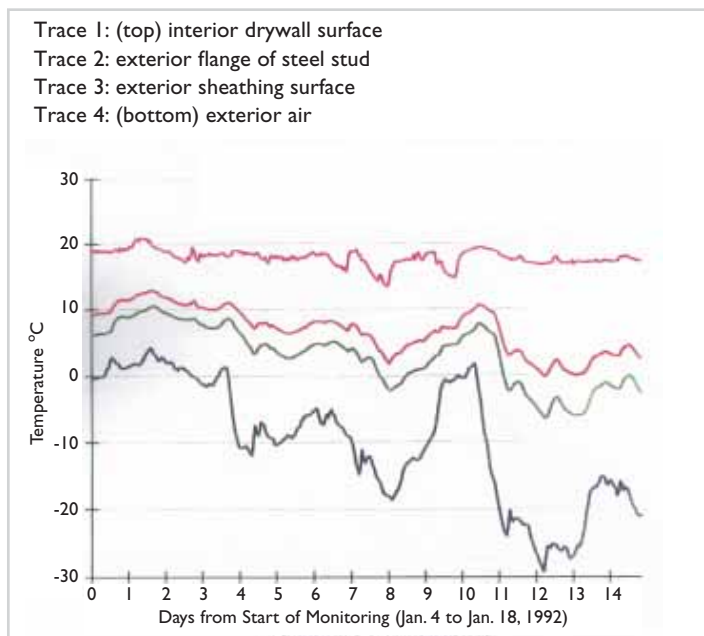
Figure 1 Temperature profile at stud

Thermocouples on stud flanges recorded different temperatures than those located on the corresponding gypsum board surfaces midway between studs. **Figure 1** shows the thermal profile through the wall at a stud, while **Figure 2** shows the profile midway between studs, for the same time period.

The temperature drop across the stud space is larger midway between studs than at a stud. At the stud, the stud space contributes about half of the total temperature difference, while midway between studs it contributes between two thirds and three quarters of the total. Since the thermal resistances of all the other components (air films, drywall, brick, and cavity) are the same in both cases, this is an indication of the extent of thermal bridging.

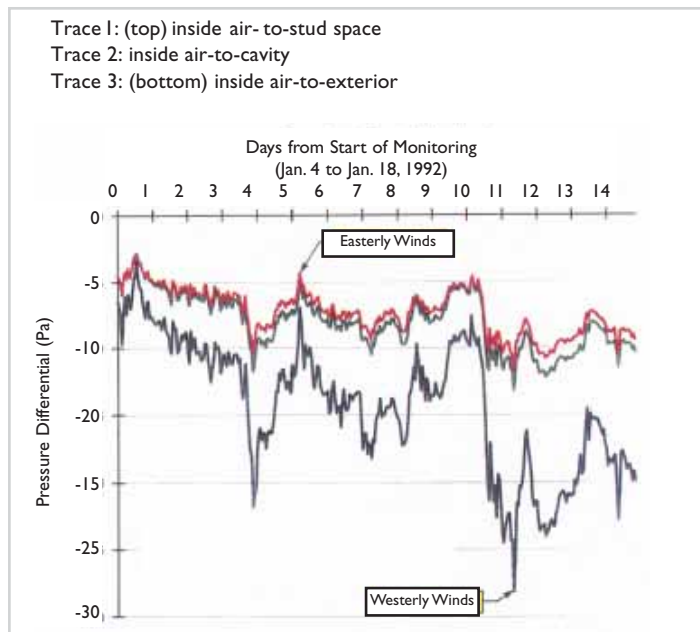
Figure 3 Hourly average pressure differences (before modification of venting)

Pressure taps were located at the exterior, in the cavity, in the stud space, and on the interior. **Figure 3**, typical for winter conditions, shows that the pressure on the interior was usually higher than on the exterior. The pressure difference driving air outward was reduced, but not reversed, by wind toward the wall, and wind away from the wall increased it. The graph also shows that the cavity behind the brick is pressure-moderated, not pressure-equalized. In fact, at least in winter, the cavity at this location was usually at a higher hourly average pressure than if it had been compartmented and pressure-equalized to the exterior. Two significant pressure drops occur, the first from the interior to the stud space, the second across the brick veneer. The relative magnitude varies, but at times the pressure difference across the brick is larger than that across the rest of the wall. Dust left in the insulation, shown in **Photograph 4**, is a further indication of air leakage.

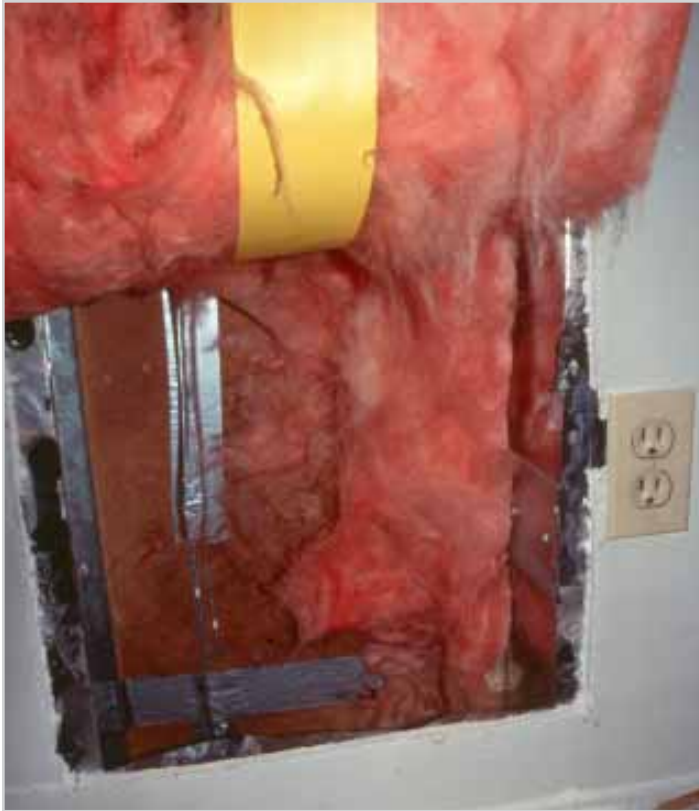
Photograph 4 Dust Staining of Insulation
Evidence of air leakage: dust left behind in the insulation.

- Insulation on the exterior, in the cavity, sufficient to keep the gypsum sheathing above the interior air dewpoint temperature (this will also reduce thermal bridging of framing).
- Better airtightness, to reduce latent heat loss and reduce condensation in brickwork.
- A larger minimum cavity depth, to promote drainage and drying.
- Better venting of the cavity (arranged to exclude rain).

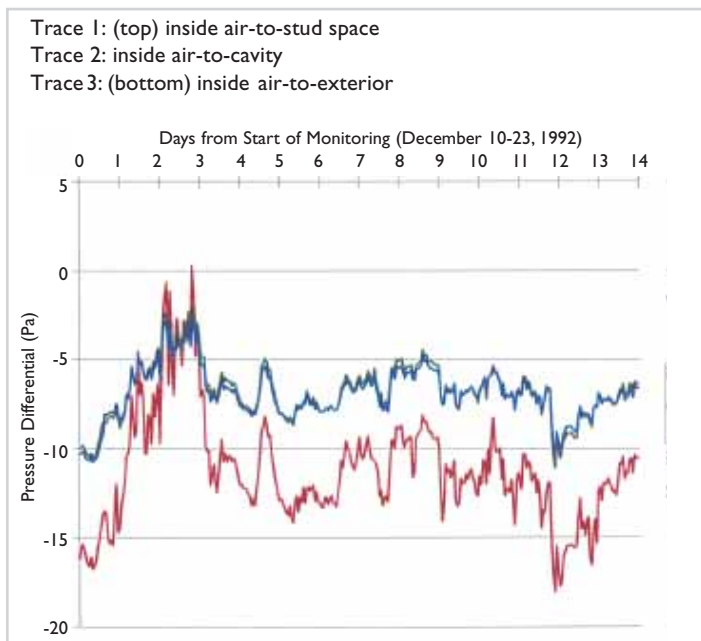
Figure 4 Hourly average pressure differences
(after adding cavity vents)

Figure 4 shows that the resistance of the brick veneer remained significant after the addition of vents. The contribution to air flow resistance of the brick was reduced from about a half of the total pressure drop to about a third, while the pressure across the air barrier increased to about two thirds. (Note that 0 Pa is not at the top of the graph, as it is in **Figure 3**). Because flow increases exponentially with pressure difference, with the same equivalent leakage area of the interior air barrier, adding the vents presumably caused an increase in air leakage.

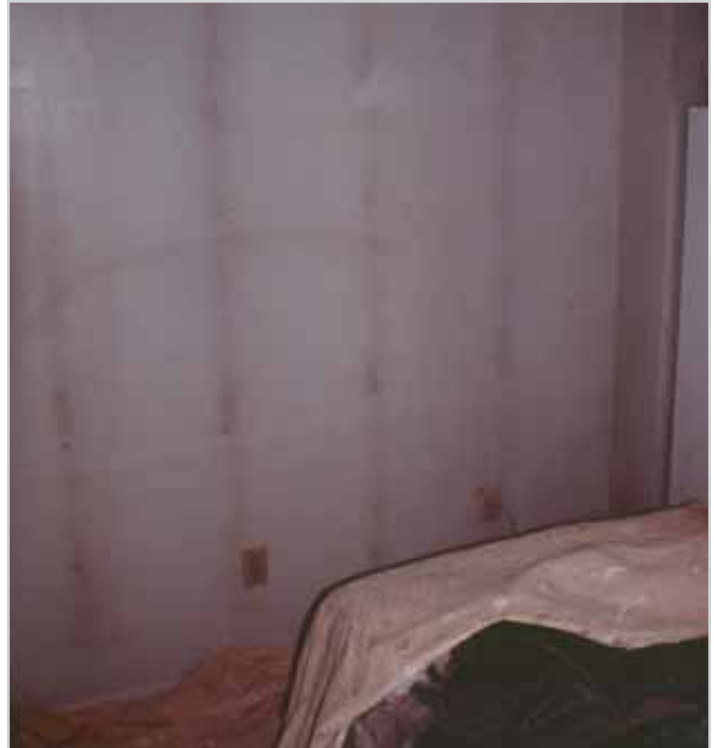
In -20°C weather the interior surface was as much as 3.5°C colder at the stud locations than midway between studs. Severe dust patterns indicating stud locations (and even drywall screws) were observed after the first year, as can be seen in **Photograph 5**.

Photograph 5 Dust Staining at Stud Locations
Thermal bridging: indoor surfaces at stud locations are colder in winter than the surfaces between studs. More dust is attracted to the cooler surfaces, resulting in the staining seen here.

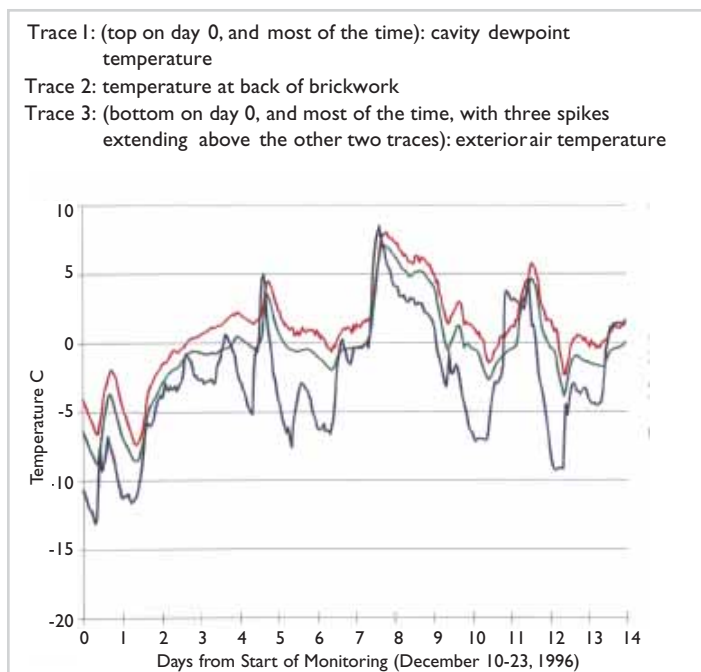
Figure 5 Temperatures of interior brick face, cavity dewpoint, and exterior air

As a result of air leakage primarily, condensation occurred on the inner surface of the brick veneer almost all of the time during late fall and winter. **Figure 5** shows the surface temperature at the back of the veneer, in relation to the dewpoint temperature of the air in the cavity and the exterior air temperature. During the period shown, the brick surface temperature was constantly below the dewpoint temperature, indicating that condensation was occurring. Even when exterior air temperature rose above the cavity dewpoint (when a period of drying might be expected), although the cavity dewpoint temperature rose, the brick remained colder.

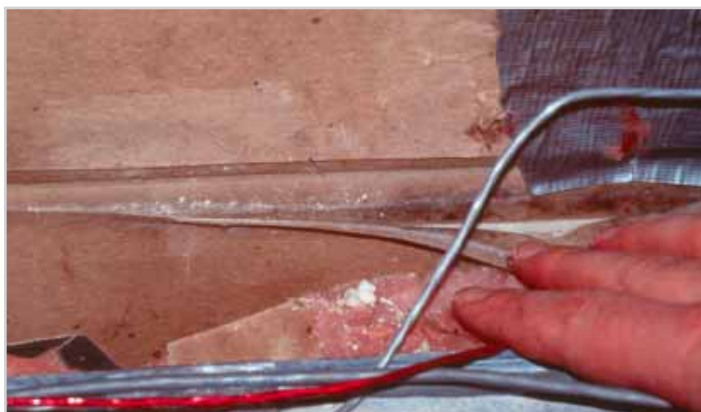
Photograph 6 Dust Staining of Insulation

The corresponding situation was similar for the back of the sheathing and the dewpoint temperature of the air in the stud space. While the coldest part of the stud, the exterior flange, was always warmer than the dewpoint temperature of the air in the stud space, the inside face of the sheathing midway between studs was consistently below dewpoint temperature. The mold seen on the back of the sheathing after a year, shown in **Photograph 6**, is further evidence.

When the wall was opened, this staining was visible on the interior side of the exterior sheathing—here at mid-height, and to a greater extent at the base of the wall.

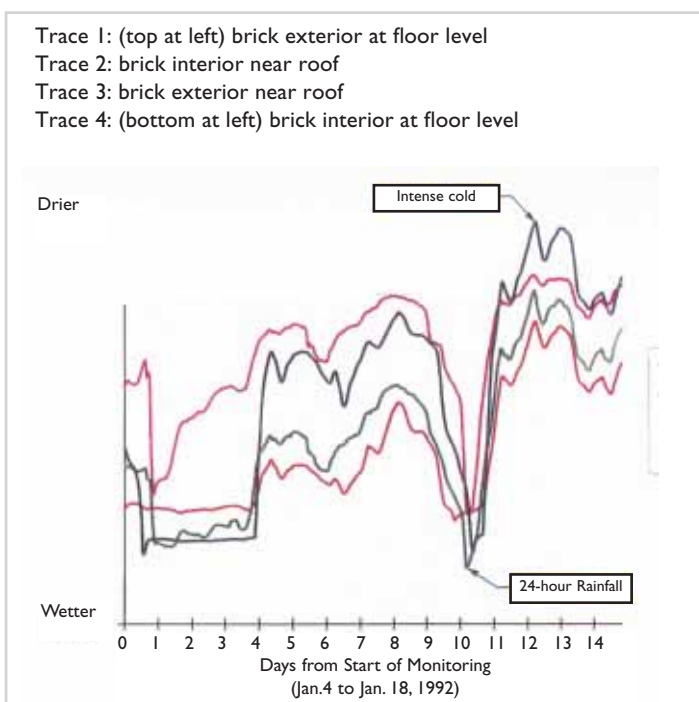
Figure 6 Relative wetness of brickwork

Moisture sensors revealed that in fall, winter, and spring the interior face of the brick was relatively wet, much more so than the exterior. When it rained, the exterior surface rapidly became wet, but dried soon after. Until the vents were added at the top of the cavity, rain penetration performance was satisfactory (after they were added the vents allowed more rain to enter the cavity). Although the wall seemed well constructed and relatively airtight, moisture problems were mainly caused by air leakage. **Figure 6** shows, in relative terms, the amounts of moisture in the brickwork, at inside and exterior faces, for locations near the roof slab, and at the floor level. In order to interpret this graph, remember that when moisture freezes, the sensor reports a false dry condition. This possibility can be judged by reading the exterior temperature, or the sheathing temperature, depending on which surface of the brick is of interest, from **Figure 2**.

The cavity did not dry out in cold weather because more moisture condensed from leaking interior air than was removed by evaporation and venting. Throughout the winter season, when freeze-thaw cycling occurred, the back of the brick remained wet. Adding vent holes allowed more moisture to enter the cavity, and did not improve drying. The brick was not uniformly wet—the cavity and the back of the brick dried out only in the summer and were wet for the rest of the year, while the exterior face was drier.
