Monitoring the Performance of a Retrofitted Preserved Wood Foundation

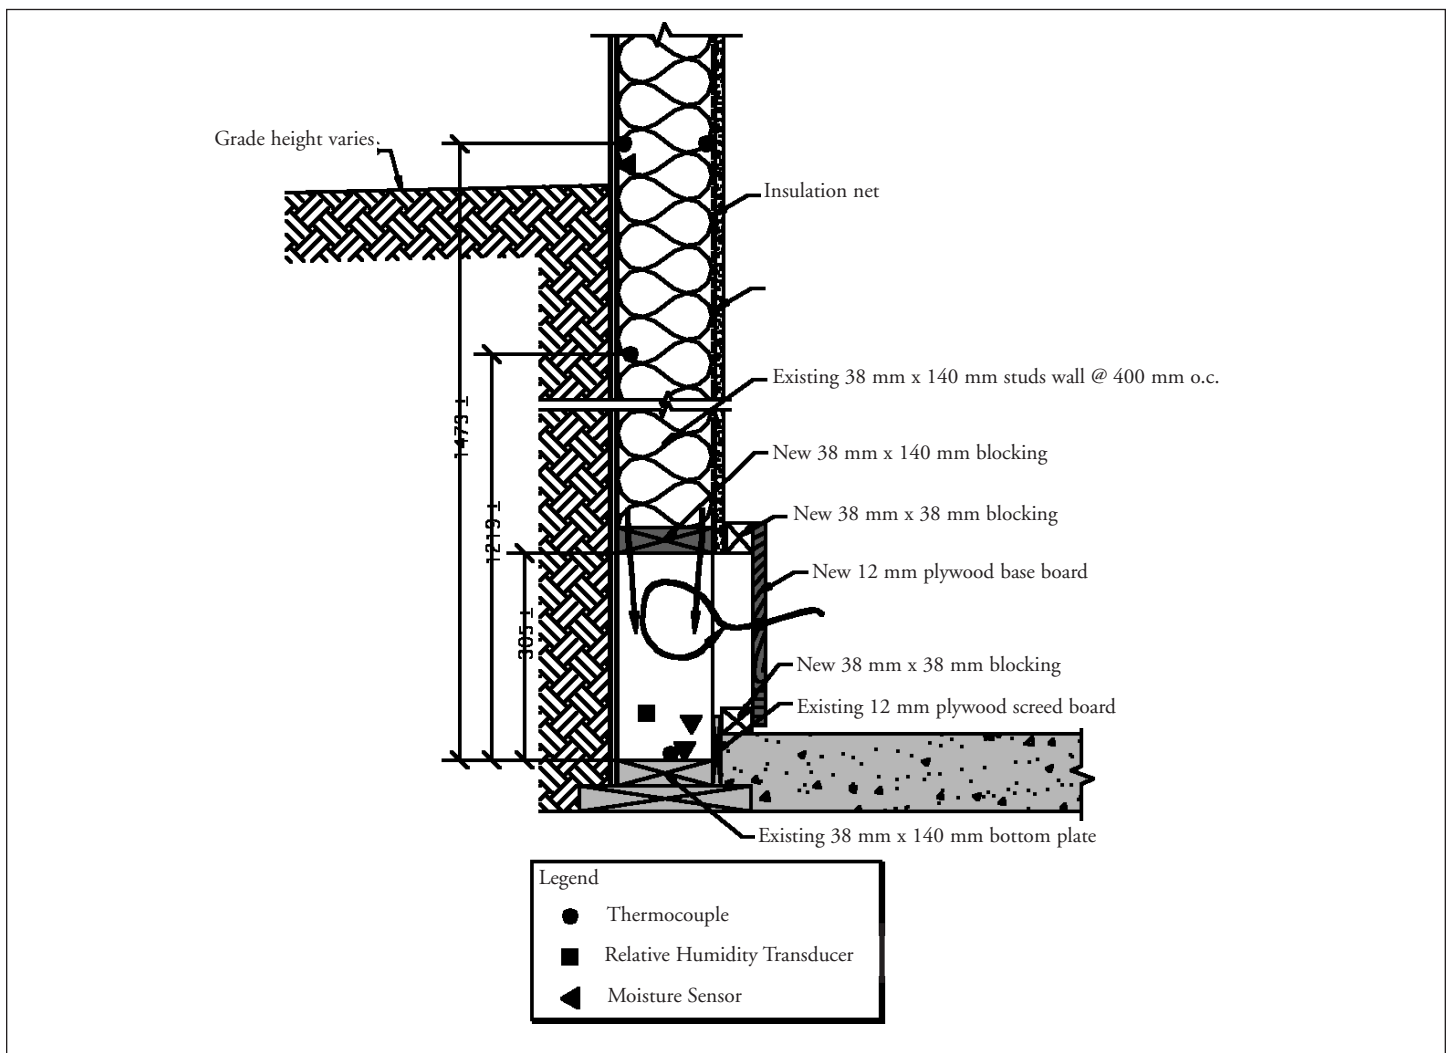
Figure 1 Typical cross-section of PWF wall

Figure 1 shows a typical cross-section of the wall and ventilation cavity, and the location of sensors. The primary findings drawn from this monitoring project were:
